Clinton Road Passive Treatment System
SRI O&M TAG Project #6 Request #1
OSM PTS ID: PA-36

Requesting Organization: Montour Run Watershed Association (in-kind partner)
Receiving Stream: West Fork of Enlow Run (Montour Run Watershed)
Watershed: West Fork of Enlow Run→Enlow Run→Montour Run→Ohio River
Municipality/County: Clinton Township, Allegheny County
Latitude/ Longitude: 40°29'42"N / 80°16'21"W
Construction Year: 2004

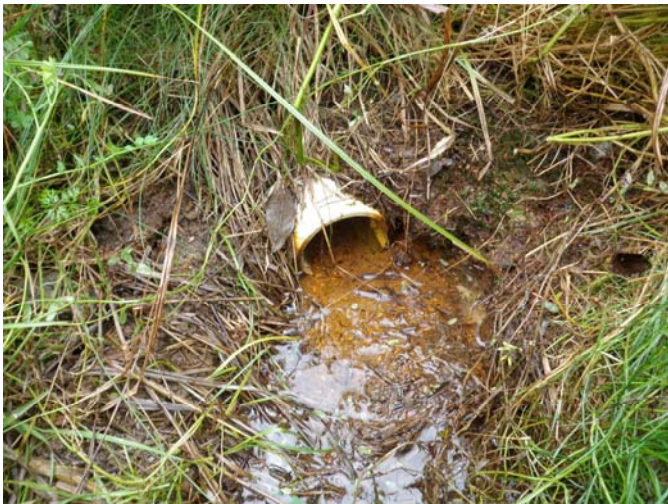
The influent pipe had become plugged and only a small portion of the AMD was flowing into the VFP (*top left*). Most of the untreated AMD was, therefore, bypassing the system. The influent pipe inlet was unplugged using a custom-made cleanout tool (*upper right*) which restored flow (*bottom left*) into the VFP. A recommendation to clean-out the inlet area and install a bar-guard on the inlet of the influent pipe was made which was later completed by the Allegheny County Airport Authority (*bottom right*).

- To update the system, BMI recommends either replacing the 4" intake pipe with a larger 8"-12" pipe or with a rock-lined channel to reduce clogging. As an interim measure, a screen or bar-guard could be installed to help protect the pipe. If this approach is used, the screen or bar-guard would need to be inspected and cleaned on a regular basis.
