**Reitz #1 Passive Treatment System**  
**SRI O&M TAG Project # 9 Request #1**  
**OSM PTS ID: PA-191**

**Laurel Run Reitz #1 Passive Treatment System: 11/20/12 Influent & Effluent Quality**

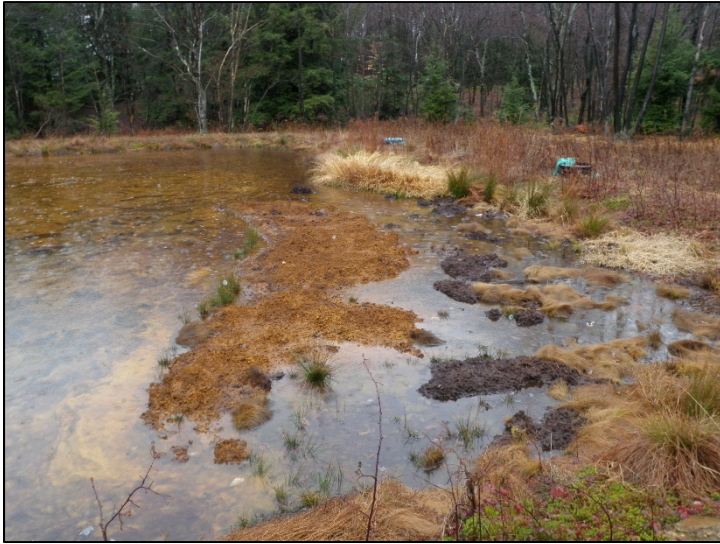
A primary maintenance issue identified for the Reitz #1 Passive Treatment System was that portions of the compost layer had been disturbed and transported across the pond (*top left*) by a large flow event or possible high winds resulting in the compost layer being significantly thinner near the inlet (*top right*) which was likely leading to short-circuiting. In addition, a large quantity of logs (*bottom left*) from the Bioreactor had floated up out of the media and needed to be removed. The compost was leveled and mixed into the top layer of limestone aggregate (*bottom right*).
