McCaslin Road Passive Treatment System
SRI O&M TAG Project # 17 Request #1
OSM PTS ID: PA-150

Requesting Organization: Montour Run Watershed Association (in-kind partner)
Receiving Stream: West Fork of Enlow Run (Montour Run)
Hydrologic Order: West Fork of Enlow Run→Enlow Run→Montour Run→Ohio River
Municipality/County: Findlay Township, Allegheny County
Latitude/ Longitude: 40°29'30.9984"N / 80°17'26.0016"W
Construction Year: 2009

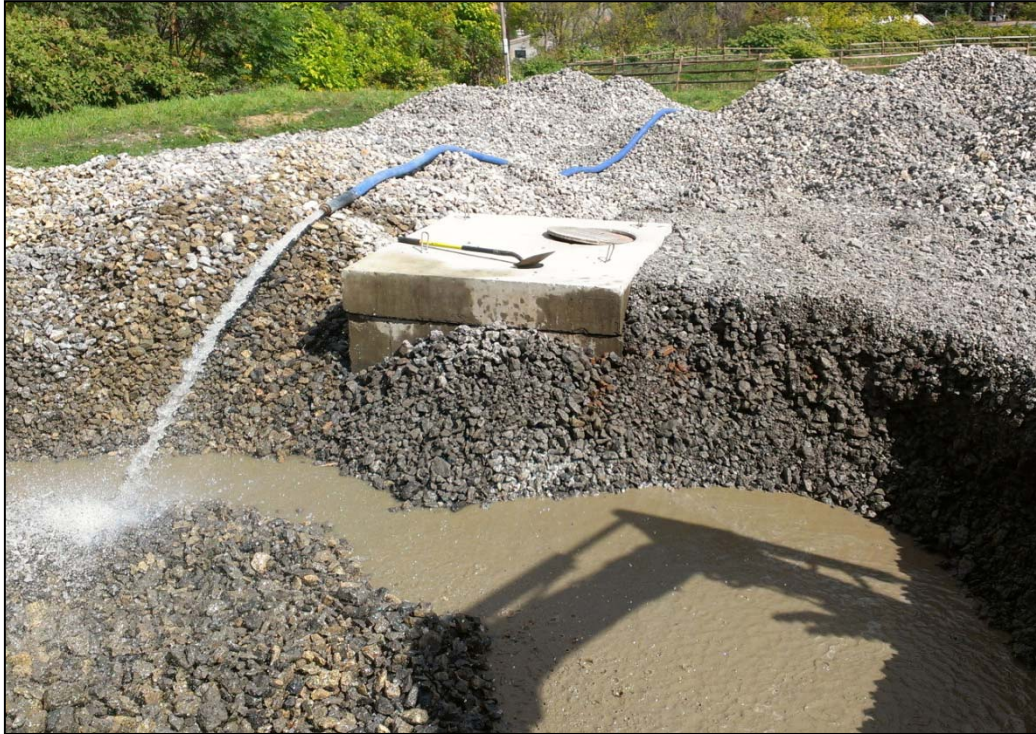
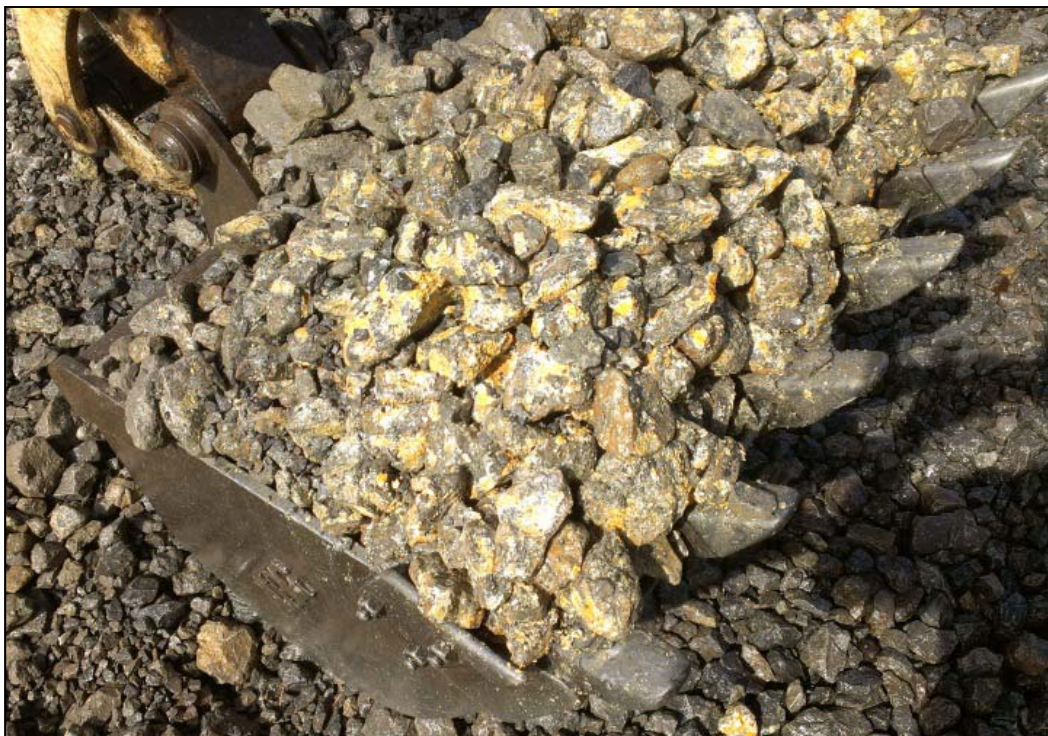
The Montour Run Watershed Association (MRWA) installed the McCaslin Road Passive Treatment System in 2009 to treat an acidic, metal-bearing, discharge from the abandoned Clinton Lake underground coal mine in Findlay Township, Allegheny County, PA. The passive system located on Findlay Township Public Works property consists of an Auto-Flushing Limestone-Only Vertical Flow Pond (AFVFP), a settling pond and a treatment wetland. On 5/15/12 during the 2012 Passive Treatment Snapshot, the effluent of the treatment system was found to be of poor quality indicating a decline in treatment efficiency. (Refer to the following table.) The system was checked again in August of 2012 and was still not functioning to expectations. The suspected cause was coating and/or plugging of the limestone aggregate by aluminum solids.

Poor effluent quality at the McCaslin Road PTS indicated the need for maintenance. In September 2012, the aluminum- and iron-coated limestone aggregate (*bottom*) in the Auto-flushing Limestone-only Vertical Flow Pond was cleaned using a small excavator to handle and to stir the limestone aggregate while using a pump to wash off the coating (*top*). The sludge material that was removed from the limestone aggregate was then flushed into the settling pond.

After discussion with project partners, the MRWA requested assistance to stir and “wash” the limestone aggregate within the AFVFP to restore functionality of the system. In September 2012, the medium within the AFVFP was stirred by BioMost, Inc., (BMI) and flushed to remove precipitates. During the maintenance activities, Public Works Director John O’Neal made an effort to watch and learn about the stirring process in order to assist the MRWA in the future.

- Conduct site inspections and water quality monitoring on a monthly basis is recommended. Include field measurement of pH at a minimum and alkalinity, iron, and flow rate as feasible.
- The limestone aggregate within the AFVFP will likely need to be cleaned and stirred every 3-5 years.
- Evaluate cleaning of the limestone aggregate when the pH of the final effluent is below ~6 at normal flow conditions.
