**Goff Station Passive Treatment System**  
**SRI O&M TAG Project # 20 Request #1**  
**OSM PTS ID: PA-115**

Requesting Organization: Slippery Rock Watershed Coalition (in-kind partner)  
Receiving Stream: Murrin Run (Slippery Rock Creek Watershed)  
Hydrologic Order: Murrin Run→Seaton Creek→Slippery Rock Creek→  
Beaver River→Ohio River  
Municipality/County: Venango Township, Butler County  
Latitude/Longitude: 41°07'51.9996"N / 79°52'19.9992"W  
Construction Year: 2000

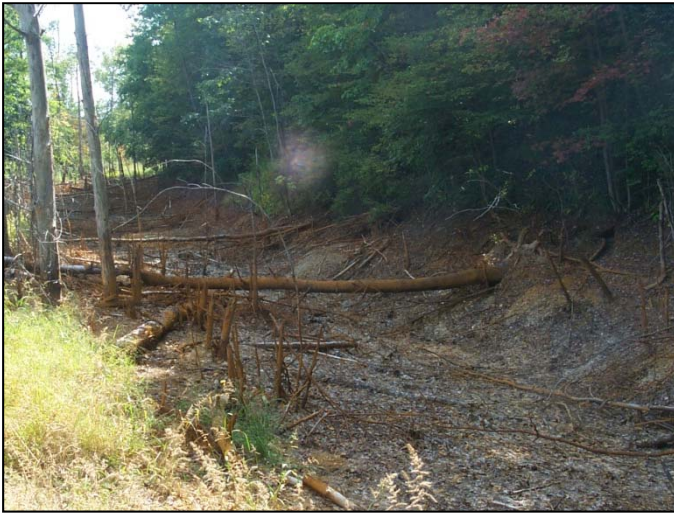
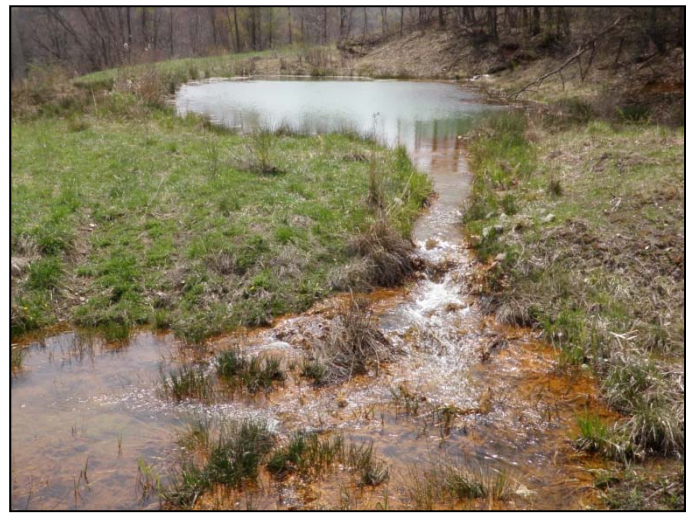
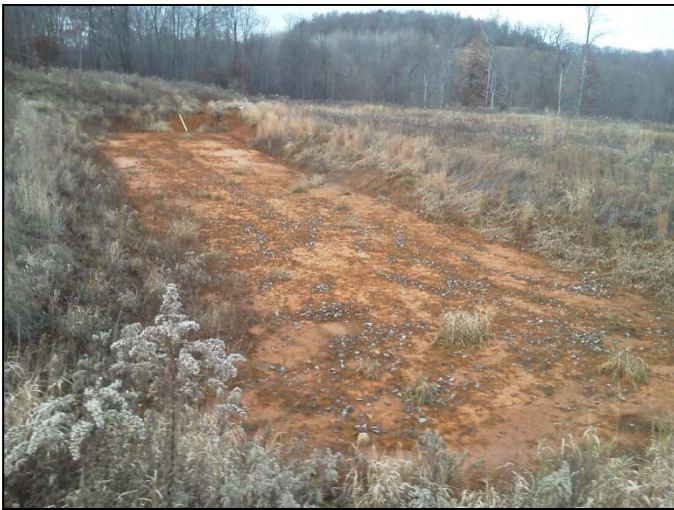
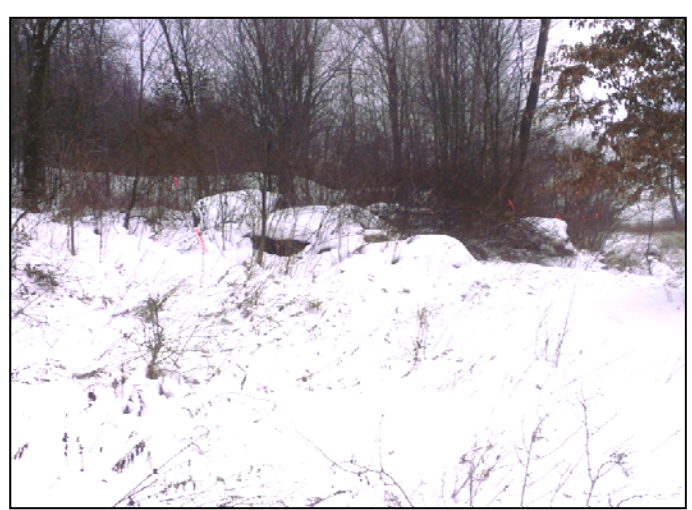
At the Goff Station Passive Treatment System, a change of conditions within the old abandoned underground mine resulted in a substantial change in flow rates at the existing discharge locations. Several of the discharges dried-up (*top left*) where iron staining indicates previous water levels and other locations received significantly more flow such as at Collection Pond 40 (*top right*), substantially decreasing retention time and treatment performance. Changing of the flow rates and also plugging of pipes has resulted in some of the treatment components not receiving any flow (*bottom left*). A plan to install a channel through a wooded section of the property (*bottom right*) has been proposed to convey AMD to unutilized sections of the treatment system. Other maintenance such as cleaning pipes will also be conducted as necessary if landowner permission can be negotiated.
