De Sale Phase 1 Passive Treatment System
SRI O&M TAG Project #21 Request #2
OSM PTS ID: PA-113

Requesting Organization: Slippery Rock Watershed Coalition
Receiving Stream: Unnamed Tributary to Seaton Creek
Watershed: Slippery Rock Creek
Municipality/County: Venango Twp., Butler Co.
Latitude/Longitude: 41° 8' 33" N / 79° 49' 48" W

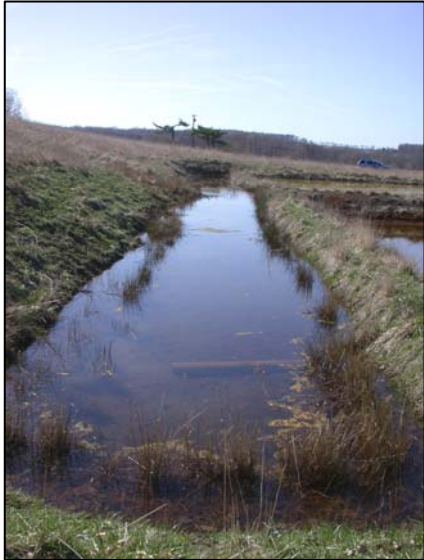
Top Left: Forebay effluent pipes extended into the middle of the Forebay which would plug with low pH iron and frequently need to be cleaned.

In December 2014, while equipment and tools were at De Sale 2 for more extensive maintenance, a site visit was conducted to replace the Forebay pipes at De Sale 1. A 10" pipe was installed in place of each 6" pipe, which should reduce the frequency of cleaning. The newly installed pipes were also shorter than the previously installed pipes, which should ease cleaning. In addition to retrofitting the Forebay pipes, it was noted while on-site that the VFP outlet pipes were overgrown with vegetation and iron accumulation. The channels below the VFP outlets were cleared of these materials to allow flow measurements to be taken at the VFP peri-pipes.

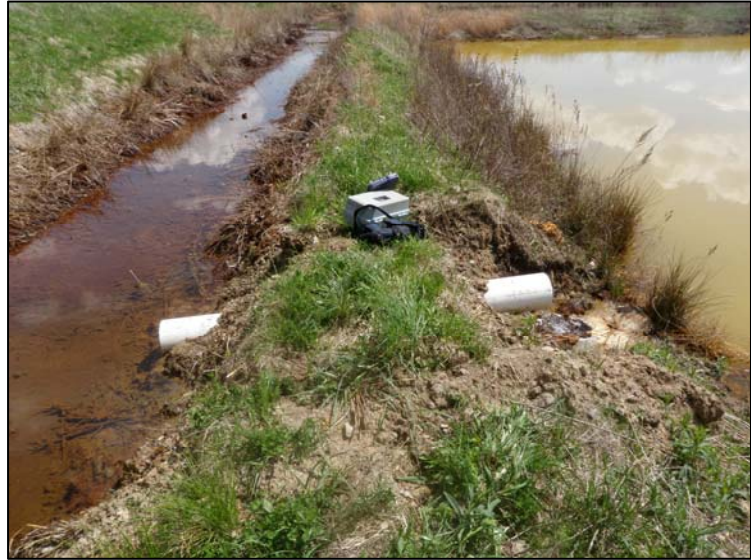
Top Right: The pipes were replaced by a shorter length, but larger diameter pipe.

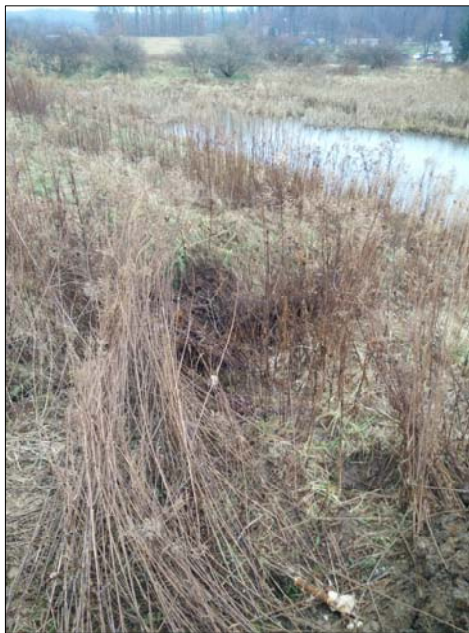
Bottom Left: The VFP outlet channels were completely overgrown and full of sediment.

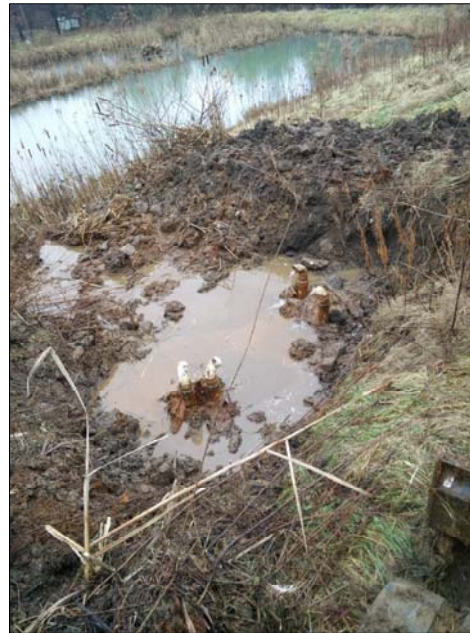
Bottom Right: The channels were excavated to remove vegetation and sediment that had accumulated.

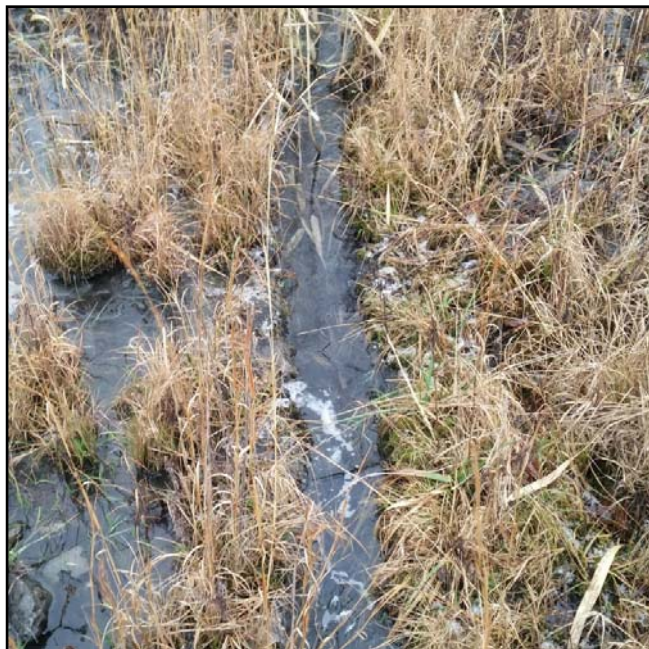
Top Left: Vegetation and sediment clogged the HFLB at De Sale 1.

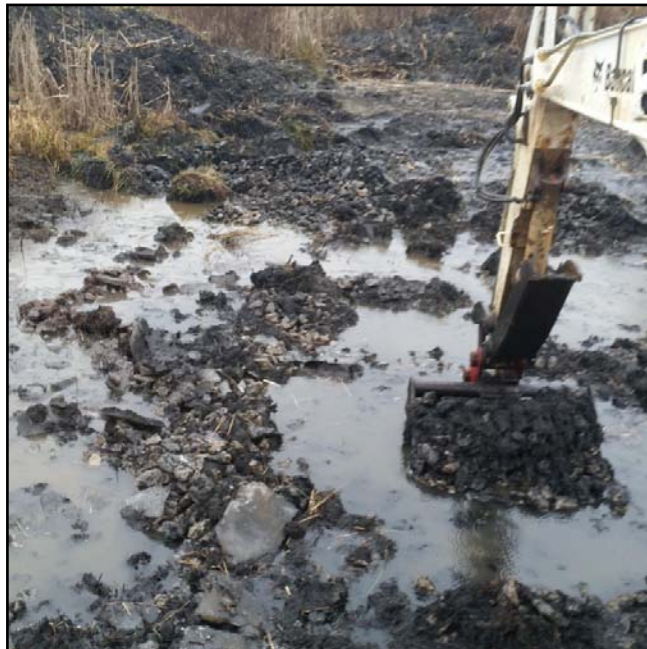
Top Right: HFLB treatment media was stirred and vegetation was removed from the surface.

In December of 2015, BMI returned to the site to stir the HFLB. The accumulation of manganese and vegetation had resulted in short-circuiting on top of the bed. While the bed was stirred, it was not cleaned. A significant amount of manganese sludge, sediment and other materials are still present within the HFLB, which will need to be removed sometime in the future. While equipment was on-site, the VFP outlets were cleared of built-up vegetation. Field water monitoring was also conducted, which revealed that VFPS had poor water quality and reduced flow capacity. Short-circuiting pathways into the treatment media were discovered after draining the pond. VFPS was then stirred, which should also increase permeability.

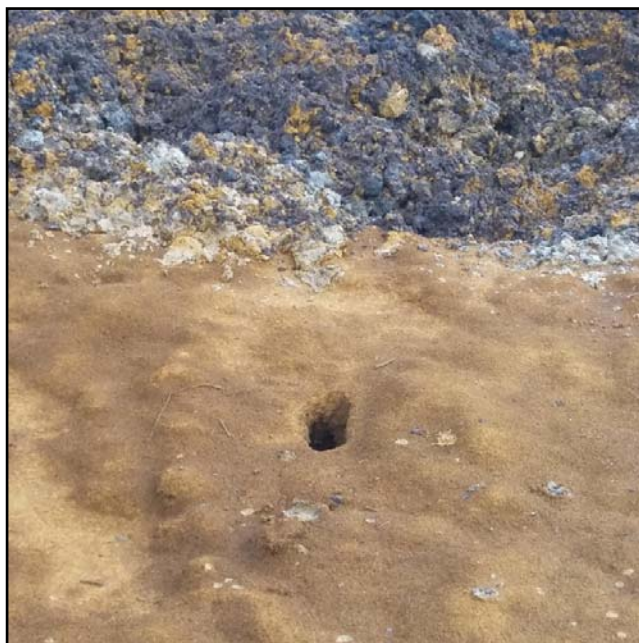
Bottom Left: Holes were discovered in the VFPS treatment media, which resulted in short-circuiting.

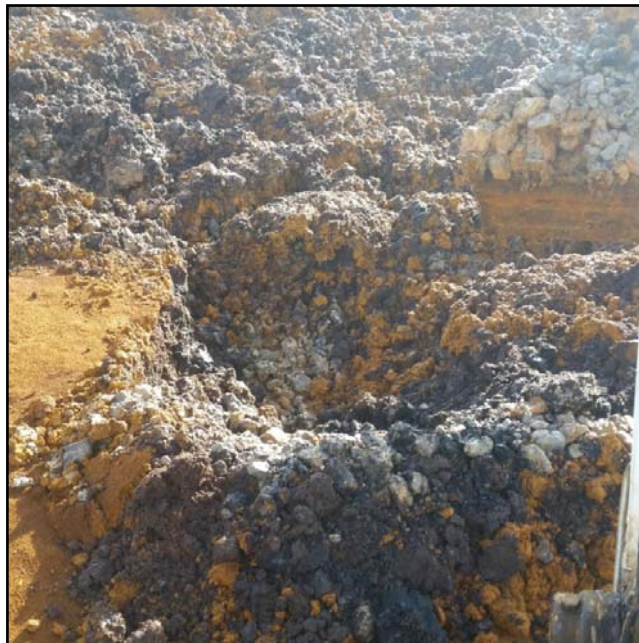
Bottom Right: VFPS treatment media was stirred using an excavator.
