Coal Pit Run Upper/Lower System AMD Remediation Systems
SRI O&M TAG Project #37 Request #2
OSM PTS ID: PA-127

Municipality/County: Blacklick Township, Cambria County

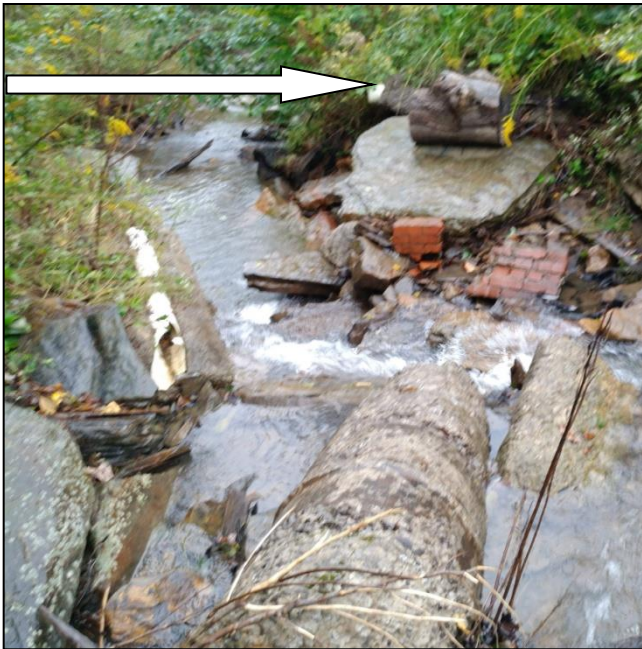
- At the Lower System, the collection piping system from the mine wet seal across the stream from the system had been severely damaged and no longer conveyed flow to the system. Damage was likely caused by erosion of the stream bank during large precipitation events over the past year.

Top Left: Lower system discharge collection and conveyance pipe from mine seal has been damaged.
Top Right: Pieces of the broken collection system conveyance pipe were still present in the stream channel.
Bottom Left: Water was poured into the damaged pipe to confirm it flowed to the system.
Bottom Right: Upper System VFP no longer appeared to be passing water through the media.

- Based upon site observations, lack of definitive as-built information, and system history, BioMost determined that the project was beyond the scope of the O&M TAG grant and recommended that funding should be sought to redesign and rehabilitate the passive system.

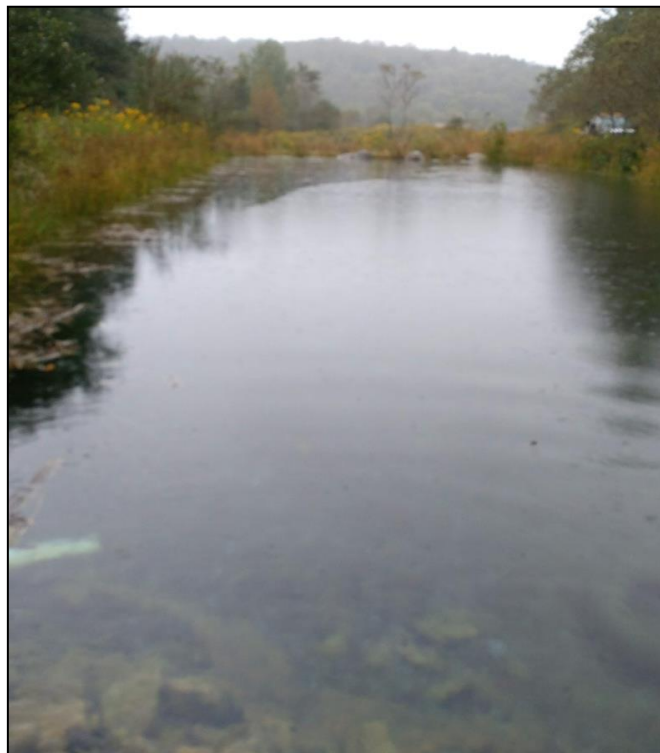
- An initial site investigation was conducted on 9/24/18 with an additional site visit on 3/6/19.
- At the Upper System, water was flowing over the emergency spillway of the VFP, indicating a likely permeability problem with the treatment media. The media had previously been stirred in 2015. The system is now almost 15 years old and the media likely needs replaced.
