**Laurel Run #2 Passive Treatment System**  
**SRI O&M TAG Project #38 Request #1**  
**OSM PTS ID: PA-191**

Requesting Organization: Blacklick Creek Watershed Association  
Receiving Stream: Laurel Run  
Watershed: Blacklick Creek  
Municipality/County: Center Twp., Indiana Co.  
Latitude/ Longitude: 40° 29'39.0012" N / 79°7'18.9984" W

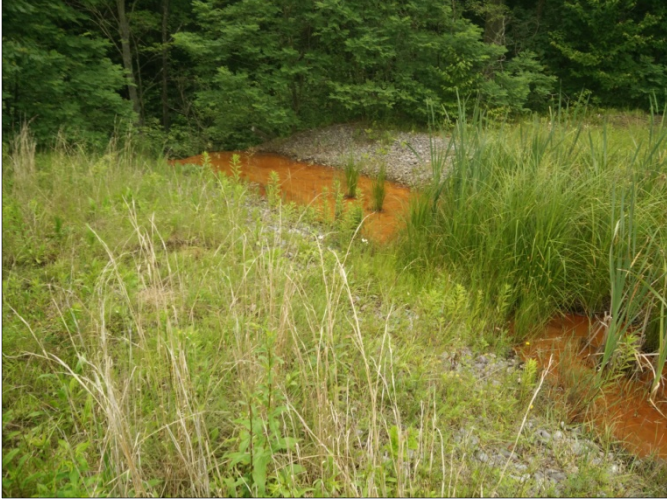
**Top Left:** Water was short circuiting and exiting the emergency spillway due to a buildup of vegetation.

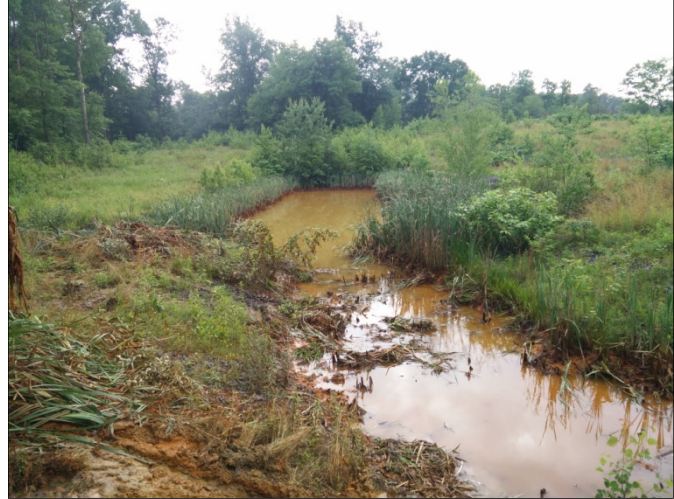
**Top Right:** The spillway between the settling pond and polishing wetland was cleared of vegetation, allowing flow to remain in the system.

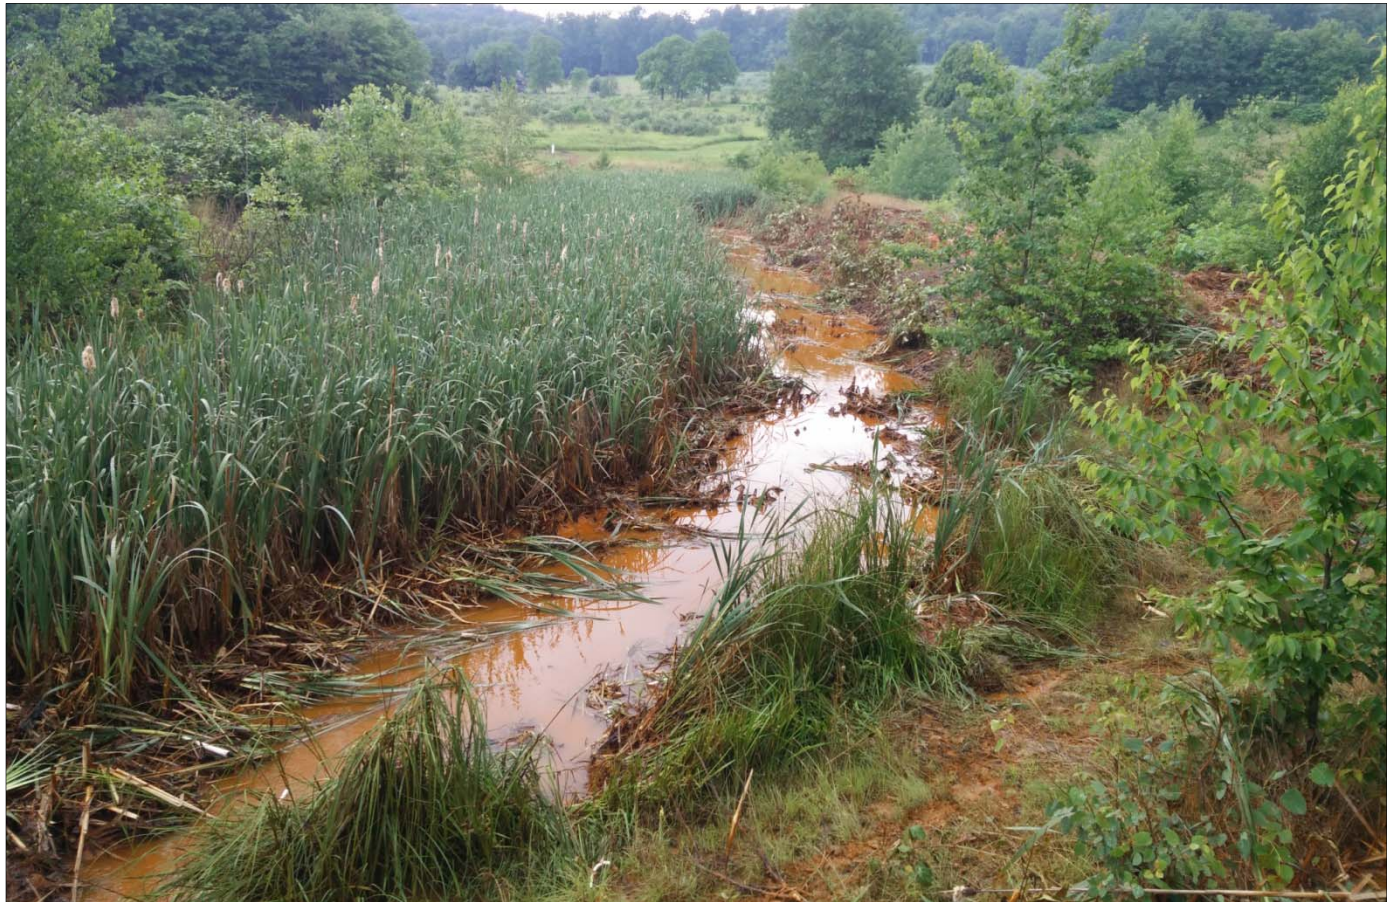
**Bottom:** Vegetation was removed from the polishing wetland to maintain flow through the entire system.
