Weaver Run D10 Passive Treatment System
SRI O&M TAG Project #42 Request #1
OSM PTS ID: PA-315

Requesting Organization: Kiski-Conemaugh Stream Team
Receiving Stream: Weaver Run
Watershed: Paint Creek
Municipality/County: Paint Township, Somerset County
Latitude/ Longitude: 40°12'43.9596"N / 78°49'21.9468"W

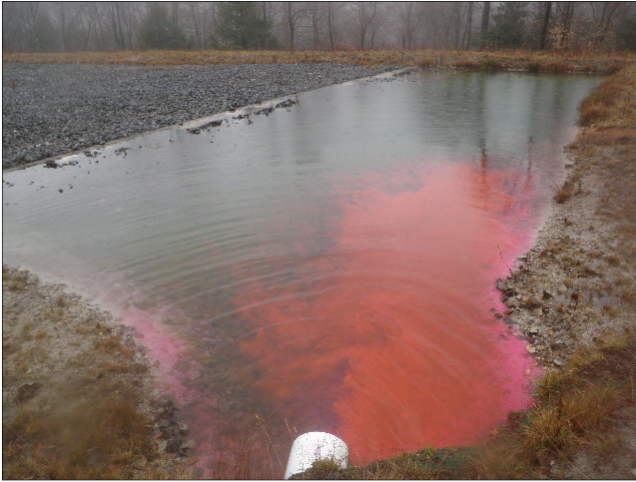
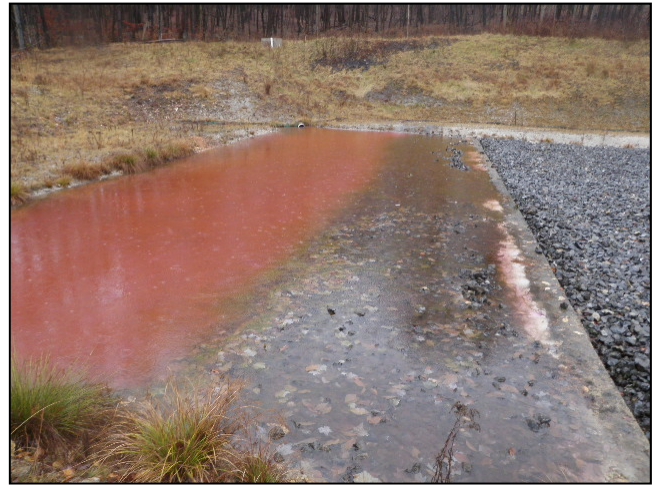
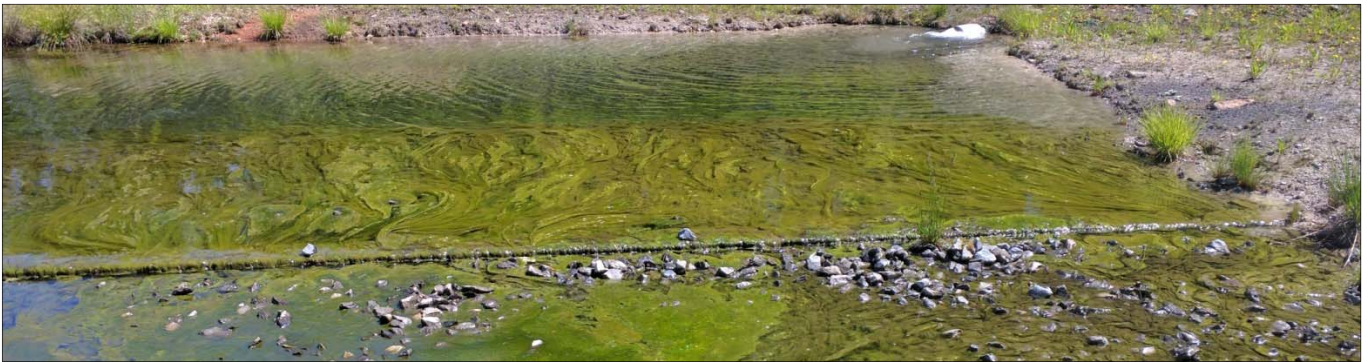
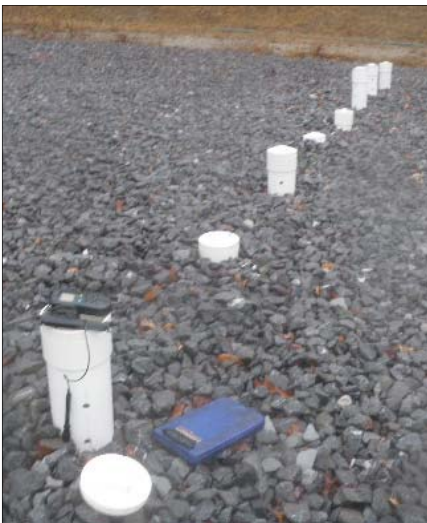
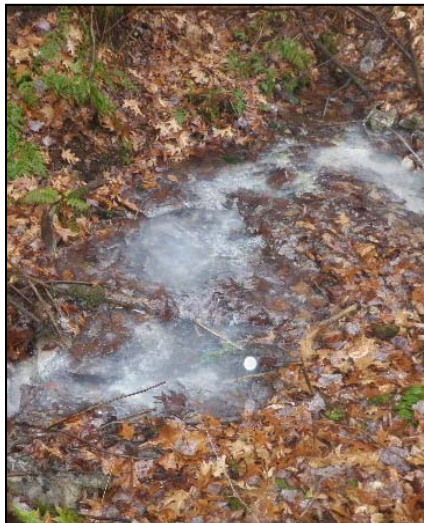
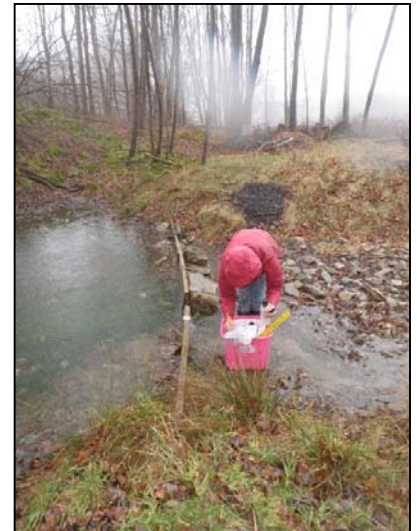
During the site visit, a dye test was conducted to try to assess whether short-circuiting was occurring. The dye test was somewhat inconclusive because much of the dye stuck to the algae growing within the Forebay; nonetheless, certain information was revealed. The dye plume initially and quickly went towards the middle and northwestern end of the Forebay and began to make its way into the limestone bed within about 20 minutes, but then the dye stopped moving forward and developed a very discernible line across the Forebay. This point is believed to represent the approximate location of where the water is entering the stone and where the algae is growing on top of the stone, thus absorbing the dye. No dye was ever observed in the effluent before leaving the site; however, this was

not necessary to determine short-circuiting. While waiting for the dye test to progress, pH measurements of the water within the 8 ports of the “pipe tree” were measured where possible. The ports were numbered 1-8 from the southeast to northwest with 8 being closest to the Agri Drain outlet of the bed. As can be seen in the table below, ports 1-4 all had good pH values, but port 8 had a very low pH value. Unfortunately the caps on ports 5, 6, and 7 were stuck and could not be removed for monitoring. Assuming that ports 1-4 are receiving flowing water, this indicates that the water entering in port 8 has much shorter retention time and is likely short-circuiting.

Dye testing (Top Left and Right) and monitoring at the pipe tree (Bottom Left) indicated that short-circuiting was occurring. The dye test was limited by dye sticking to algae in the forebay (Center and Top Right). During the dye test, a break in the dye (Top Right) indicated where the water was likely entering the stone instead of flowing over the level spreader. Without a settling pond there is no place to settle aluminum solids (Bottom Center) during normal operation or flushing events. A difference in flow measurement techniques and a bent unlevel weir (Bottom Right) may be contributing to discrepancies of flow rather than indicating a leaking pond.

- The weir should probably be re-installed to be straight and level.
- Completing a tracer study might help to identify if leakage is occurring.

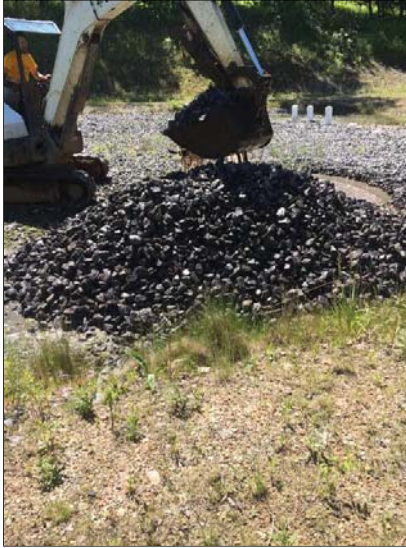
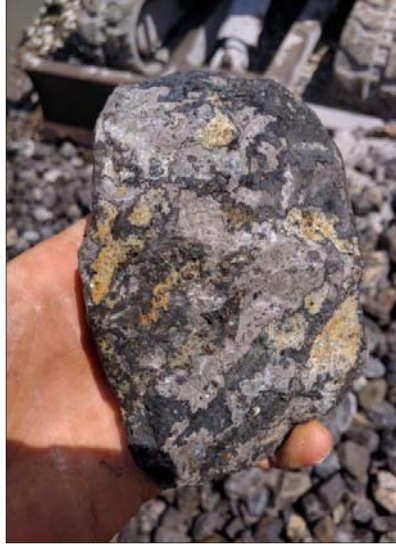
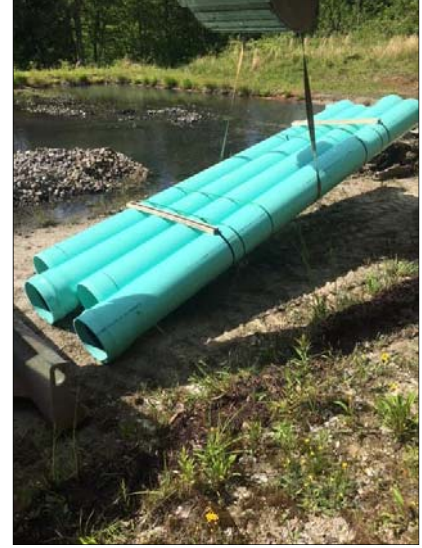
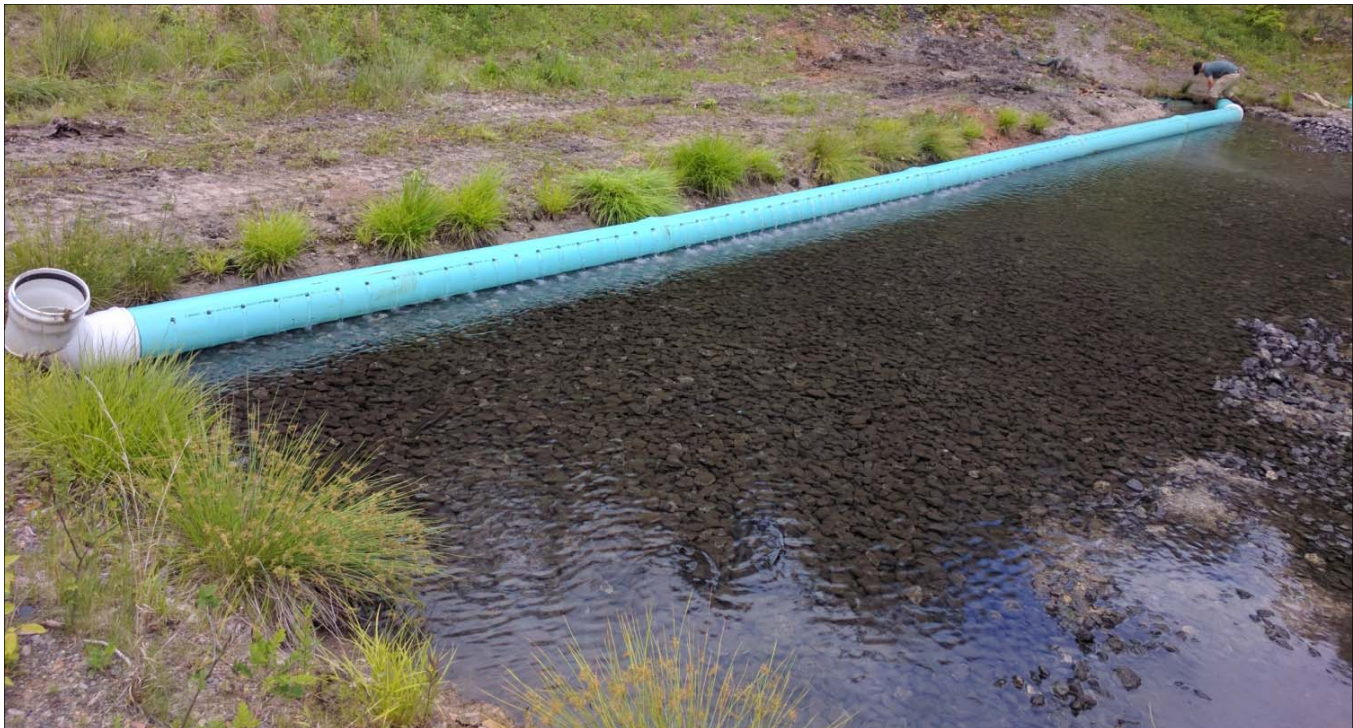
Stone in the limestone bed was stirred (Top Left) to remove metal precipitates coating the stone (Top Center) and disrupt short-circuiting pathways. As the forebay and concrete level spreader were not functioning as intended to distribute flow evenly across the bed, the level spreader was removed and the forebay was filled in with limestone. 12" pipe (Top Right) was perforated and then connected to the inlet pipe to distribute flow evenly across the width of the bed (Bottom).

In May 2017, BioMost mobilized to conduct maintenance and make improvements to the system with the primary goal of addressing short-circuiting and improving water quality. The concrete level spreader was permanently removed as it was not functioning and would no longer be needed. The limestone bed was stirred over the course of four days to clean sludge and sediment, but more importantly to disrupt pathways that may have developed within the media. Multiple partial flushes were performed to remove sediment from the system while maintaining water within the bed to continue stirring. The stop logs for the water level control structure were lubricated to increase ease of use. During the stirring process, a portion of the limestone was redistributed to fill in and eliminate the inlet pool (aka Forebay). A new perforated inlet distribution pipe with overflow was then installed to evenly distribute the flow across the bed to maximize retention time and improve treatment performance.
