Boyce Park Passive Treatment System
SRI O&M TAG Project #43 Request #1
OSM PTS ID: PA-281

Requesting Organization: Allegheny County Conservation District
Receiving Stream: Piersons Run
Watershed: Turtle Creek
Municipality/County: Plum Boro, Allegheny Co.
Latitude/Longitude: 40° 27' 52" N/ 78°44' 56 " W

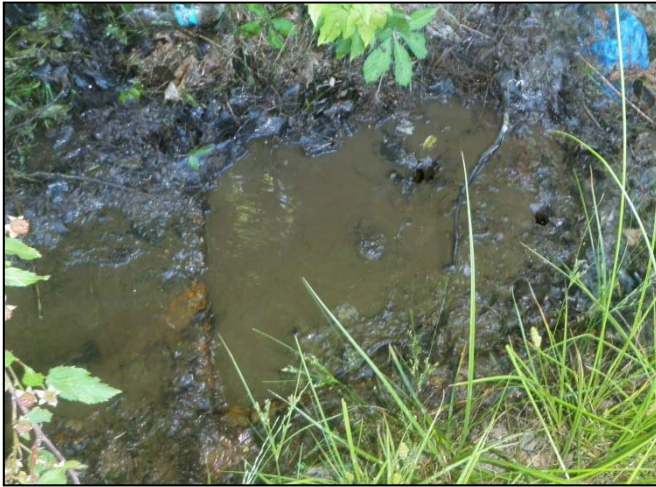
Top Left: The inlet box grates for BP3 & BP4 were found to be covered with sludge and debris which could prevent AMD from entering the system.

- Conduct water monitoring of the system on at least a quarterly basis. Contact SRI for assistance if the water quality begins to decline.
- Continue to follow the flushing regimen.
- Regularly inspect and clean the inlet box grates for BP3 & BP4.
- Eventually the BP2 limestone will need to be stirred and washed once water quality begins to decline.

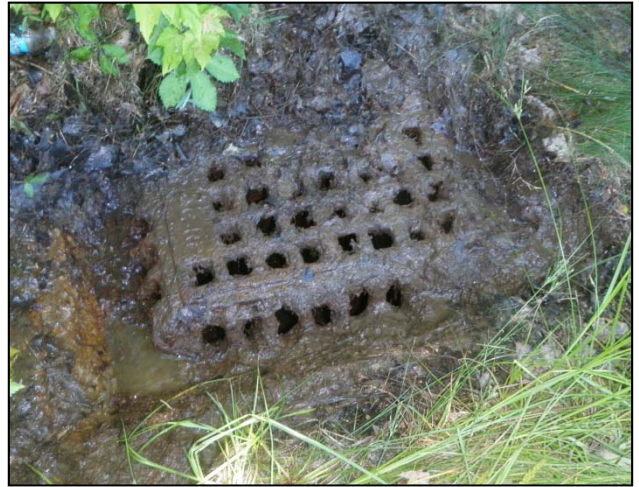
Top Right: Both were cleaned at the time, but will need to be regularly inspected and cleaned.

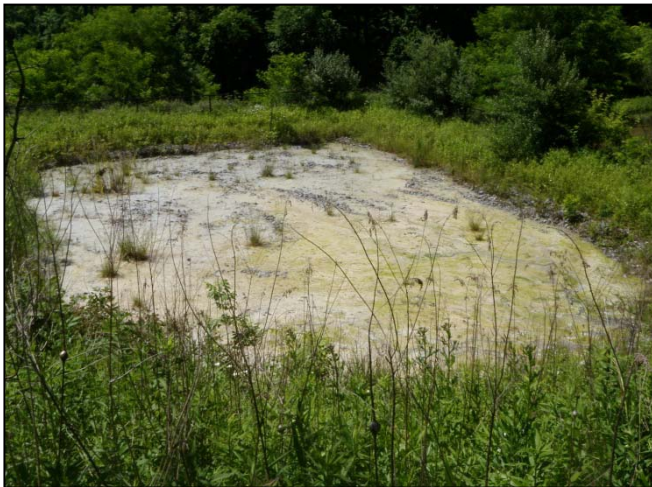
Bottom Left: The BP2 Limestone Pond was covered with aluminum solids and algae. As the pond was producing very good water, a decision was made to leave it be for the time being, but will likely need to be cleaned in the near future.

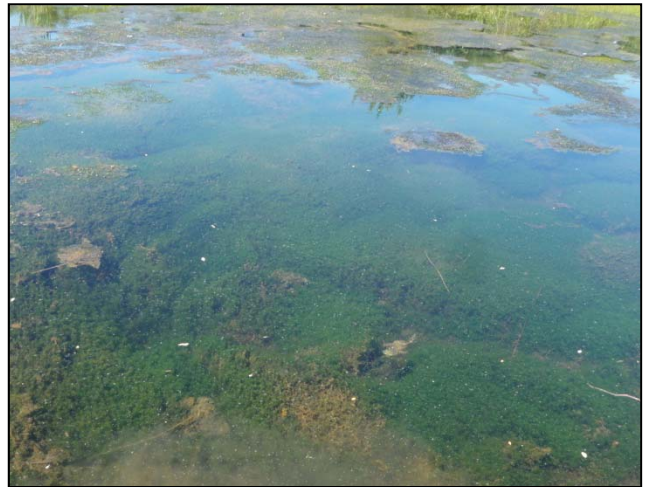
Bottom Right: Several of the ponds had large amounts of algae growing in them, but did not appear to negatively affect treatment effectiveness.

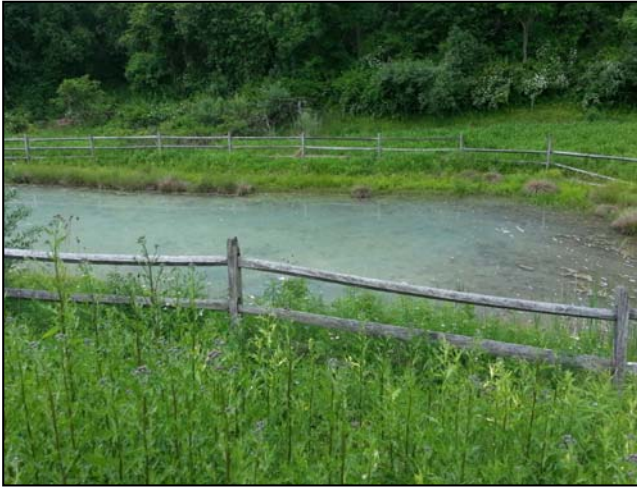
Top Left: Final Wetland with no plants prior to lowering water level (6/10/14)

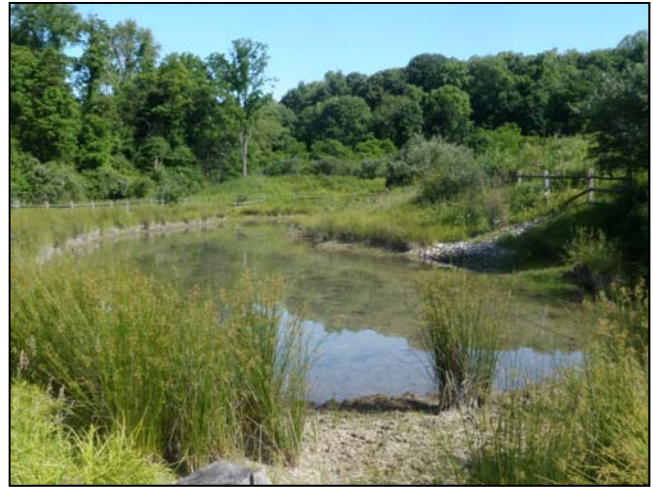
Top Right: Final Wetland shortly after removing stop logs. Water level was lower, but vegetation had not yet had time to become re-established (6/14/16)

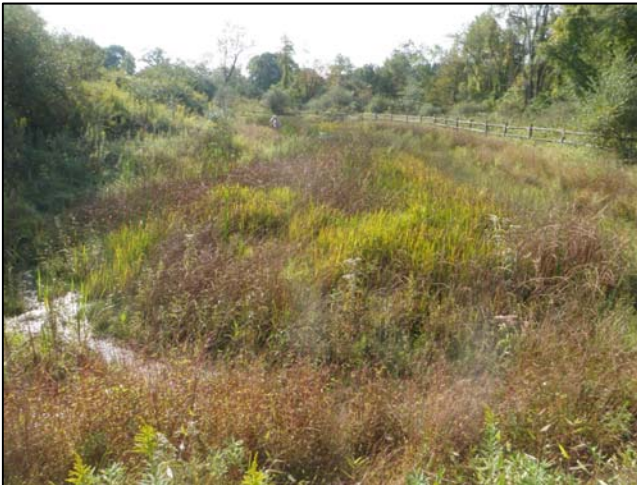
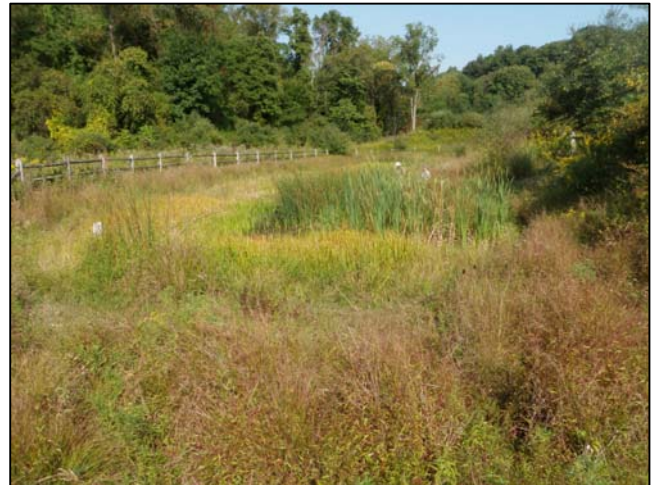
Bottom: Final Wetland after given a year to re-establish under good growing conditions (9/18/17)
