Ferris Passive Treatment System
SRI O&M TAG Project #45 Request #1
OSM PTS ID: PA-108

Requesting Organization: Pennsylvania Game Commission & SRWC
Receiving Stream: Slippery Rock Creek
Watershed: Slippery Rock Creek
Municipality/County: Venango Township, Butler County
Latitude/Longitude: 41°6'8"N / 79°51'31"W

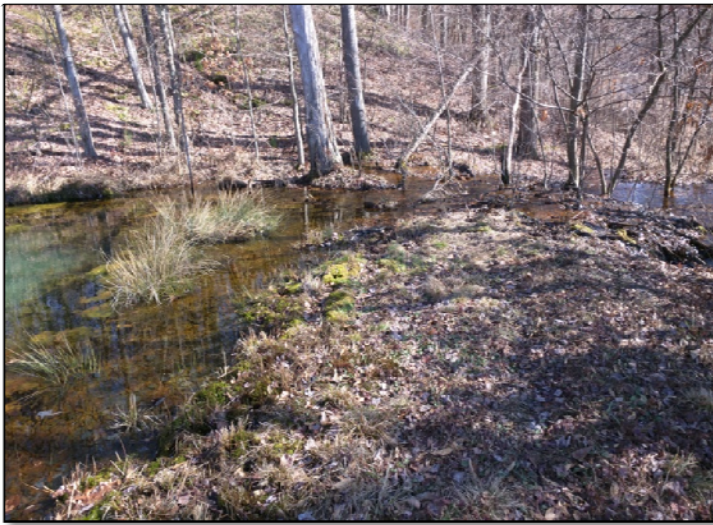
Top Left: Water was backing up and overtopping the forebay indicating the treatment media and/or underdrain were plugged.

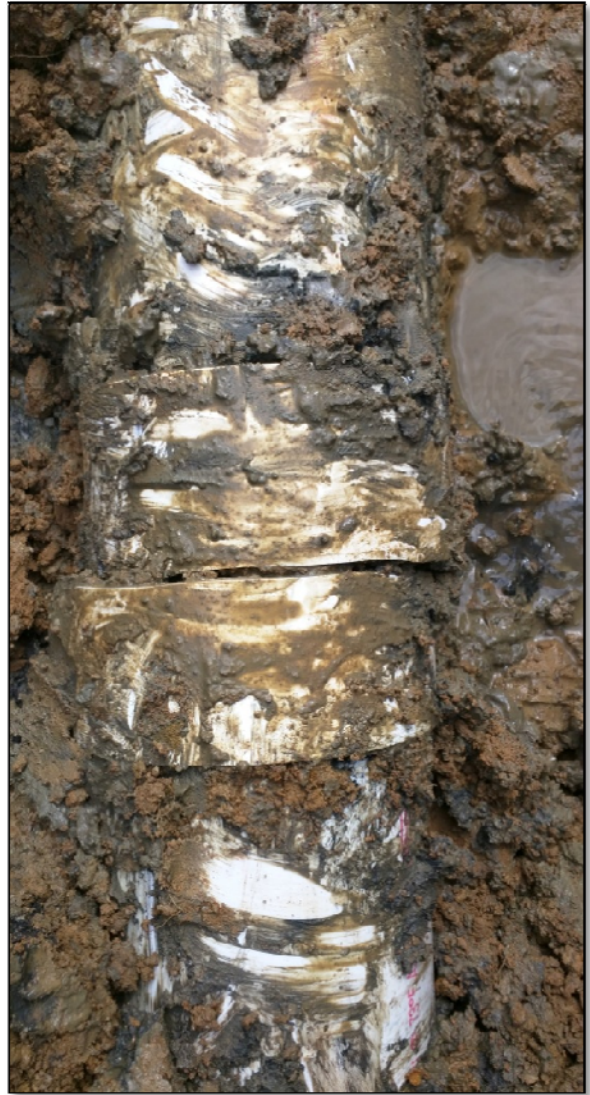
Right: During backflushing, water began to upwell from the berm. A broken flush pipe for VK1 was found to be the source of the water.

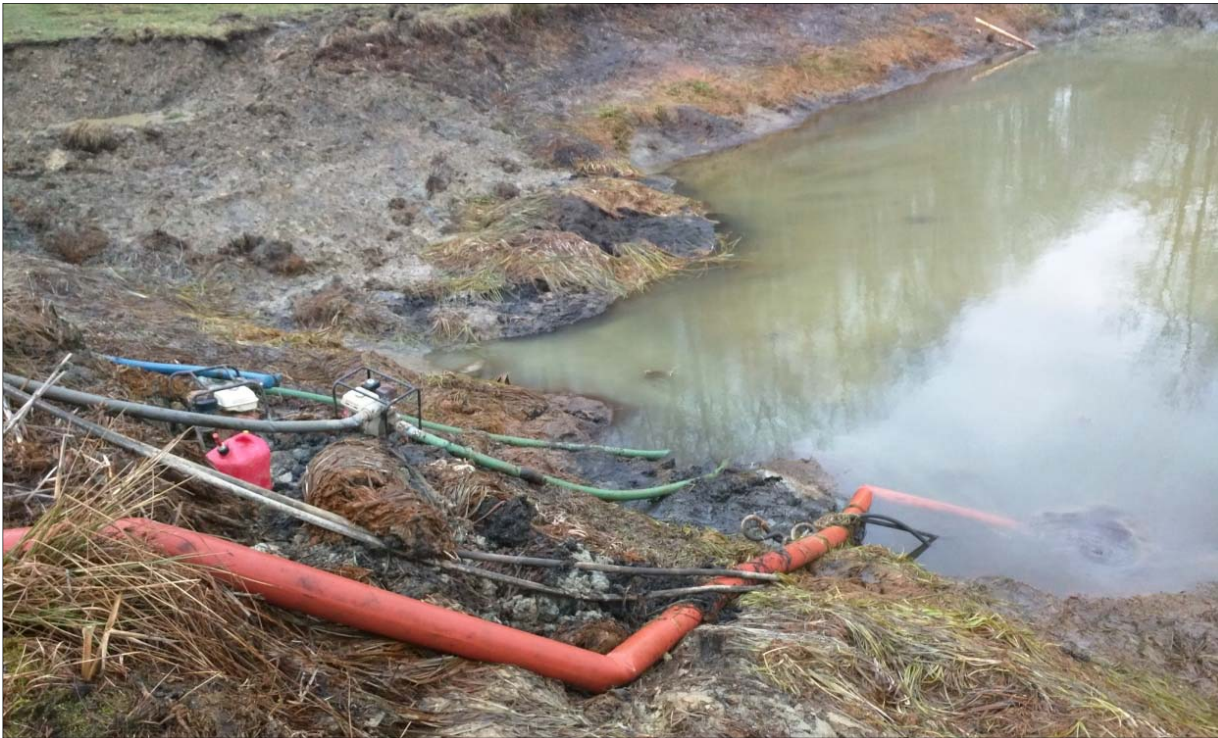
Above: As the underdrain was not functioning, VK1 was pumped to gain access to the media.
Bottom Left: The top layer of VK1 media was highly degraded with no structure.
Bottom Right: The lower layer of VK1 was highly compacted with minimal permeability.

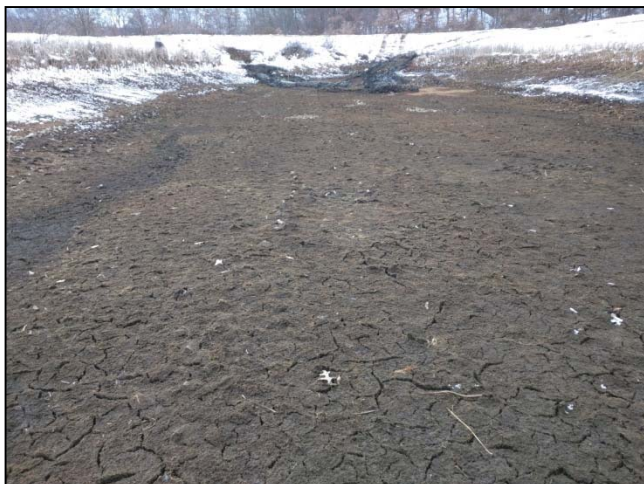
Top Left: VK2 was drained revealing 6-8" of sediment on top of the limestone which was removed.
Top Right: Once the sediment was removed, the limestone was inspected and then cleaned.
Bottom: VK2 after limestone cleaning and new pipe conveying the AMD from VK1.
