**BLACKLEGGS CREEK WATERSHED ASSOCIATION  
POST OFFICE BOX 59  
CLARKSBURG, PENNSYLVANIA 15725-0059  
724-639-3002**

**FINAL REPORT  
FOR U.S. EPA  
SECTION 319 GRANT**

**BIG RUN AMD REMEDIATION PROJECT  
PHASE II**

**NOVEMBER 2007  
REV. 1**

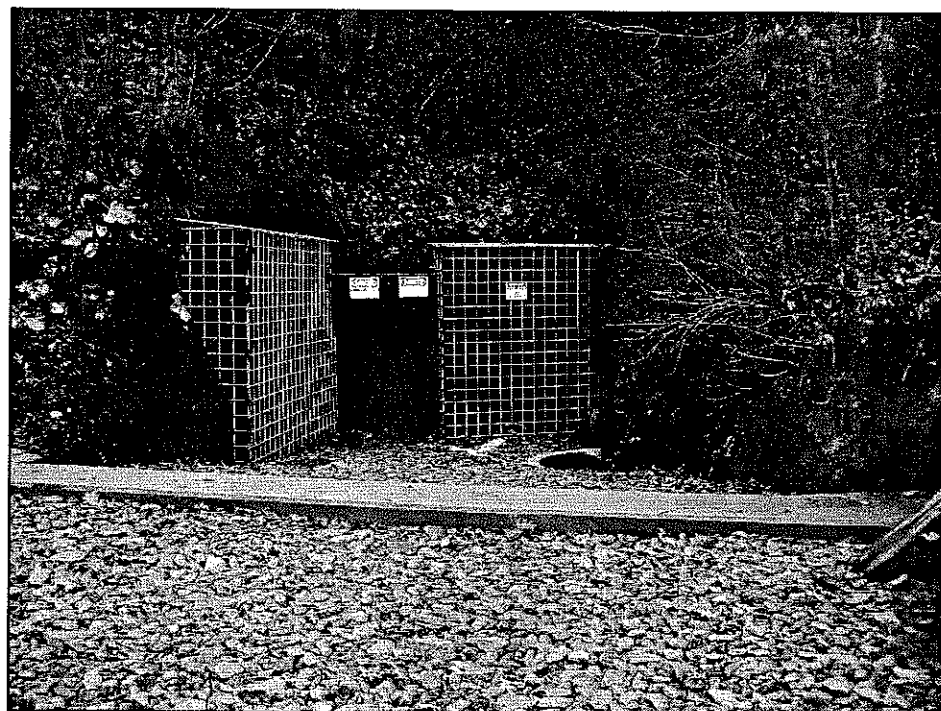
PHOTO 1-BIG RUN #7 MINE OPENINGS AND MINE SEAL

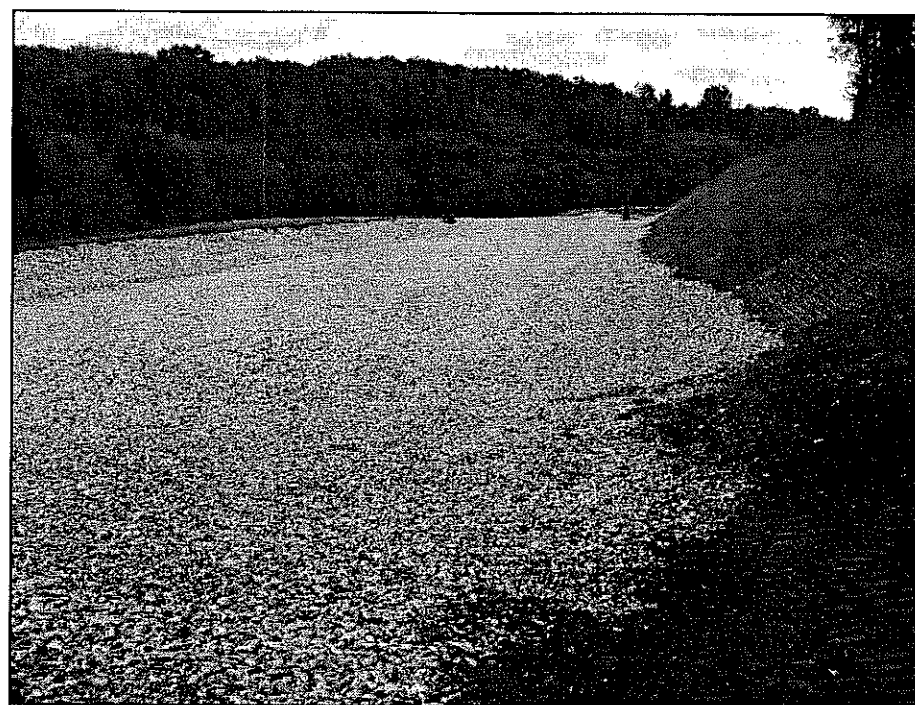
PHOTO 2-DOWNSTREAM VIEW FROM MINE SEAL OF LIMESTONE POND AND INLINE STRUCTURES

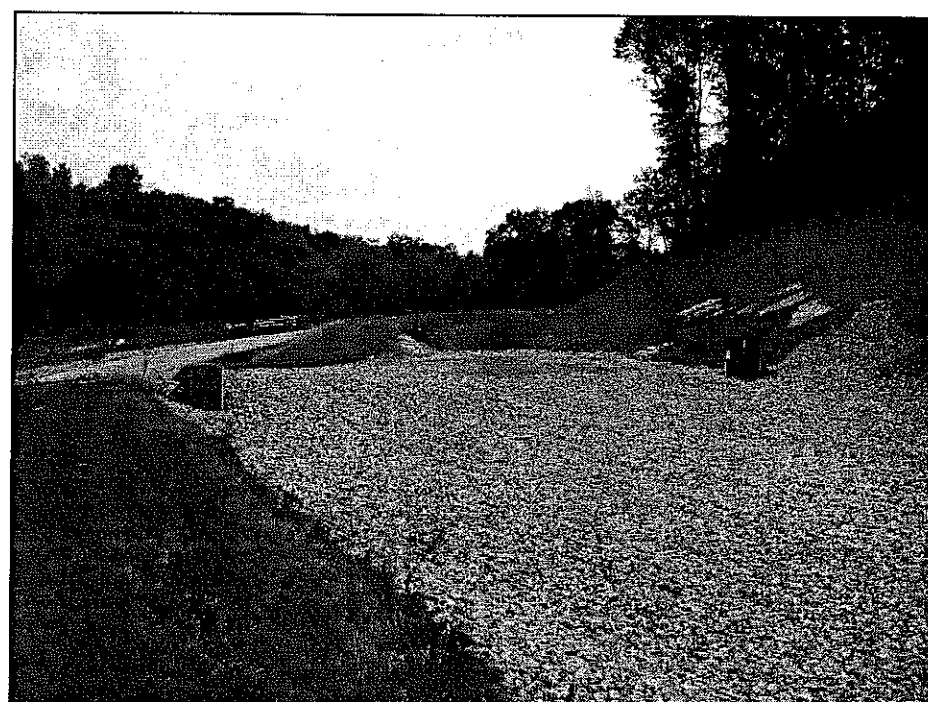
PHOTO 3-VIEW OF DOWNSTREAM END OF LIMESTONE POND, INLINE STRUCTURES, AND SETTLING POND

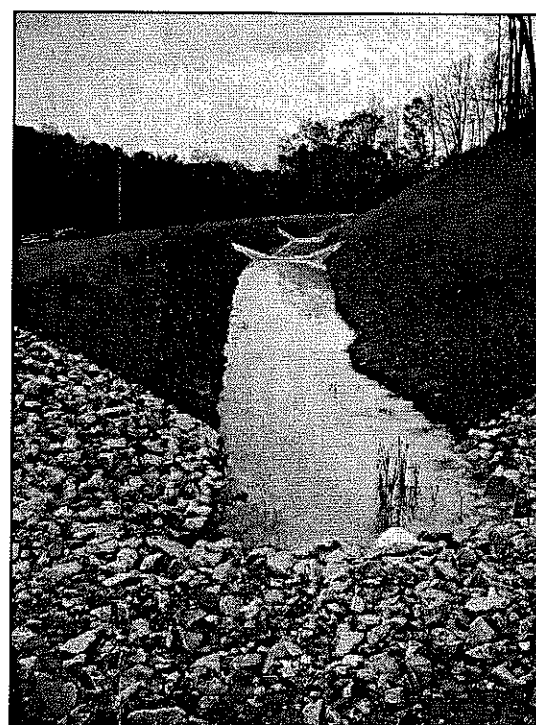
PHOTO 4-DOWNSTREAM VIEW OF SETTLING POND, BAFFLES, AND OUTLET PIPE FROM THE LIMESTONE POND
