FINAL REPORT

C & K GLASGOW PASSIVE TREATMENT SYSTEM PROJECT

Clearfield Creek Watershed Association
March 2010

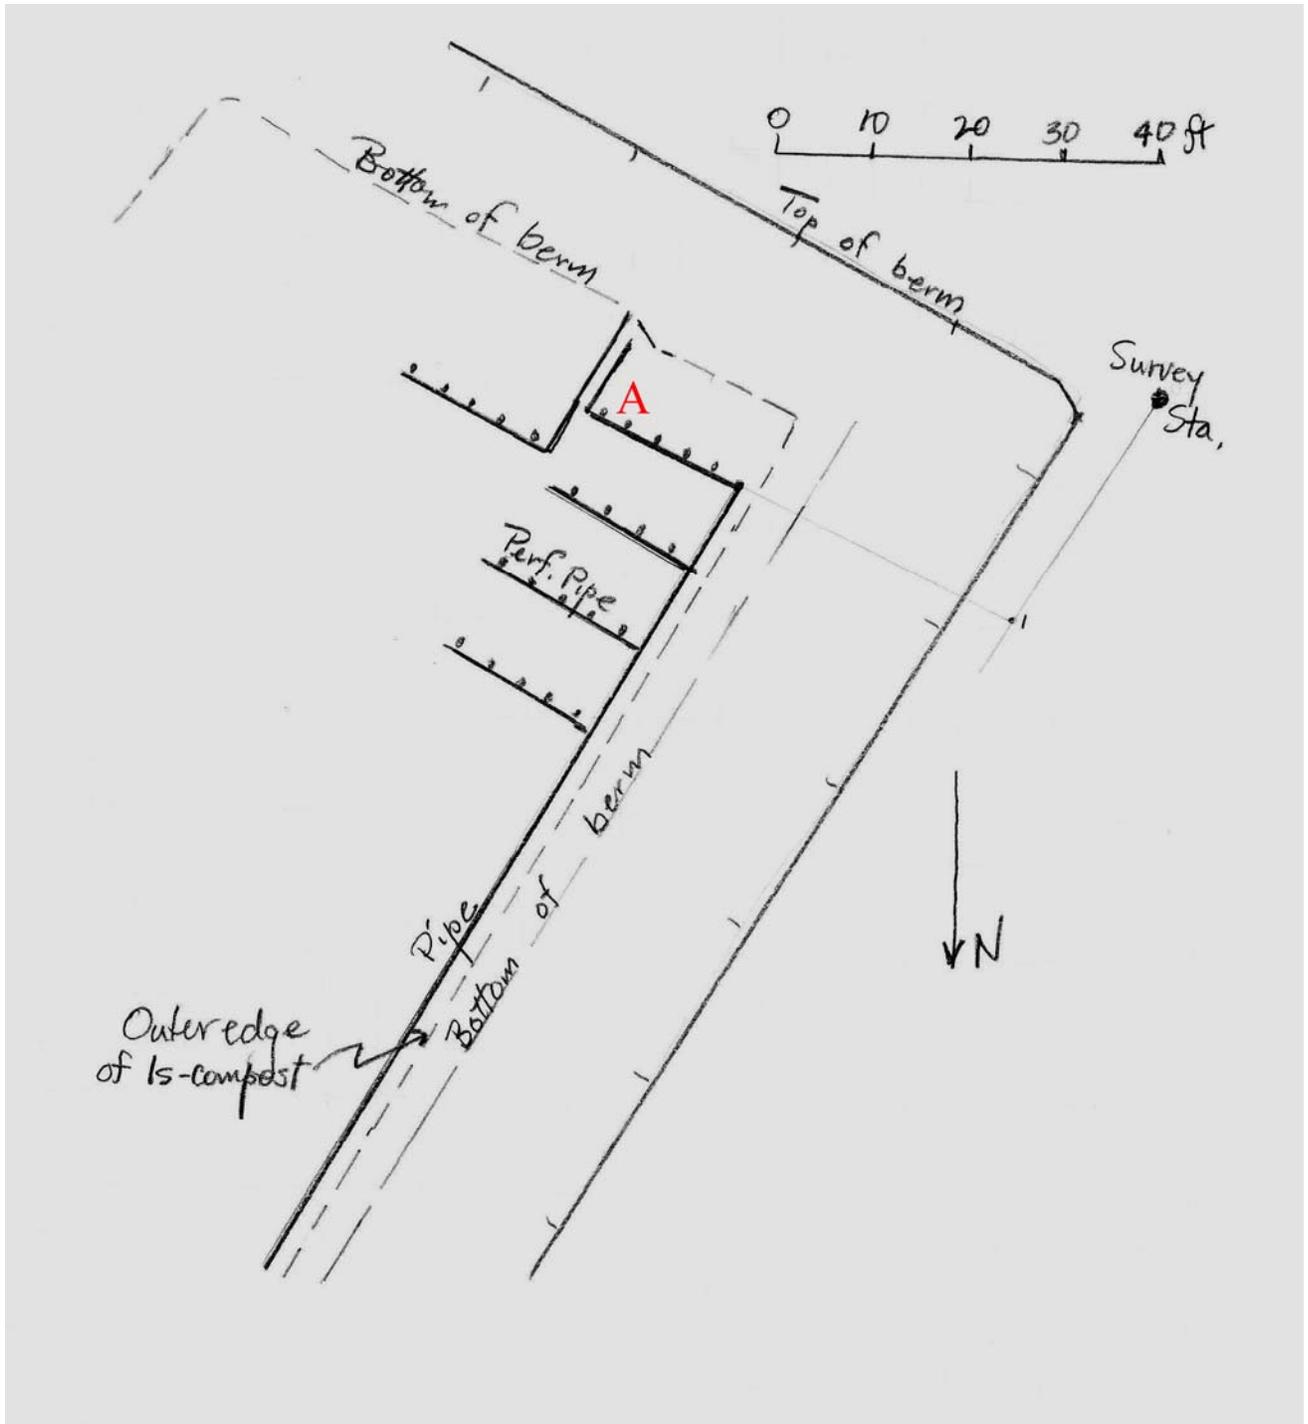
Figure 2. Map showing location of underdrain pipes, limit of compost and berms at VFP 1. Pipe location based on numerous holes dug through compost and limestone. "A" is the location of a break in pipes that was later repaired. Left side of figure is incomplete.

After draining VFP1 and removal of Fe sludge, numerous small holes were dug to determine the location and condition of underdrain pipes, and the extent of precipitate in the limestone layer. At most sites, the top 3 to 6 inches of the limestone bed was extensively coated with white material, presumably Al hydroxide, but the deeper material was largely uncoated.

Following the underdrain pipes from the outflow inward, the two outflow pipes came through the berm and then turned outward to the sides of the pond (Figure 2). A 6 inch manifold extended the length of the pond along the west side about 2-4 feet in from the base of the berm. Perforated 4 in. laterals of corrugated white plastic pipe extended from this manifold toward the center of the pond every 10 feet. At the inflow end of the pond, compost and limestone were absent for 20 to 25 feet from the end of the pond. Presumably the east side of the pond has similar underdrain. The pipe was broken near point A on Figure 2 but was later repaired.

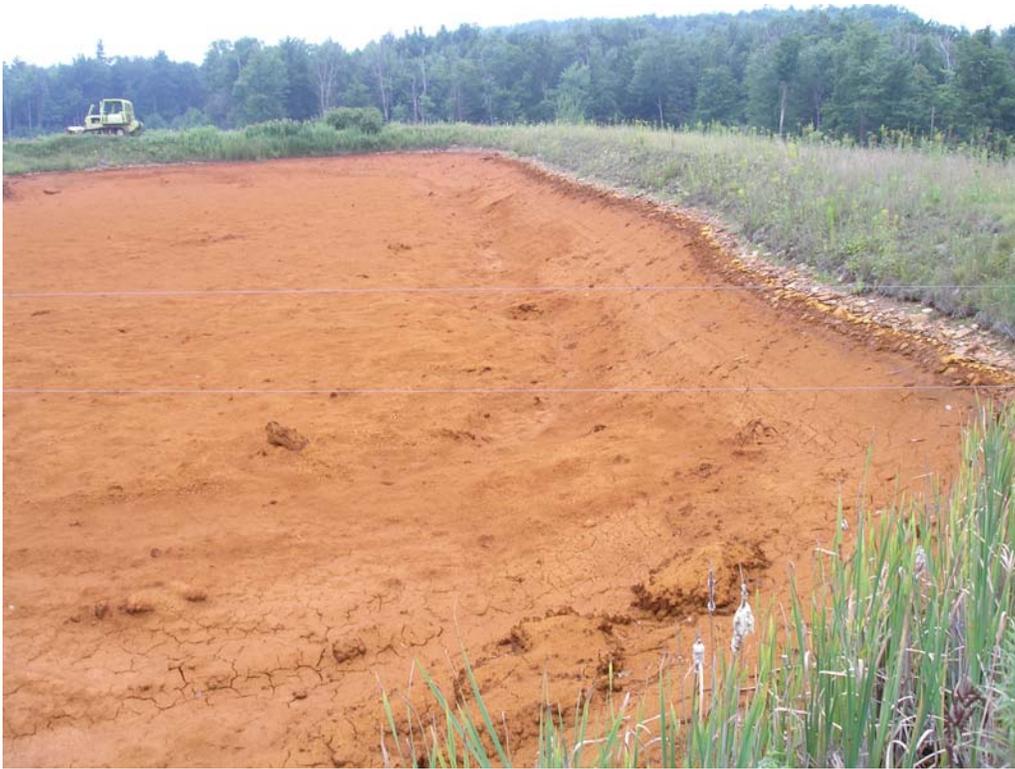
Photo 1. VFP 1 after draining, showing Fe precipitate.

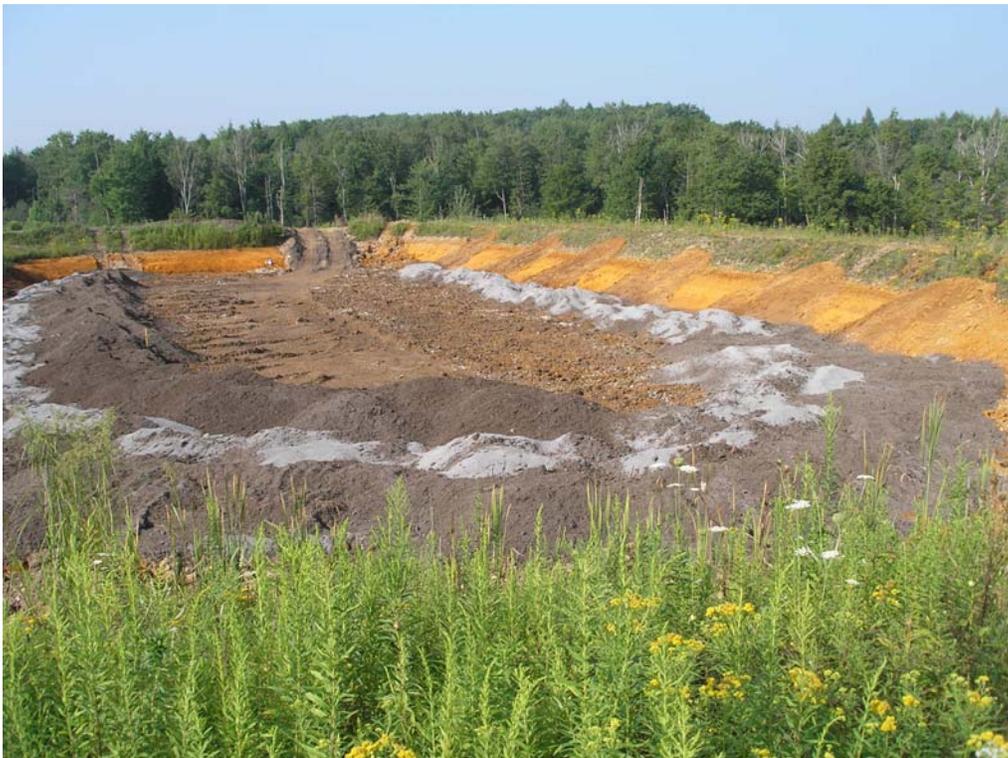
Photo 2. VFP 1 after removal of Fe precipitate and partial addition of new compost.

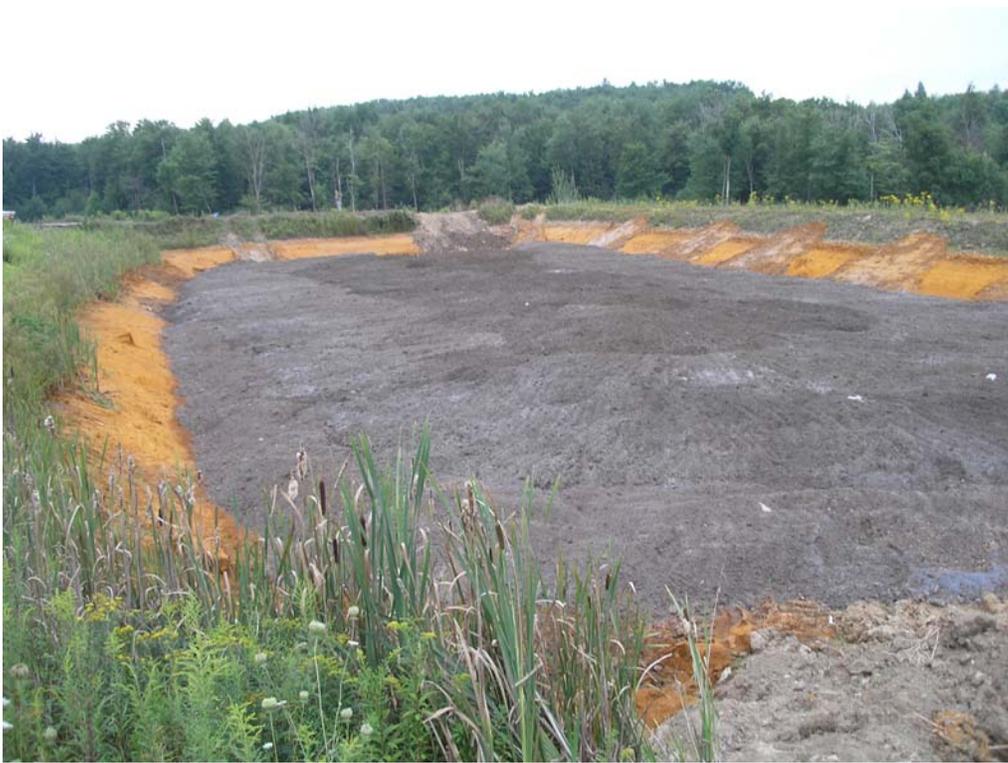
Photo 3. VFP 1 after addition of new compost.

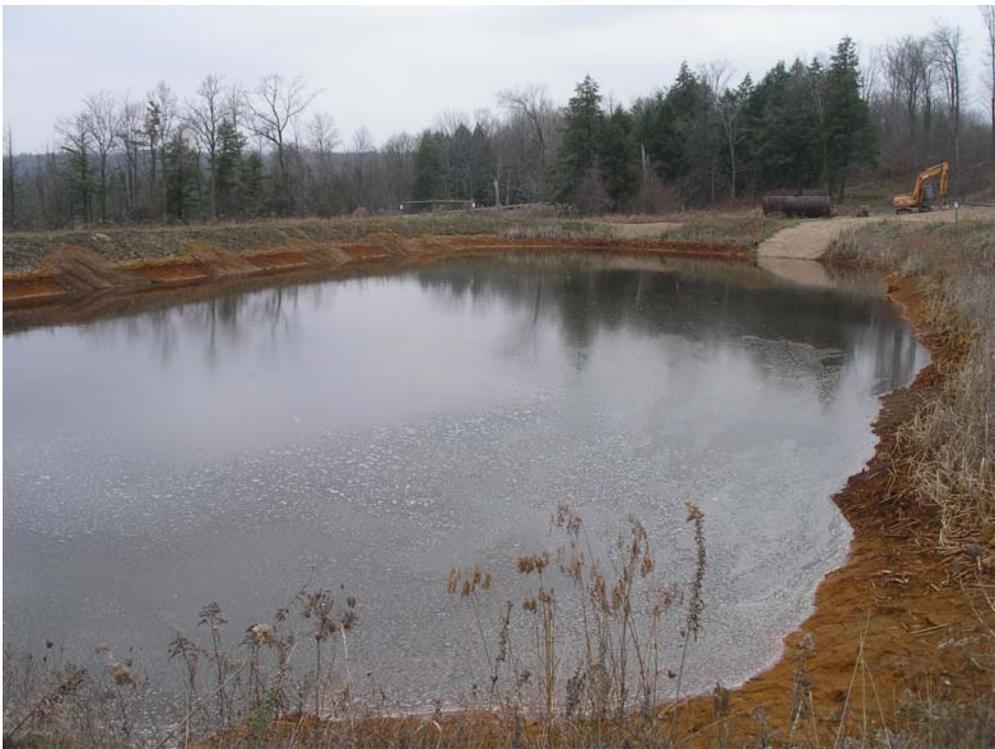
Photo 4. VFP 1 after partial refilling with water

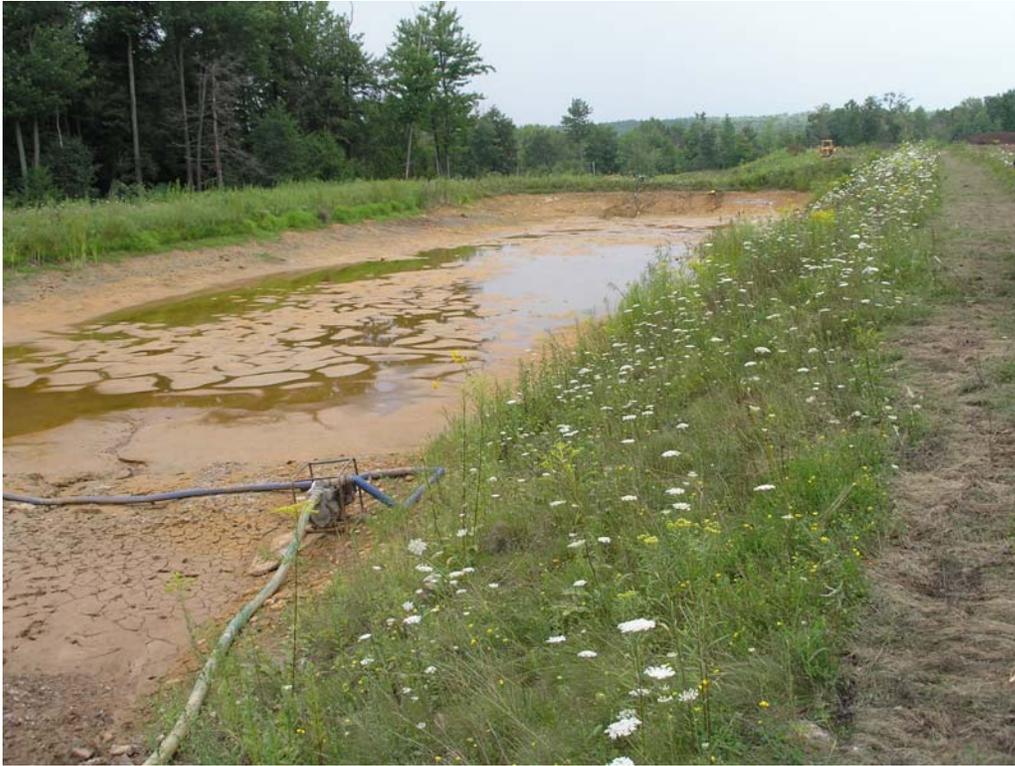
Photo 5. VFP 2 after draining, showing Fe precipitate.

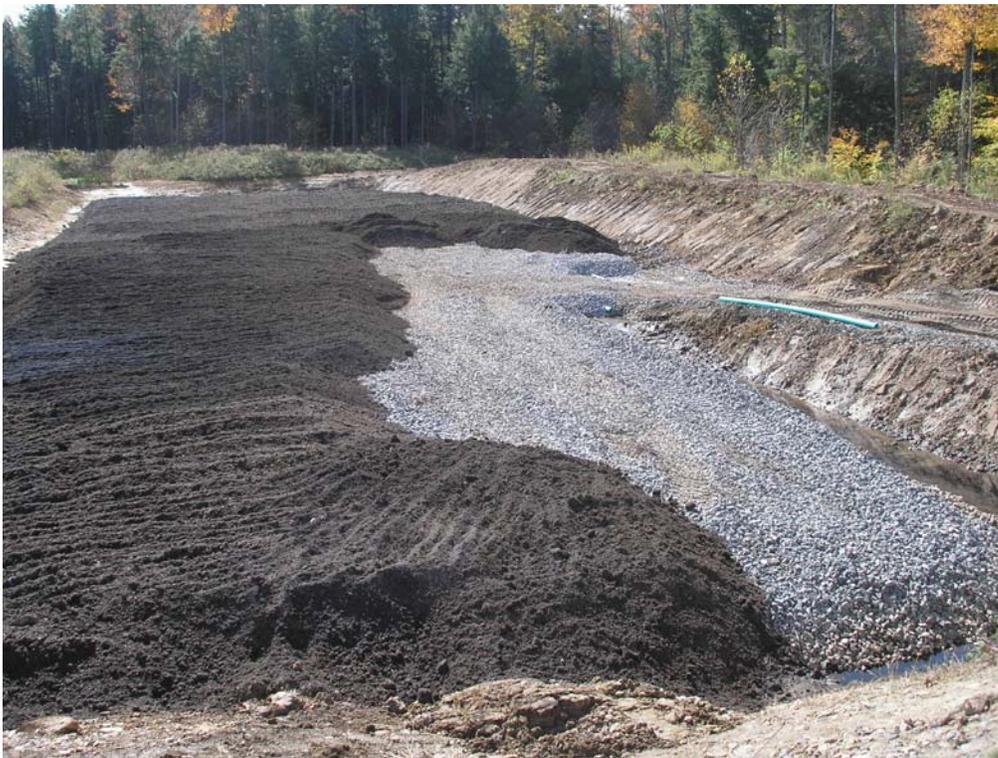
Photo 6. VFP 2 after emplacement of new limestone, underdrain and part of compost.

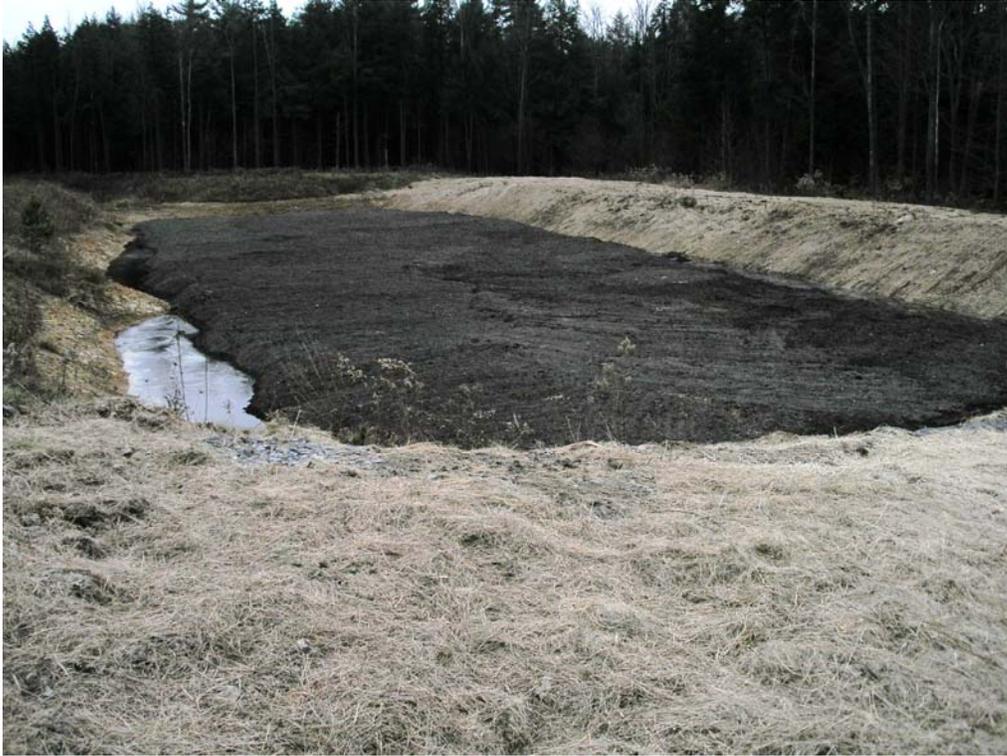
Photo 7. VFP2 after completion of compost addition.

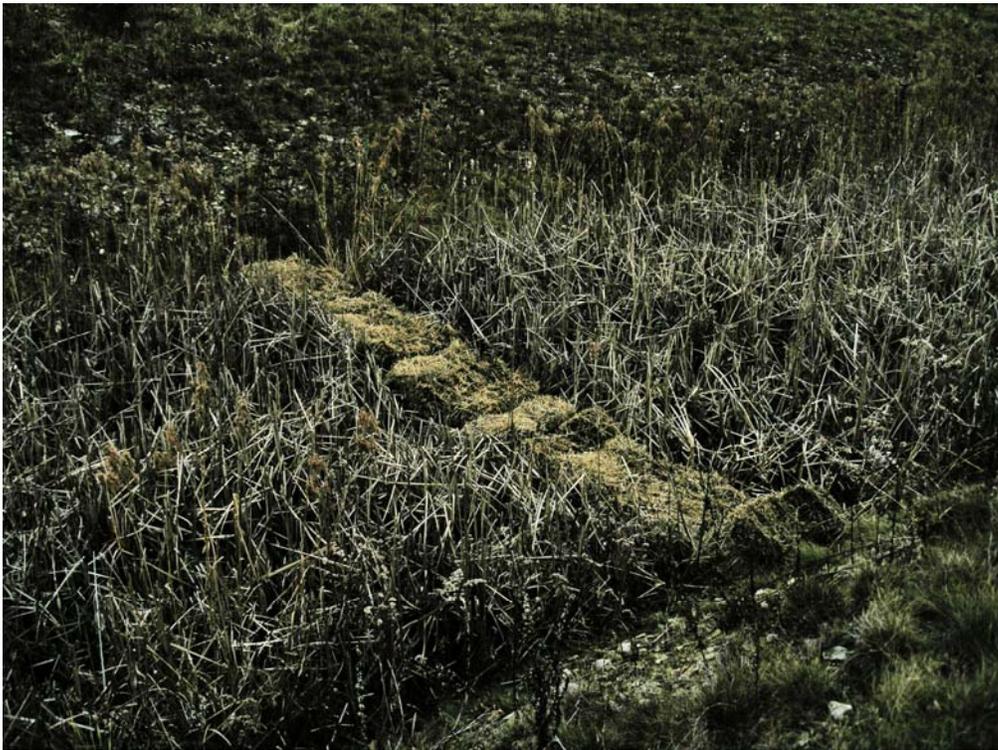
Photo 8. Straw bale dam in Wetland 1
