# Kiski-Conemaugh Basin Treatment System O&M Assessment Report

December 2017

Prepared by  
Stream Restoration Incorporated and BioMost, Inc.

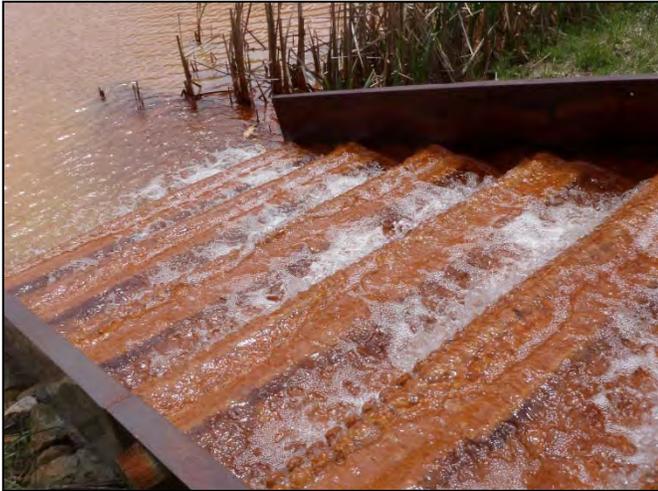
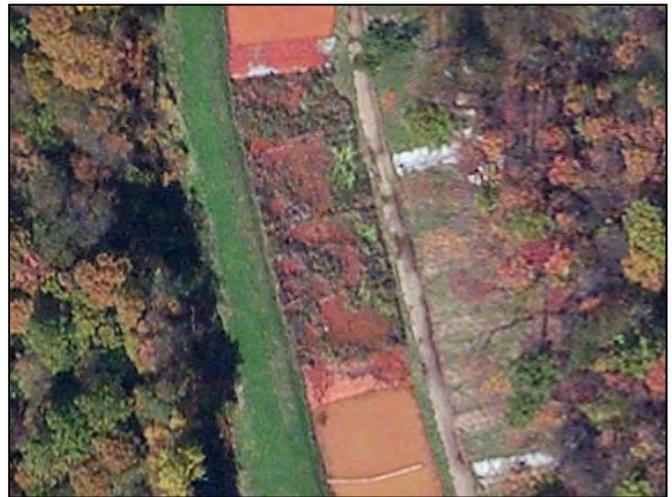
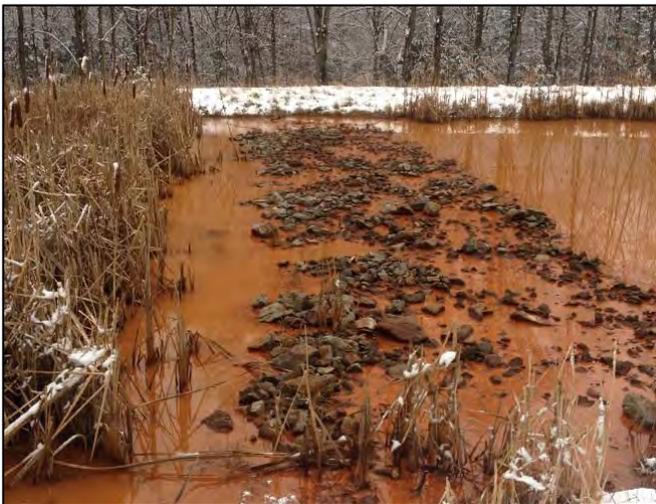
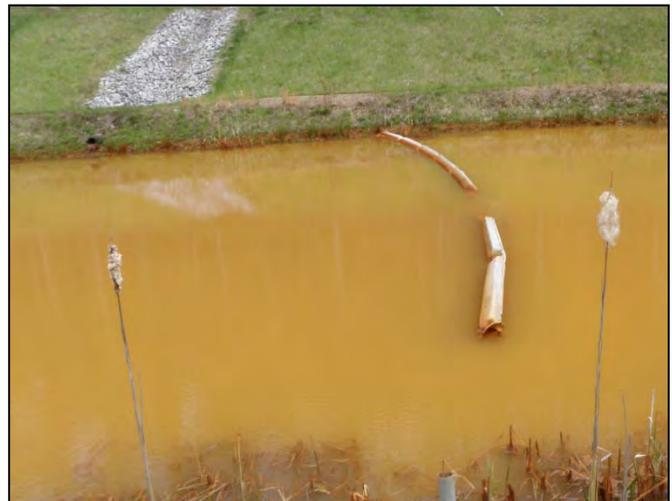
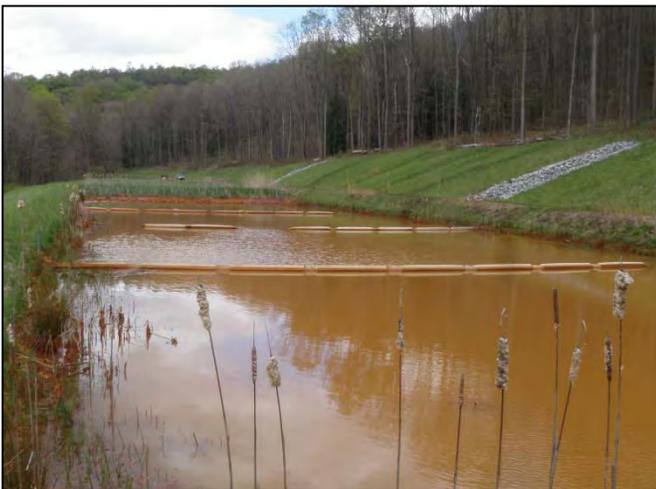
### Mineral Point Photos

At the Mineral Point system, the Step Aerator (Top Left) quickly fills with iron precipitates that regularly need to be removed. Several maintenance issues may be reducing treatment efficiency including short-circuiting in the wetland as can be seen from the aerial photo (Top Right). This might be partially caused by uneven spillways (far side Middle Left). One of the baffle curtains needs to be repaired (Middle Right) although there may be a benefit to replacing a few of the directional curtains in cell 3 (Bottom Left) with windowed curtains to help settle solids. Removal of iron sludge may also help to improve treatment.

- Continue monitoring the system on a regular basis including flow rates.
- Continue to clean the step aerator as needed.
- Address short-circuiting pathways at spillways.
- Repair/replace baffle curtains as needed.
- Sludge removal will likely need to be conducted in the near future.
- Consider building a sludge dewatering pond if a location is available.
- Clean flume or develop another method to measure flow with look-up table.
- May need to address muskrats if they become a problem.

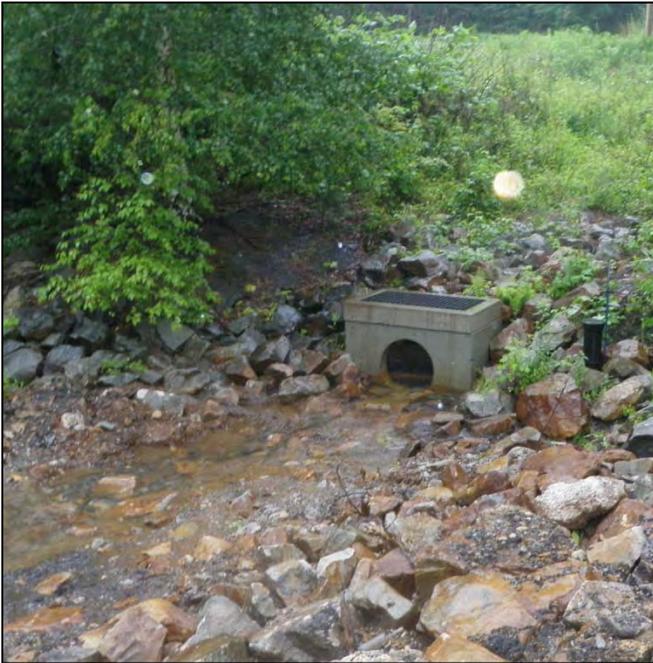
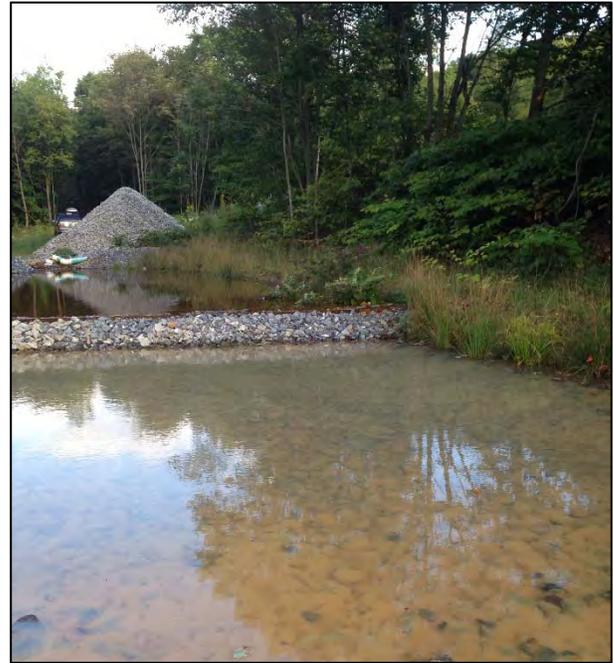
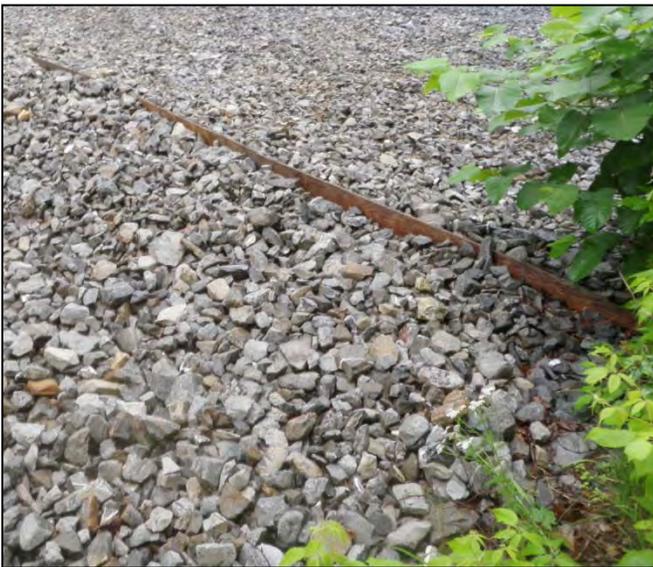
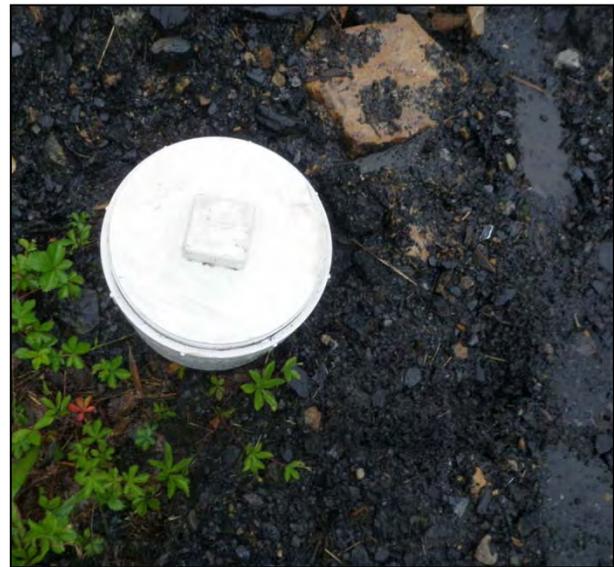
### Puritan Photos

At times, a large portion of the AMD is bypassing the Puritan passive system (Top Left). The first two cells of the limestone bed are regularly clogged with metals (Top Right). At least once per year, the limestone in these cells is removed for cleaning and placed in a pile (Top Right) and then the cleaned stone from the year before is put in its place. The limestone bed uses wooden baffles (Bottom Left) to try to fully utilize the treatment media. Water monitoring indicates the treatment system is likely leaking which would probably be due to fact that the system was built in coal refuse material and does not appear to be lined (Bottom Right).

While the Puritan system generally provides significant treatment in terms of raising pH, neutralizing acidity and removing much of the metals from the mine drainage, the system only treats a portion of the drainage as it is undersized. In addition, the leaking pond further reduces the amount of water treated. The importance of treating this discharge has dramatically increased because once the proposed large Portage Active Treatment Plan is constructed for the major discharges in the basin, the Puritan discharge will be one of the last major impacts in the headwaters of the Little Conemaugh River. The system needs to be modified/rebuilt in order to treat the entire discharge, fix leaks and simultaneously reduce future maintenance needs.

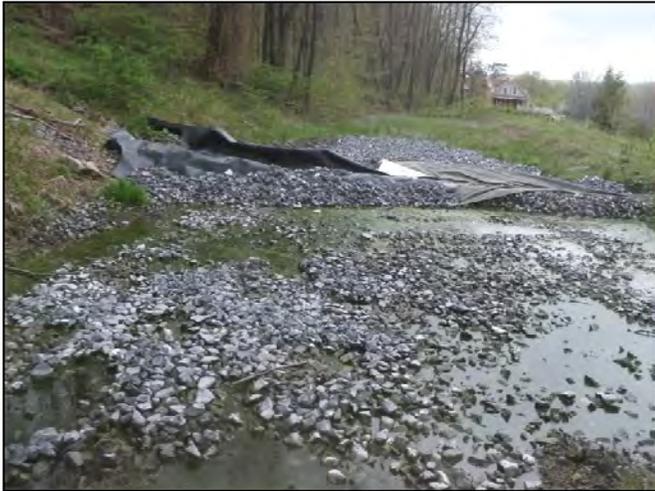
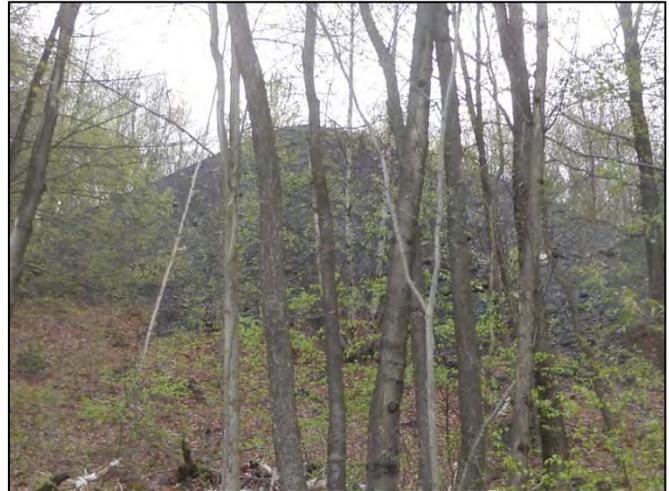
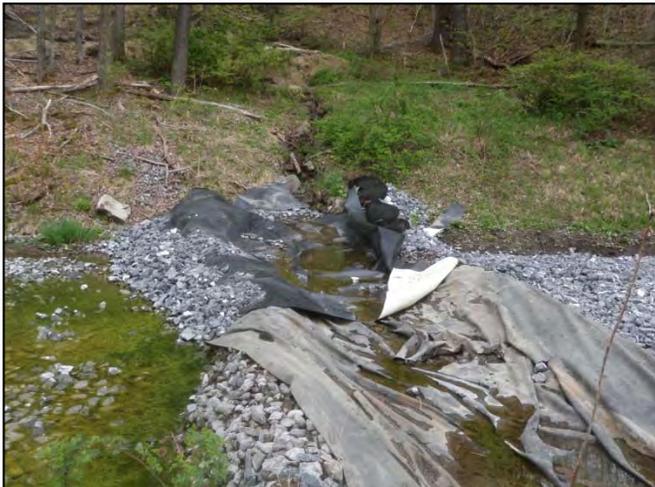
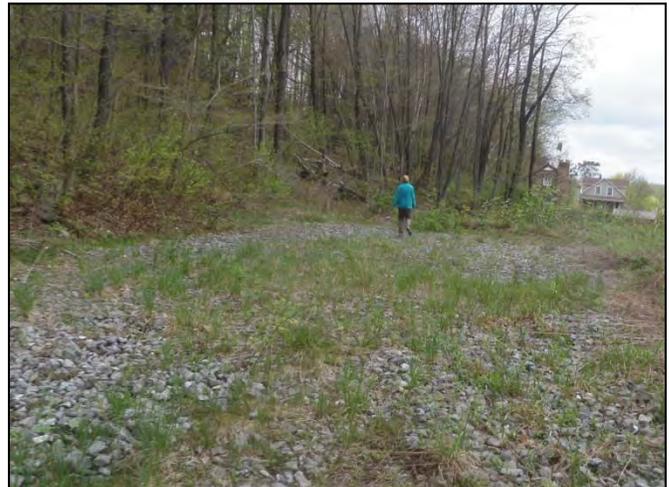
### South Fork AMD50 Photos

The South Fork AMD50 site consists of a single limestone bed, which appears to be partially plugged at the first 1/3 of the bed (Top Left) as evidenced by the standing water. Algae growing in the standing water could add to this problem. A coal refuse pile (Top Right) is situated above the system to the west and has in the past been a source of sediment and plugging. A WCPAMR Quick Response grant provided funding to stir the limestone and construct a diversion channel across the bed (Top & Bottom Left) to help keep the sediment out. There may be a need to add stone to the diversion channel. Vegetation is growing (Bottom Right) in places through the other 2/3 of the bed, but at the present time does not appear to be affecting treatment. The bed can be flushed, but there is no pond to flush the solids to due to limited room, public roads, and a stream.

- It might be possible to find a location to either build a flush pond or to at least use a pumped filter bag during flushing events.
- Establishment of an O&M fund for future maintenance needs is also recommended.

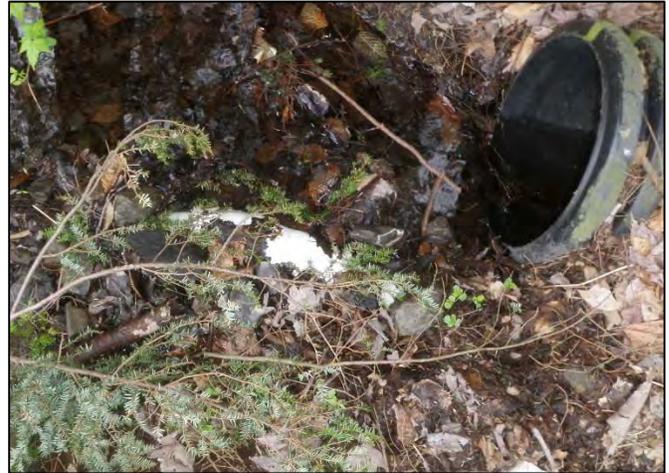
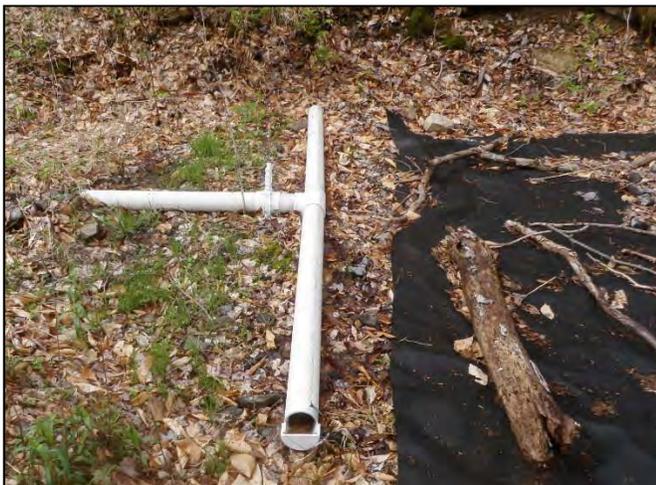
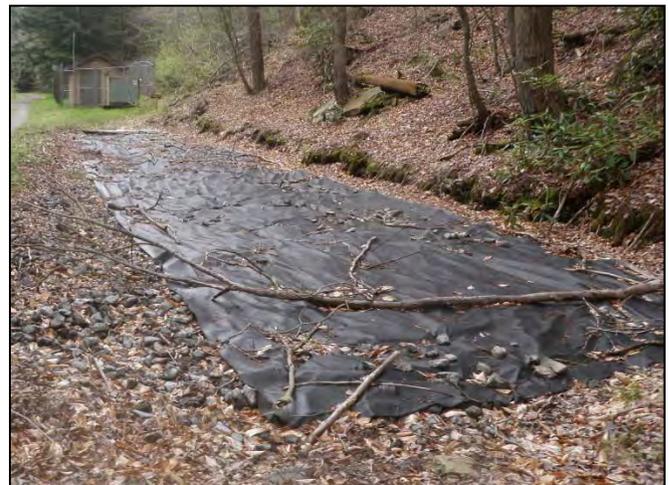
### South Fork AMD60 Photos

The South Fork AMD60 discharge is collected by a white perforated PVC pipe (a portion visible Top Right) that was placed within a rock-lined channel (Top Left). Any water not collected by the pipe is bypassed to the stream by the black culvert pipe (Top Left and Right). The collection pipe is easily covered and plugged by leaves and debris. The collected AMD is conveyed around a pump house to the influent distribution pipe with bottom perforations (Bottom Left) which also can be easily clogged with leaves and debris. The water then flows through the limestone bed (Bottom Right) which has geotextile placed on top of the limestone to prevent clogging with leaves and debris.

- Regularly inspect the intake and flow distribution manifold for the accumulation of leaves and debris and remove as necessary.
- Due to the passive system design, water quality characteristics, etc., the accumulation of metal sludge, sediment, and debris will decrease permeability and treatment effectiveness over time. There will be a need to periodically clean the bed. It is recommended that the stone be stirred and washed and if possible that sediments and sludge are collected and removed from the site rather than being flushed into the stream.

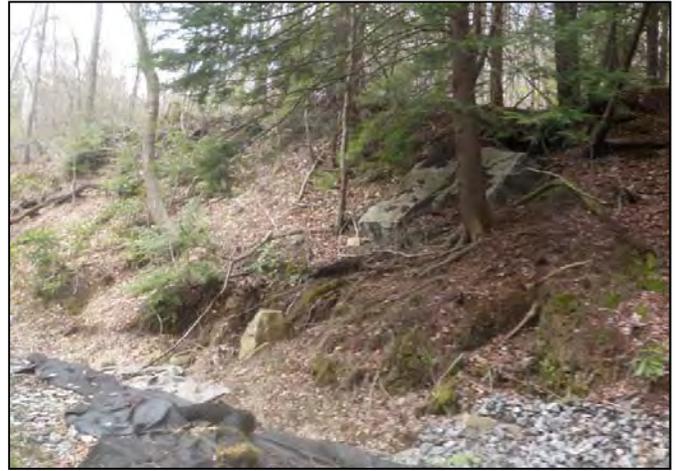
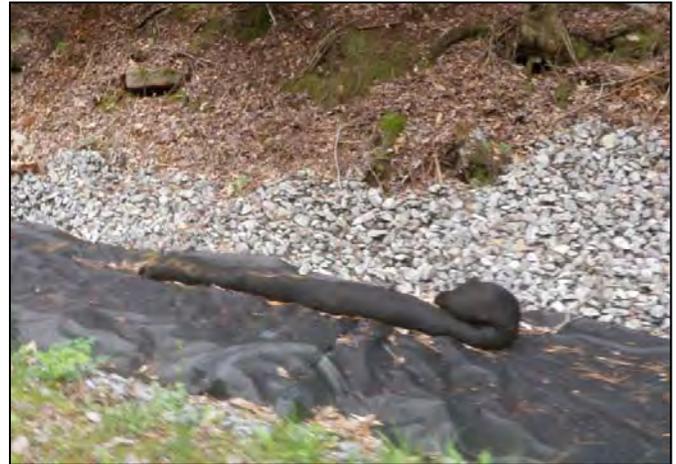
### South Fork AMD67 Photos

The South Fork AMD67 system consists of a long narrow limestone trench used to treat a small seep(s). Space was limited due to the hillside and access road (Top Left). The system is experiencing significant erosion of the cut slope and some large boulders are falling down (Top Left & Right). There have been attempts to stabilize the hill side and a number of compost filter socks have been placed at the toe (Bottom Left & Right) to help prevent sediment from entering the trench. The trench has been stirred a couple of times. At one point, geotextile was placed over top of the stone to help protect the bed from becoming plugged.

- Continue to conduct regular inspections and water monitoring of the system including flow measurements whenever possible.
- Pay particular attention to increases in water level and the accumulation of water on top of the limestone trench, which is an indicator of the trench becoming plugged.
- Due to the passive system design, water quality characteristics, etc., the accumulation of metal sludge, sediment, and debris will decrease permeability and treatment effectiveness over time. There will be a need to periodically clean the trench. It is recommended that the stone be stirred and washed and if possible that sediments and sludge are collected and removed from the site rather than being flushed into the stream.
- Establishment of an O&M fund for future maintenance needs is also recommended.

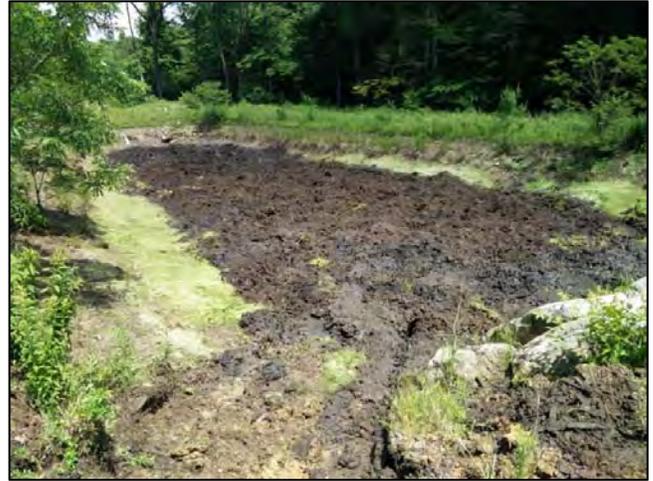
### Coal Pit Run Upper and Lower Systems Photos

The permeability of the Coal Pit Upper Vertical Flow Pond had decreased and was flowing over the berm (Top Left). The pond was drained and stirred (Top Right). The valve for flushing the pond had broken and was replaced (Middle Left). Vegetation, sludge, and debris had accumulated around the influent pipe of the Lower system (Middle Right) which made sampling difficult. The material was removed (Bottom Left).

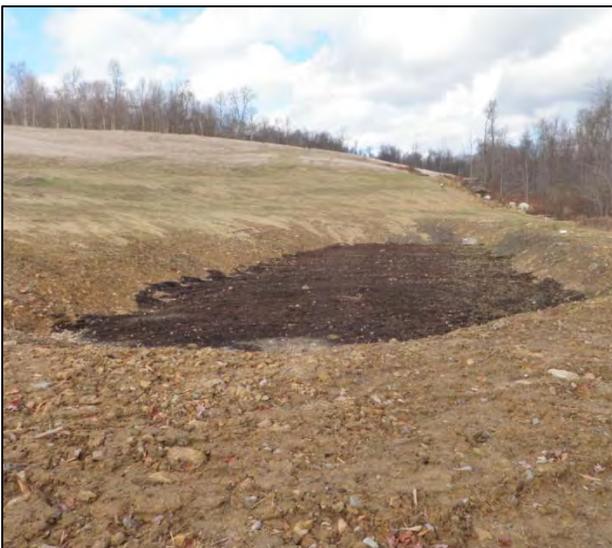
### Laurel Run #1 (North) Photos

The underground collection system had become plugged causing AMD to upwell to the surface and bypass system (Top Left). A new collection and flow splitter system was installed by Amerikohl during mining (Top Right). After replacing the valves, a skid-loader and small excavator were used to stir the upper 2 to 3 feet of the treatment media of the existing Vertical Flow Ponds to increase permeability and promote better utilization of the treatment media. Compare before stirring the media (Middle Left) with after stirring (Middle Right). As part of the surface mine permit conditions, Amerikohl converted a settling basin to a third Vertical Flow Pond (Bottom Left) to provide greater treatment capacity especially during high flow periods.

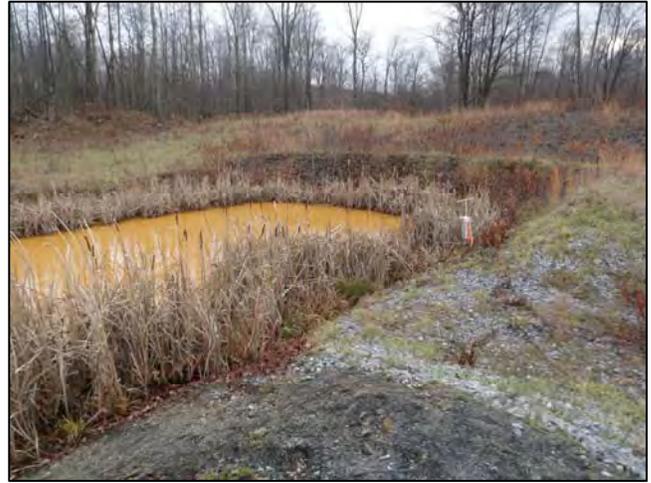
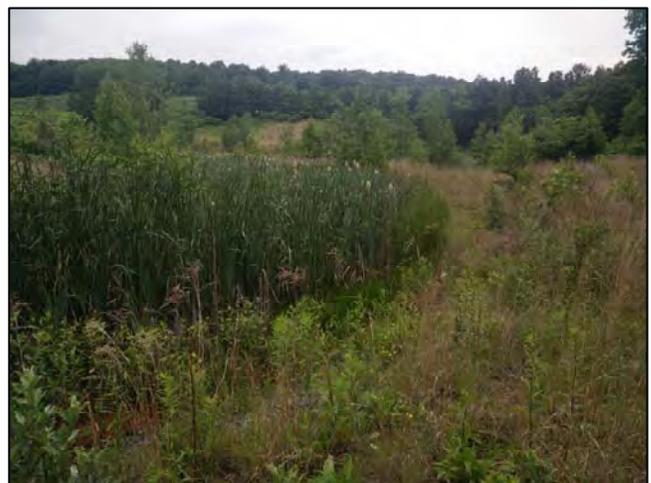
### Laurel Run #2 (South) Photos

A set of valves (Top Left) control the abandoned underground mine discharge to the Laurel Run #2 passive system. The Vertical Flow Ponds discharge to a settling pond (Top Right) followed by a wetland before discharging to the stream (Center Left). The vegetation within the wetland was so successful (Center Right) it caused the water to dam up and flow out of the emergency spillway therefore bypassing treatment. The SRI TAG program was utilized to clean out vegetation to open up pathways (Bottom Left) and restore flow through the system.

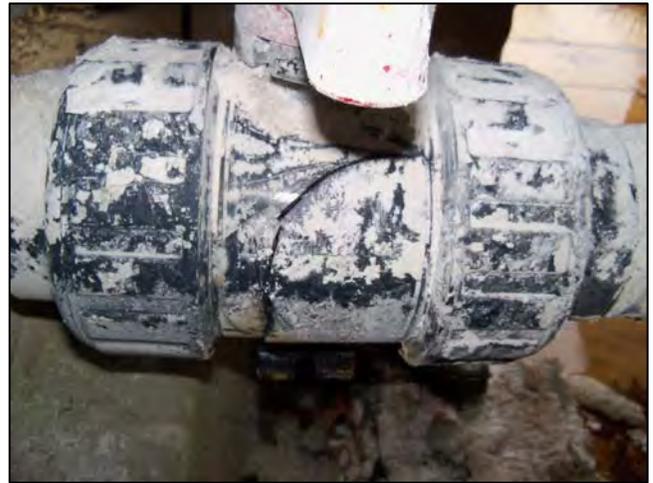
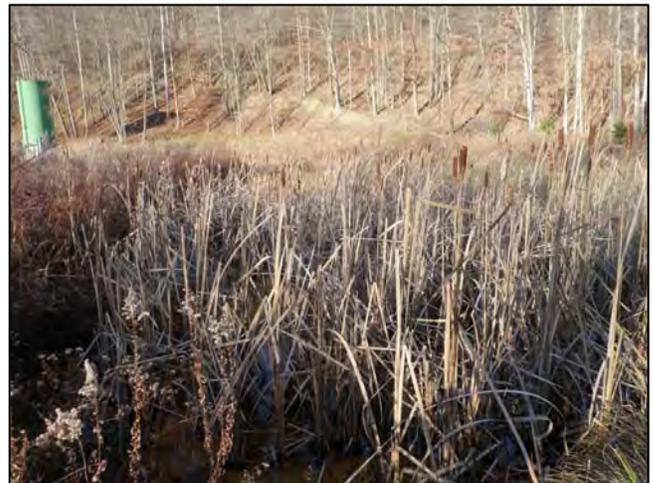
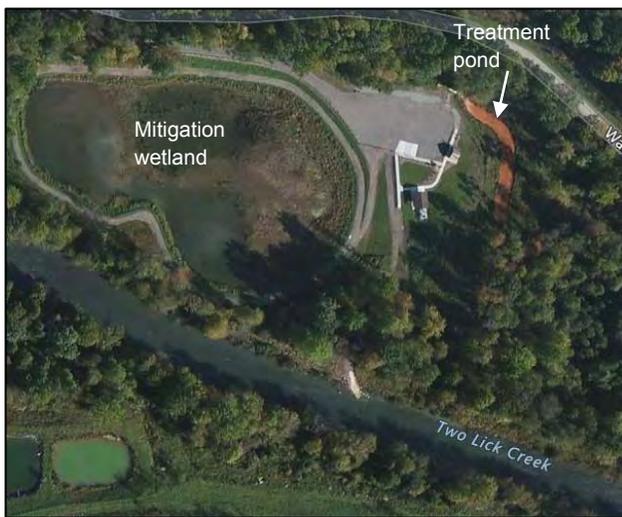
### Lucerne 3A Photos

The Lucerne 3A treatment system consists of a lime doser (Top Left) and settling pond/wetland (Center Left and Right). A broken valve (Top Right) was replaced through SRI's O&M TAG grant. The system could greatly benefit from having additional treatment pond area for settling of solids. Use of the large existing mitigation wetland (Bottom Left) would be ideal. It may be possible to expand the existing treatment system to the east and south. Adding windowed baffle curtains would also be beneficial to help settle solids.

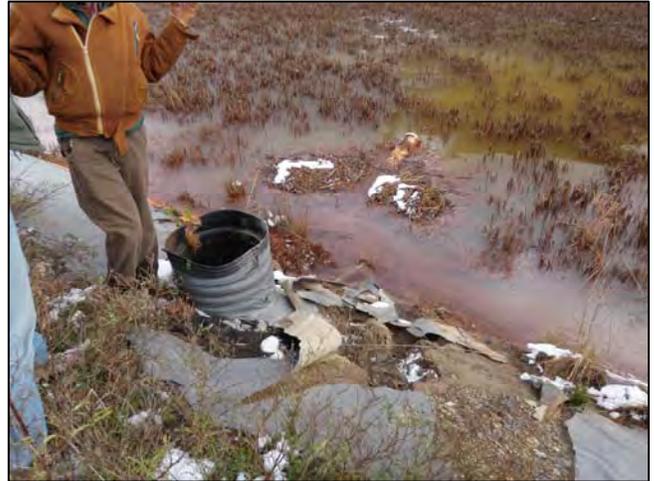
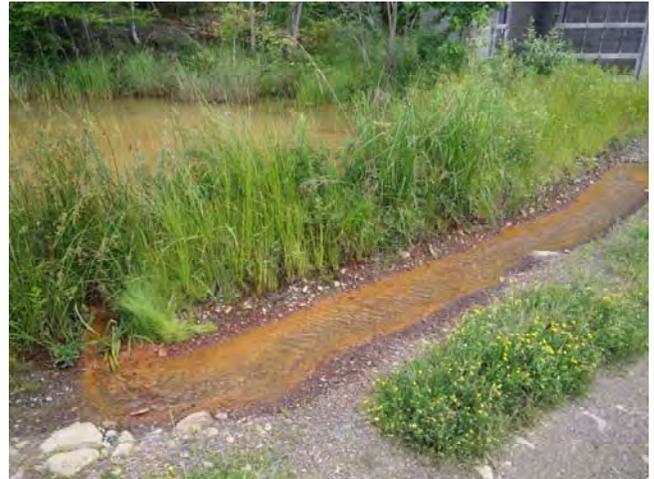
## Penn Hills #2 Photos

At the Penn Hills #2 system, the BCWA was concerned about vegetation growing within the Vertical Flow Reactors (Top Left) and the deterioration of pond liners (Top Right). An untreated mine discharge was flowing across and eroding the long access road (Center Left) to the system. A culvert was installed and the road repaired (Bottom Right) under SRI's O&M TAG program. An unknown pond structure which received AMD was overflowing and impacting the access road around the system (Center Right). This was also fixed through the O&M TAG program. Iron in the flow splitter box was also removed (Bottom Left) to return even flow distribution to the VFRs.

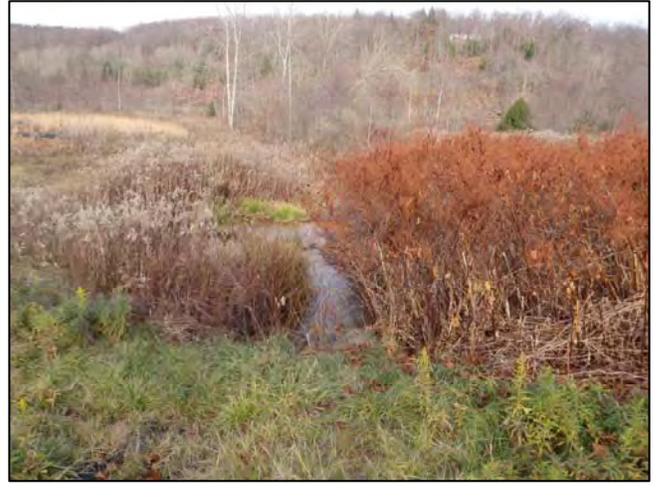
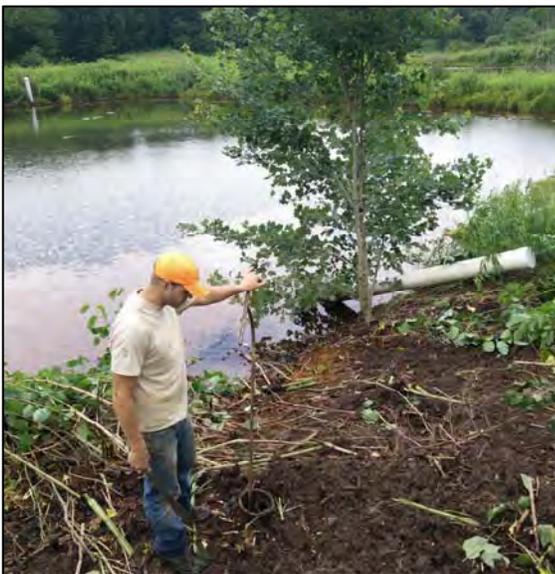
### Richards Systems #1 & #2 Photos

At the Richards Passive Treatment complex, the intake and conveyance pipe had become plugged (Top Left) causing most of the water to flow through a culvert and bypass the treatment system (Top Right). Additional plugged pipes from the flow splitter prevented water from getting to two of the VFR ponds (Center Left). An overgrowth of vegetation was causing difficulties for StreamTeam to sample, which needed to be removed (Center Right). After vegetation removal occurred, valve boxes were able to be located (Bottom Left).

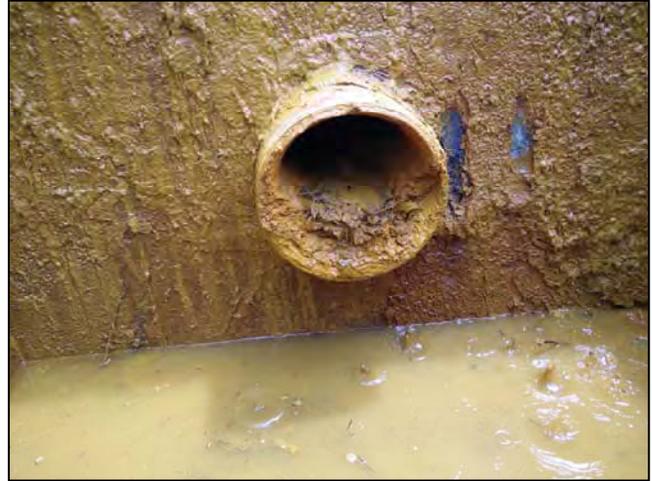
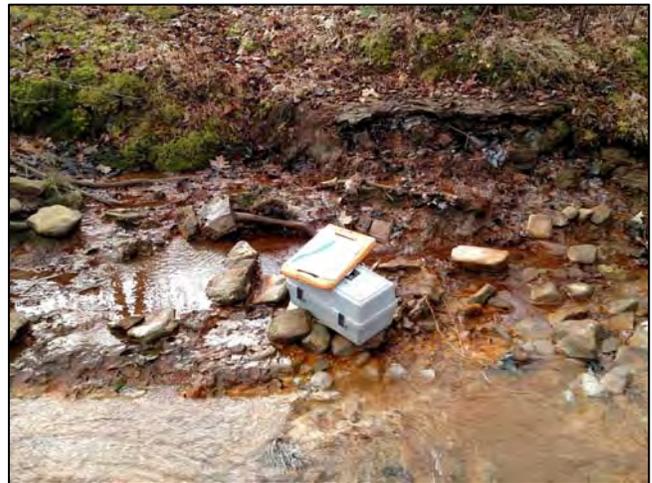
Water within the drop inlet box had to be pumped in order to access and clean the box (Top Left). The conveyance pipe to the treatment system was plugged (Top Right) as well as the piping from the flow splitter box to two of the VFRs. These were cleaned out using a power snake (Center Left). Debris that had accumulated with the mine discharge pipe was also removed (Center Right). Seeps from the leaking Settling Pond and potential other sources flow into South Branch Two Lick Creek (Bottom Left).

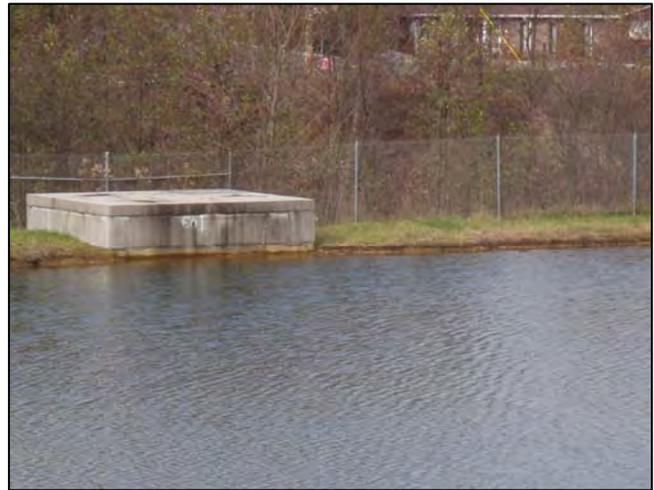
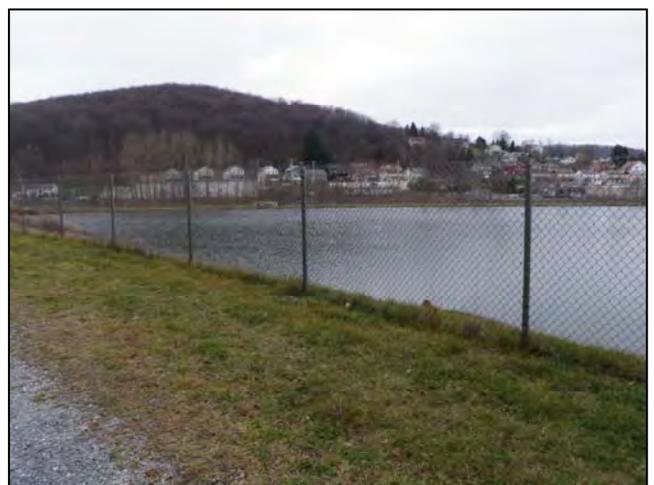
### Webster Photos

After two years of operation, the treatment effectiveness of the Webster passive treatment system (Top Left) suddenly and dramatically declined. The flow distribution piping system for VFP1 is currently underwater (Top Right) indicating the media or piping system may be plugged. A flow splitter device was not used at the site. Instead the AMD has to flow across the 3.5 acre VFP1 into VFP2 via valved pipes in manholes located in the berm between the ponds (Bottom Left). Unfortunately, these manholes were not built flush with the ground so trucks and equipment cannot easily reach critical parts of the system to conduct maintenance. Fencing around the outer perimeter (Bottom Right) causes similar problems in some locations.

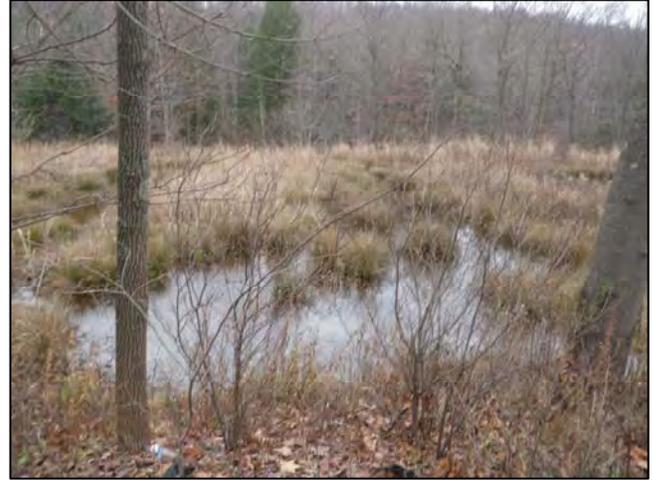
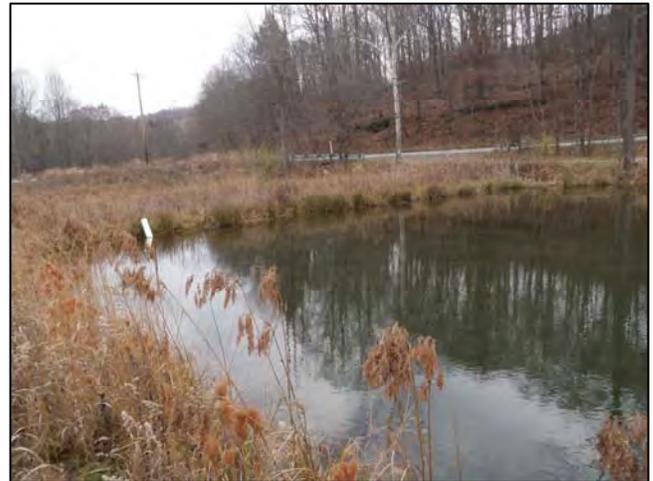
### Yellow Creek 1A Photos

At the Yellow Creek 1A passive system, mine drainage is collected by a perforated pipe (Top Left) and then conveyed under the highway to the collection pond of the treatment system. A dike was also built to keep clean water out of the system. As lower flow rates are entering the system, the collection system probably needs to be repaired. Water from the collection system then flows into the wetland (Top Right). Accumulation of vegetation and debris possibly combined with elevation problems of the spillways are likely the cause of water flowing out of the emergency spillway of the collection pond (Bottom Left) causing more water to bypass the system. The treatment media within the VFR (Bottom Right) likely needs to be stirred and possibly replaced.

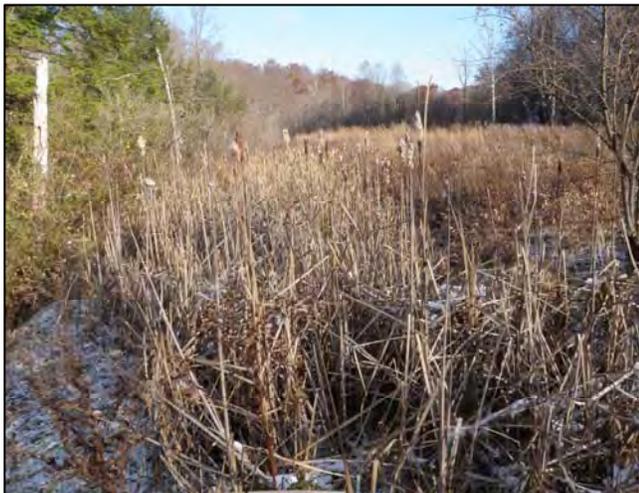
### Yellow Creek 1B System Photos

At the Yellow Creek 1B passive system, the mine drainage is first collected in a series of ponds (Top Left) and then conveyed under the access road to the Vertical Flow Reactor (Center Right). A gas and water line run parallel with the road. A pipe found at the collection ponds (Top Right) is likely overflow from the 1A system. Permeability problems within the VFR are causing water to bypass the system through a culvert pipe (Center Left). The effluent of the 1A & 1B systems share an outlet channel to Yellow Creek that is clogged with cattails (Bottom Left).

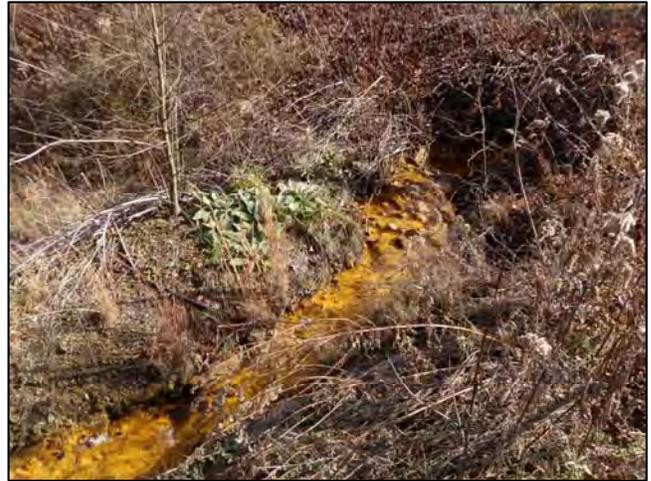
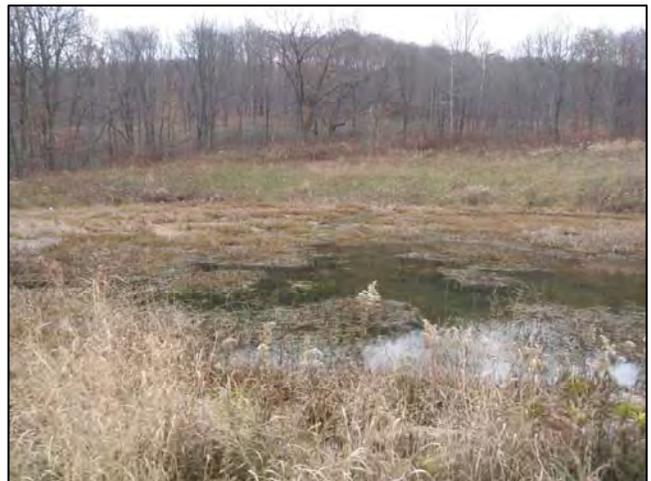
### Yellow Creek 2A & 2B Photos

Mine drainage from multiple entries of the Judy #14 mine is first collected in a pond (Top Left) before being conveyed to the 2A & 2B system. Some of the water is bypassing the system (Top Right). A flow splitter device (Center Left) is used to direct AMD into both parts of the system, but reportedly has some issues. VFR 2A (Center Right) is experiencing permeability issues. Dense cattails (Bottom Left) growing in a channel creates a dam that causes the water to overflow and bypass a portion of the treatment system.

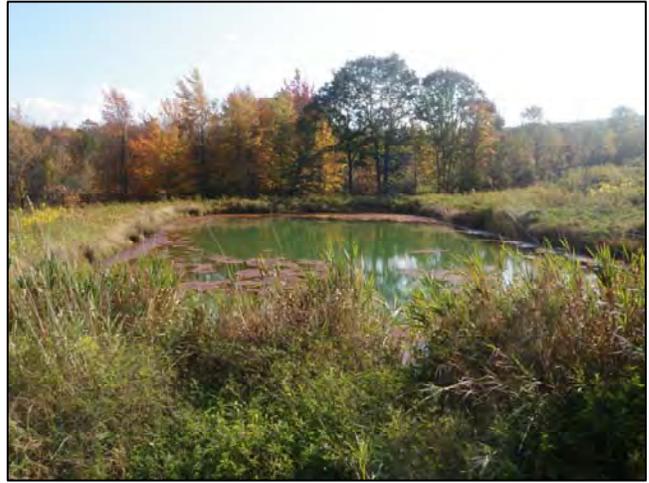
### Cottagetown Photos

At the Cottagetown passive treatment system, two pipes (Top Left) convey AMD to pond #1 (Top Right). Those pipes were not visible during the inspection due to the high water level within the pond, which was caused by the buildup of iron sludge, vegetation and debris in the channel from the pipe to the weir (Center Left). The effluent pipe of the VFP hangs out over the third pond (Center Right) so much that sampling is very difficult. The effluent of the system (Bottom Left) flows in a channel into a “wetland” and mixes with other sources of mine water before discharging to the stream.

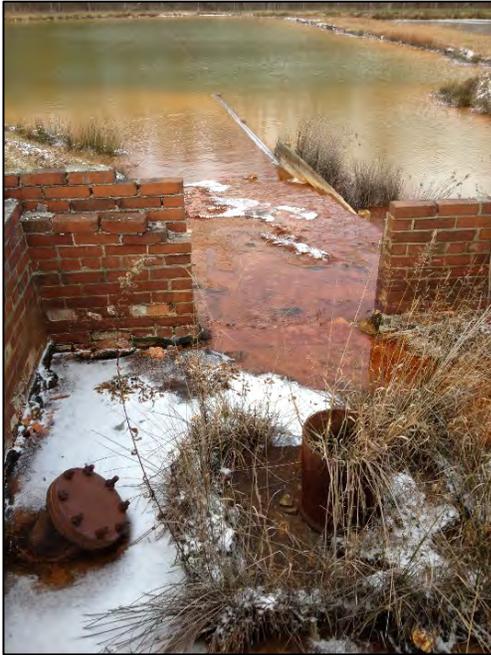
### Jenners Photos

At the Jenners passive system, the AMD emanates from an old municipal water supply well (Top Left). A build up of iron sludge and failing wooden baffles may be causing short-circuiting within the first settling/aeration pond (Top Right and Bottom Left). The wooden baffles could be replaced with directional curtain baffles. Iron precipitates within the spillway between the first settling/ aeration pond and the vertical flow pond (Bottom Right) are likely increasing water levels within the ponds.

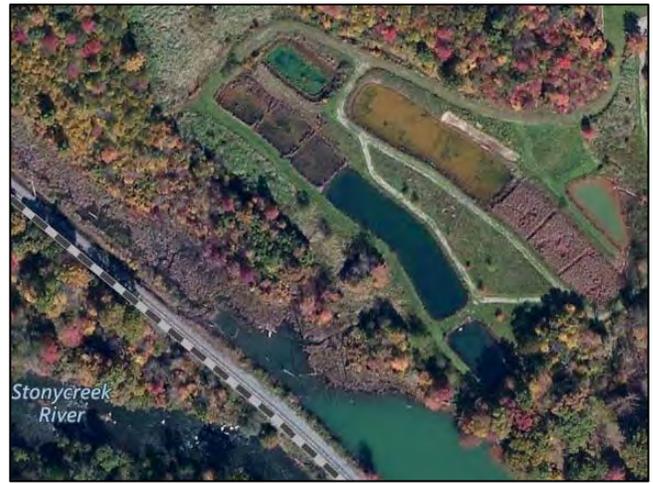
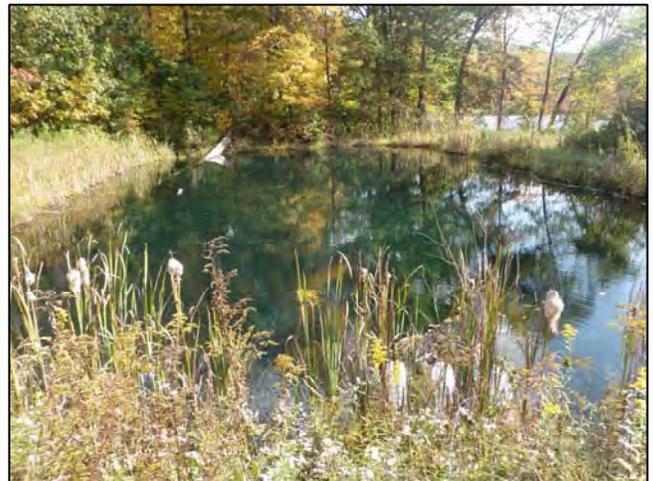
### Oven Run D Photos

AMD is conveyed by a channel (Top Left) to the Oven Run D System (Top Right). A buildup of debris, vegetation, etc., was causing water to flow over the berm of Settling Pond #2 (Center Left). This was fixed during the inspection. Water flowing out the system from Settling Pond #3 (Center Right) is generally of good quality, but then mixes with untreated AMD (Bottom Left) before flowing into an unknown body of water and eventually discharging to the Stonycreek River.

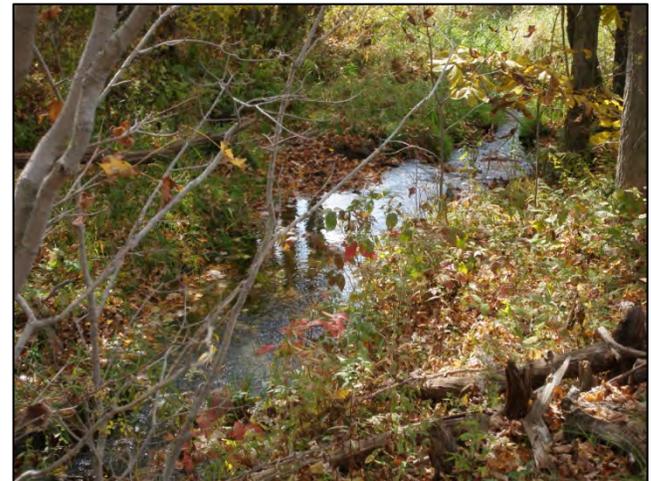
### Oven Run F Photos

During the initial site visit on 11/20/12, the Oven Run F Passive Treatment System (Top Left and Right) appeared to be functioning well. Greg Shustrick expressed concerns about the media becoming plugged; however, there were no obvious signs of decreased water treatment or water overtopping the berms. After reviewing available water quality data, BMI revisited the site to further investigate the apparent reduction in effluent flow rates. During the site visit, mine water was found to be flowing in a channel between SAPS2 and Settling Pond 2 (Bottom Left). The water was traced (Bottom Right) to the source, which was a pipe located near the influent pipe. This was believed to be an overflow or by-pass pipe. The Somerset County Conservation District was contacted and they have since acquired funding to complete repair work.

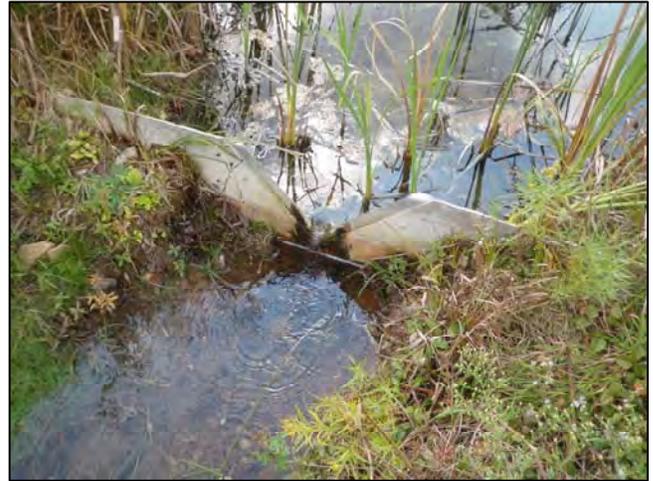
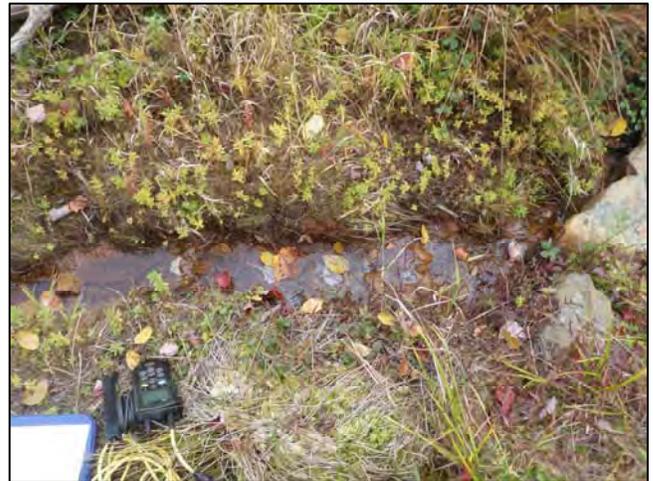
### Swallow Farm Photos

At the Swallow Farm passive system, mine drainage is collected and then directed into a limestone bed with wooden baffles (Top Left). A weir and effluent spillway maintains a water level above the top of the stone (Top Right). The effluent of the limestone bed is considered the effluent of the system even though there is settling pond and wetland (Bottom Left) which are reported to leak and despite water still flowing out of the system (Bottom Right). As the system has been successful, it may be possible to collect additional seeps and direct them into the limestone bed.

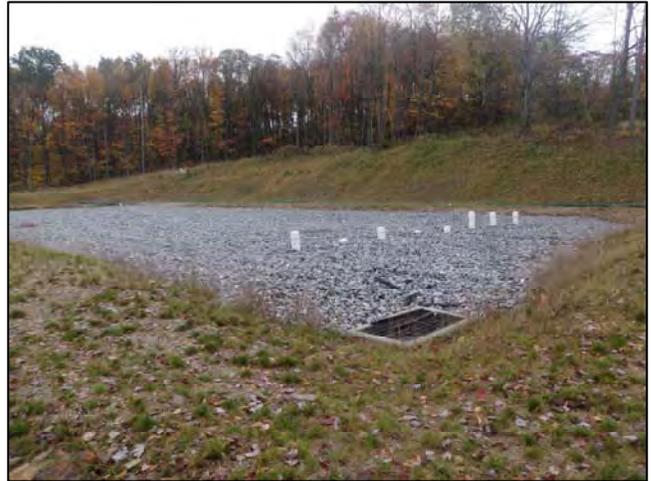
### Weaver Run D10 Photos

The Weaver Run D10 limestone bed is experiencing a variety of issues. Dye testing (Top Left) and monitoring at the pipe tree (Top Right) indicated that short-circuiting was occurring and the level spreader was not functioning. Without a settling pond there is no place to settle aluminum solids (Center Left) during normal operation or flushing events. Installing a settling/flush pond is recommended. Wooden stakes were installed along the steep outer berm (Center Right) to monitor the seeps and potential slumping. Disparity in flow data may be due to the condition of the weir (Bottom Left) and/or differences in flow measuring techniques.

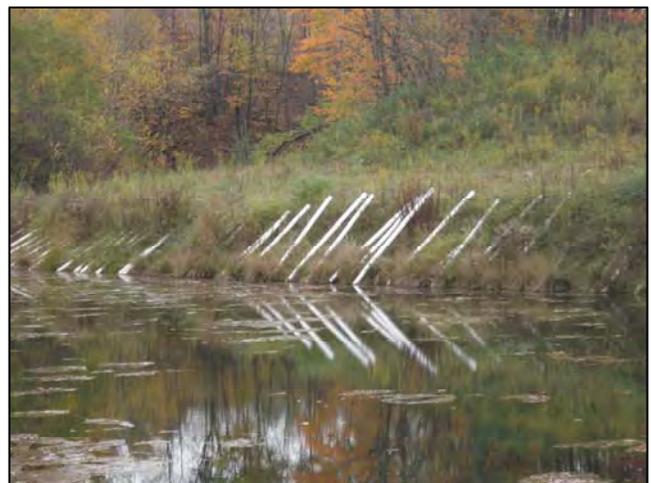
### Adams #7 Photos

At the Adams #6 passive system, a large flow underground mine discharge (Top Left) has pooled and then flows into a VFP. Much of the water is flowing over the emergency spillway, which is located directly across from where the AMD enters the VFP (Top Right). Water bypassing the VFP through the emergency spillway mixes with the effluent of the VFP (Center Left) before flowing into the Settling Pond (Bottom Left) helping to treat the bypassed flow. The VFP has an unusually large number of cleanout pipes (Center Right). Work has been conducted by the WCWA to improve treatment.

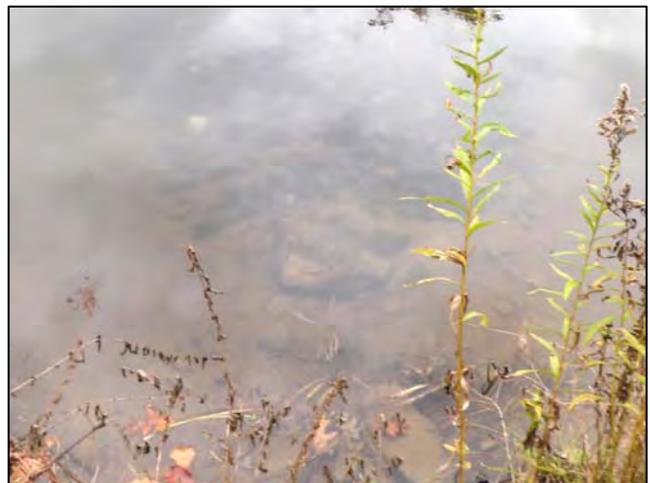
### Onstead Photos

At the Onstead passive system, the influent piping carrying the AMD to the system was under water (Top Left) which may be an indication of hydraulic issues which could be caused by plants and algae growing in the Vertical Flow Pond (Top Left and Right) or may be an indication of reduced permeability of the treatment media. From the VFP, the water flows into a settling pond (Bottom Left) which contains a rock baffle (Bottom Right), which the purpose of is not clearly known. The water level may be too high. If intended to help settle solids, the use of windowed baffle curtains could achieve similar and likely better

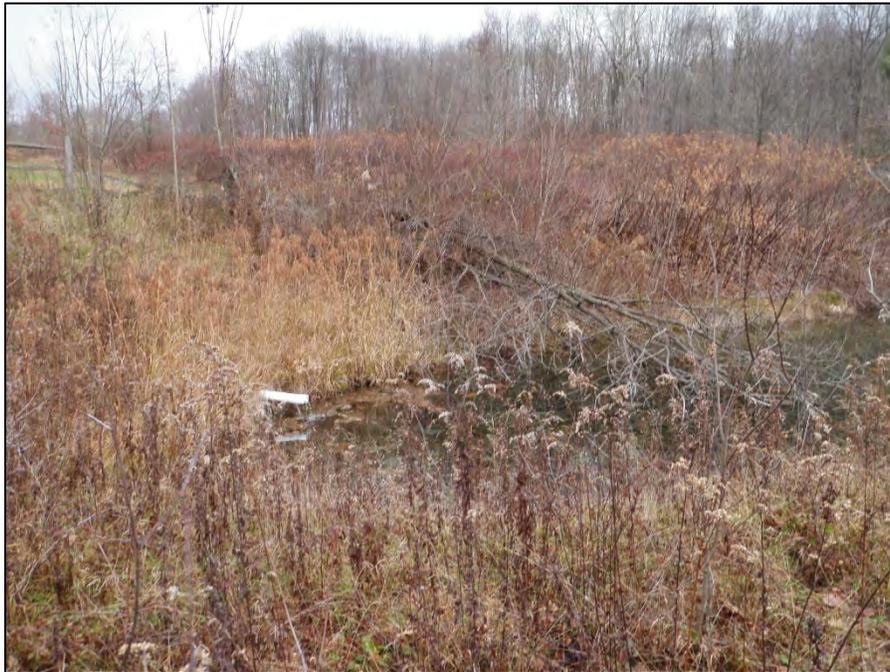
### Gray Run Photos

At the Gray Run passive system, fencing, downed trees, thick thorny vegetation, etc., made traveling around and seeing the system difficult. The system which is nearly 20 years old consists of a SAP or VFP (Top) and a settling pond (Bottom) which are not fully treating the water.

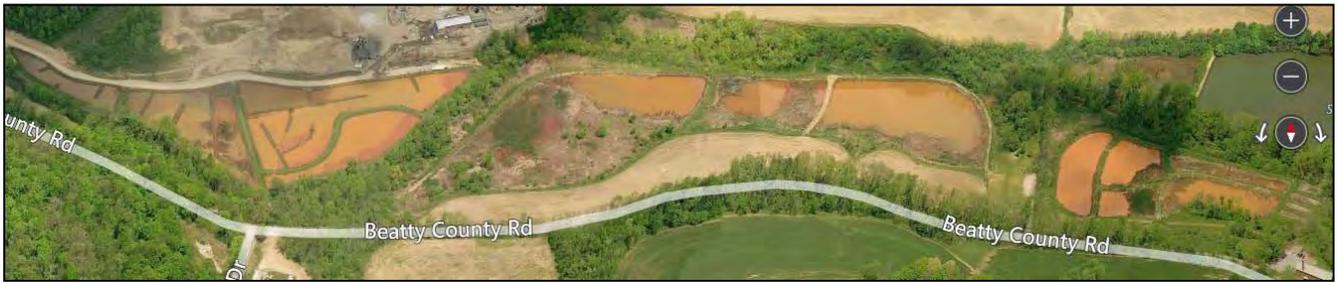
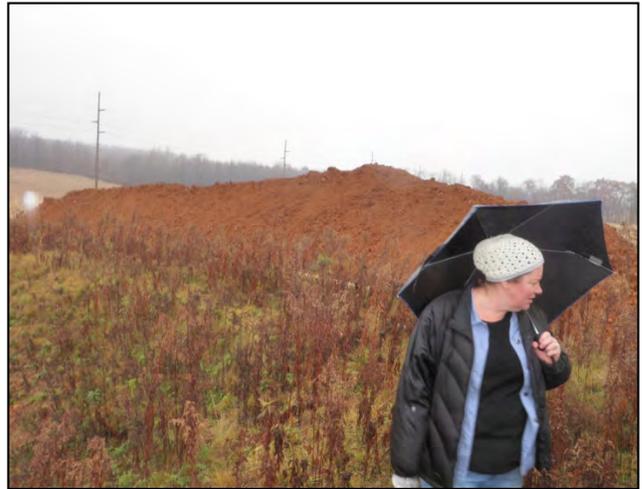
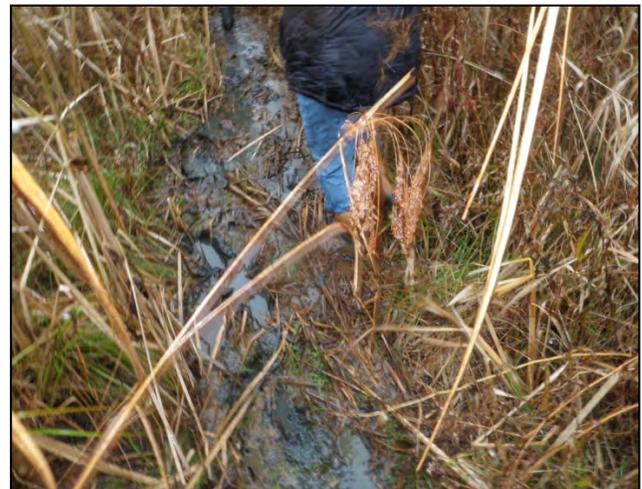
## Monastery Run Improvement Project Photos

At the Monastery Run Improvement Project (Top), the Wetland #1 system (Middle Left) had maintenance conducted around 2012, including removing iron solids. Because there was not a market for the material, the iron oxide has been stockpiled (Middle Right) for future use. Recently acquired funds will be utilized to conduct additional maintenance, including removing accumulated iron solids (Bottom Left), replacing valves as needed, and raising berms to prevent overflowing and short-circuiting (Bottom Right).
