# Kiski-Conemaugh Basin Treatment System O&M Assessment Report

December 2017

Prepared by  
Stream Restoration Incorporated and BioMost, Inc.

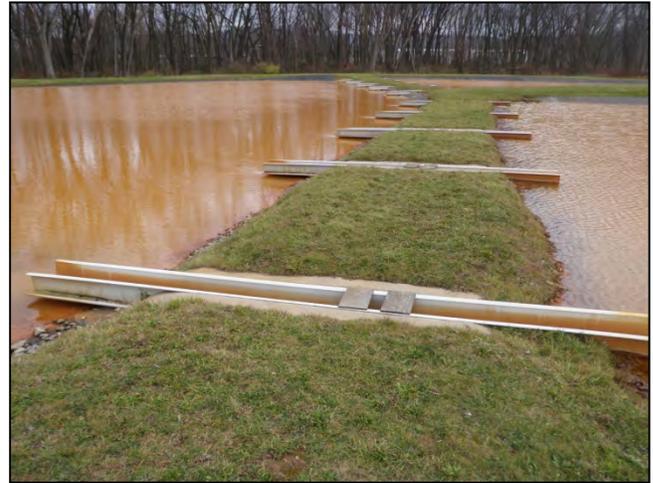
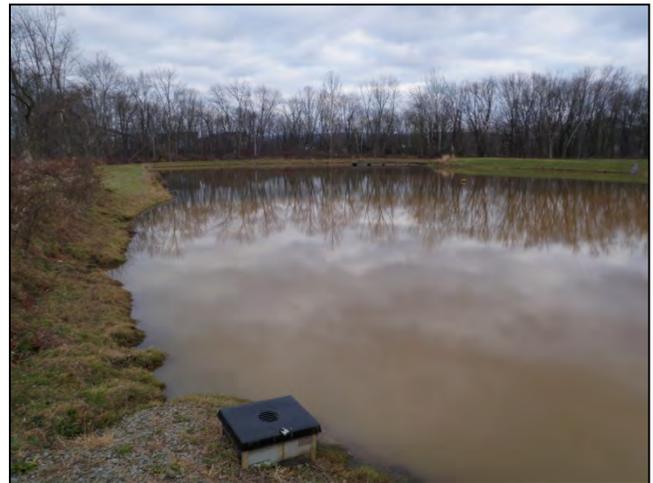
### Upper Latrobe System Photos

At the Upper Latrobe passive treatment system, the discharge is split between two settling ponds. A perforated influent pipe stretches across the width of each pond (Top Left) to distribute and aerate the flow. Metal troughs (Top Right) spaced within the berms are intended to convey water evenly from one pond to the next. Haybales (Bottom Left) were strategically placed within the wetland to help address short-circuiting that was occurring, but they need to be periodically replaced. Installing baffle curtains, plastic z-piling, compost filter sock or utilizing persistent vegetation in the wetland (Bottom Right) would likely improve treatment performance.

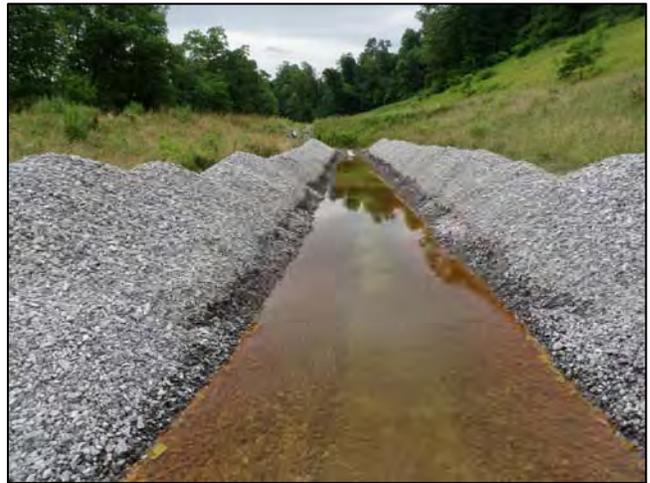
### Big Run #8 Photos

A large collection pipe and valve (Top Left) was needed to capture the AMD for the Big Run #8 system. The valve is leaking and should be repaired. The AMD enters a limestone bed with no underdrain and plugs quickly due to low pH iron and aluminum requiring frequent cleaning (Top Right and Center Left). The water then flows into a settling pond/wetland (aka Pond 2) (Bottom Left) and then into another limestone bed (Center Right) which also frequently plugs. Plugging became such a problem that a trench was cut through the treatment media. Converting the first bed to an OPC and the second bed to a flushable limestone bed may help to improve treatment and reduce maintenance.

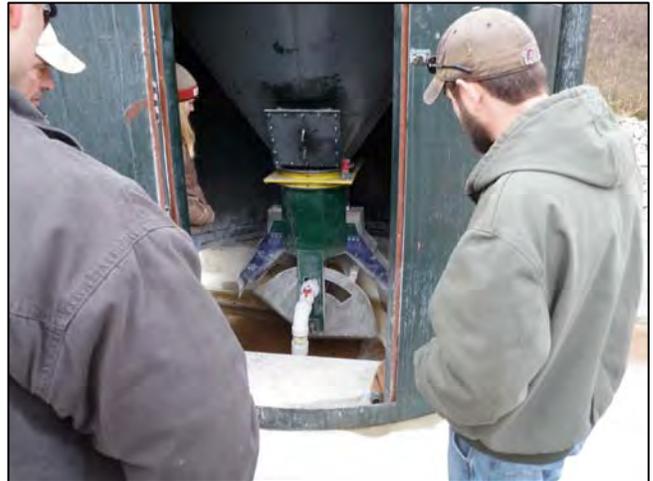
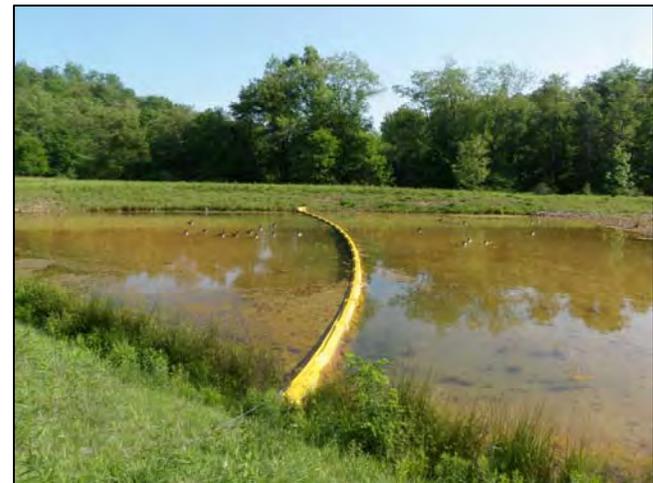
### Big Run #3 Photos

The Big Run #3 system (Top Left) receives partially treated mine water from the #7 and #8 passive systems and untreated discharge #7A. The chemical based system consists of a lime silo (Top Left) containing a “Sweedish” tipping bucket lime doser (Top Right), a mixing channel (Center Left), a settling pond with baffle curtain (Center Right) and a constructed wetland (Bottom Left). The #3 system faces a variety of O&M challenges, some of which may be addressed by improving the #7 and #8 systems as well as adding additional passive components.

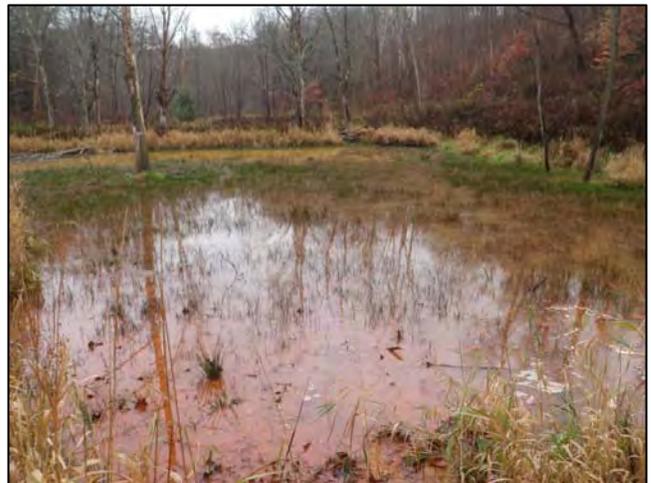
### Booker Photos

Volunteer John Linkes regularly inspects and samples the Booker Discharge (Top Left) passive treatment system. The only maintenance needed since construction was cleaning out the limestone channel (Top Right) that conveys the discharge to treatment system. Overall the system is working well. Due to the shape of the ponds and the location of inlet and outlets, Pond 1 (Center Left) and Pond 3 (Bottom Left) may be short-circuiting. Installing directional baffle curtains to disrupt short-circuiting and windowed baffle curtains to assist with settling solids could help improve treatment. Pond 2 (Center Right) is shallow enough that wetland plants could be planted if desired, which could help with removal of iron solids.

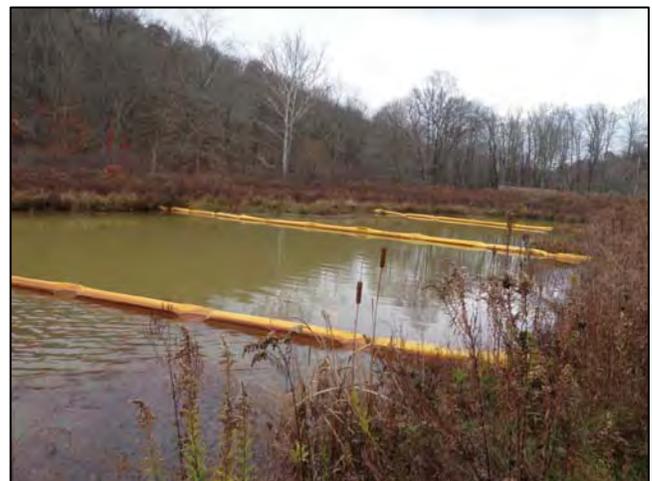
**Kolb Photos**

At the Kolb passive system, a large underground mine discharge has been collected and conveyed by pipe to two aerobic settling ponds in series. A large fountain (Left) was installed to provide aeration and degassing of CO<sub>2</sub> to promote oxidation of dissolved iron, while baffle curtains (Right) were installed to help settle solids. The treatment system would benefit from being expanded to include a constructed wetland and using persistent vegetation.
