Camp Lutherlyn Passive Treatment System
SRI O&M TAG Project #1 Request #3
OSM PTS ID: PA-100

Dates of work performed: 8/17/2023-8/23/2023

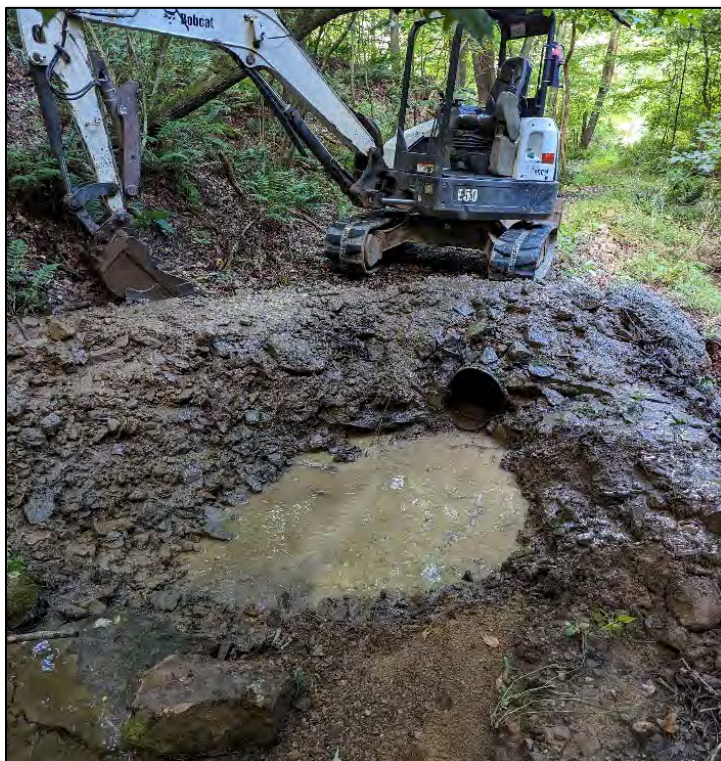
Top Left: Excavated upper stream diversion inlet (8/17/23).

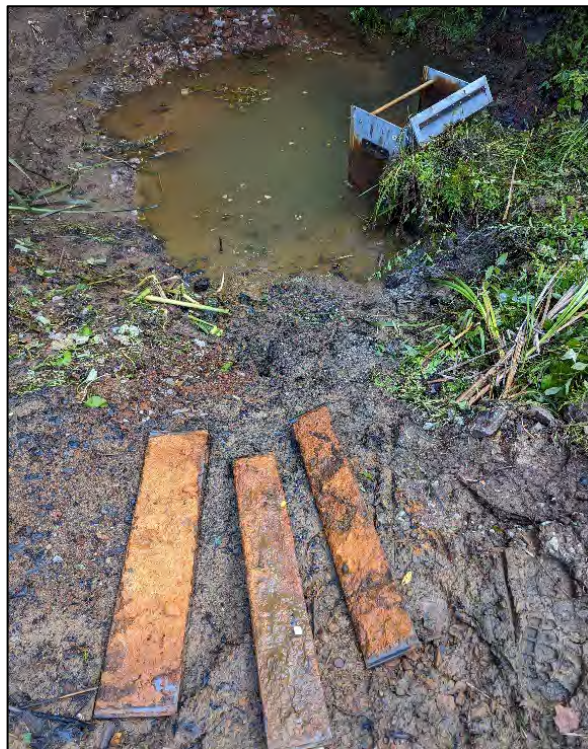
Top Right: Excavated raw water inlet pool for Agri-drain structure, cleaned stop logs (8/18/23).

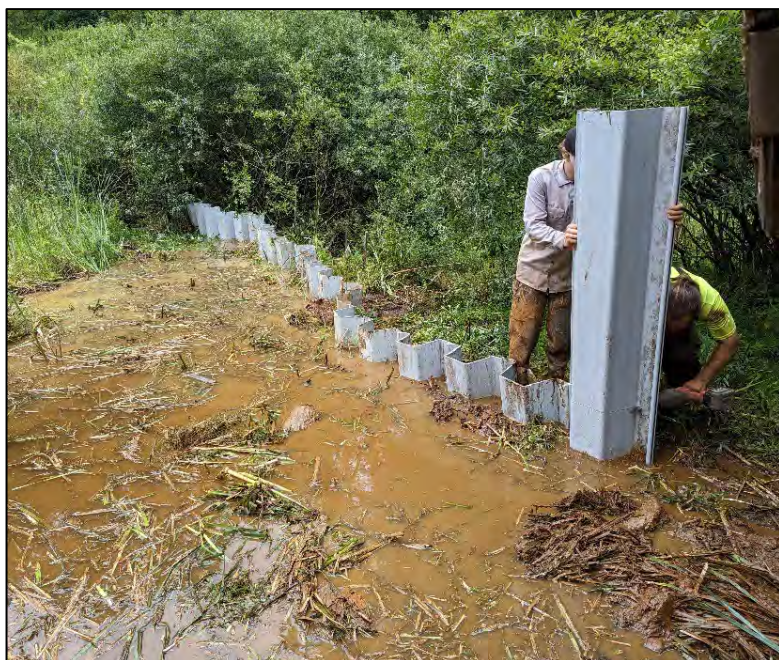
Bottom Left: Used z-piling and filter sock to de-channelize wetland (8/17/23).

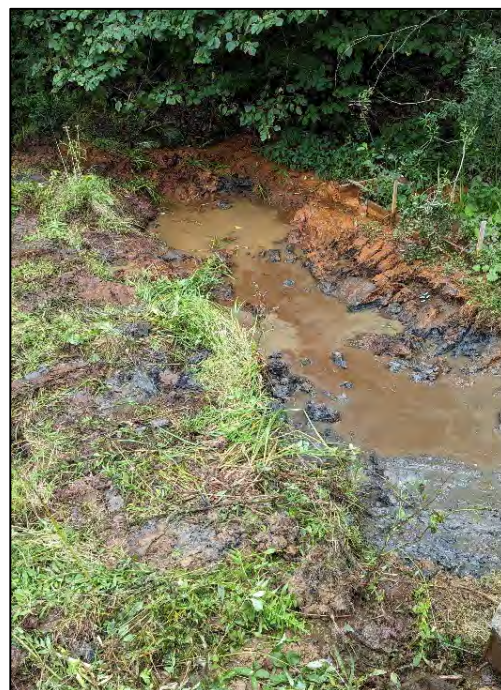
Bottom Right: System outlet pool and additional wetland bench constructed (8/17/23).
