# Maiden Passive System Rehabilitation

Dunkard Township, Greene County, PA  
39°44'55.6"N 79°57'50.6"W

## Final Report

**PA DEP Growing Greener Grant**  
(Grant Contract Number: C990002578)

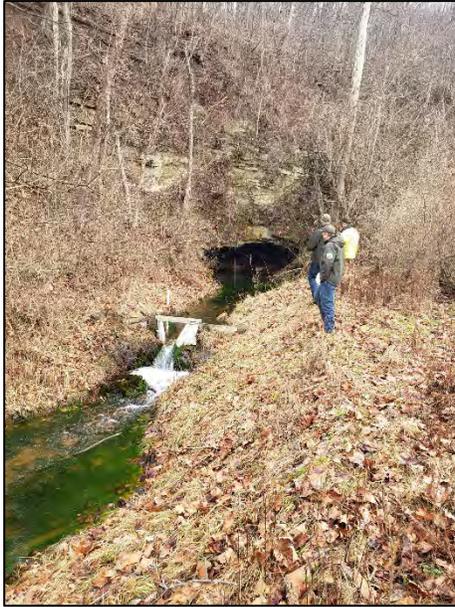
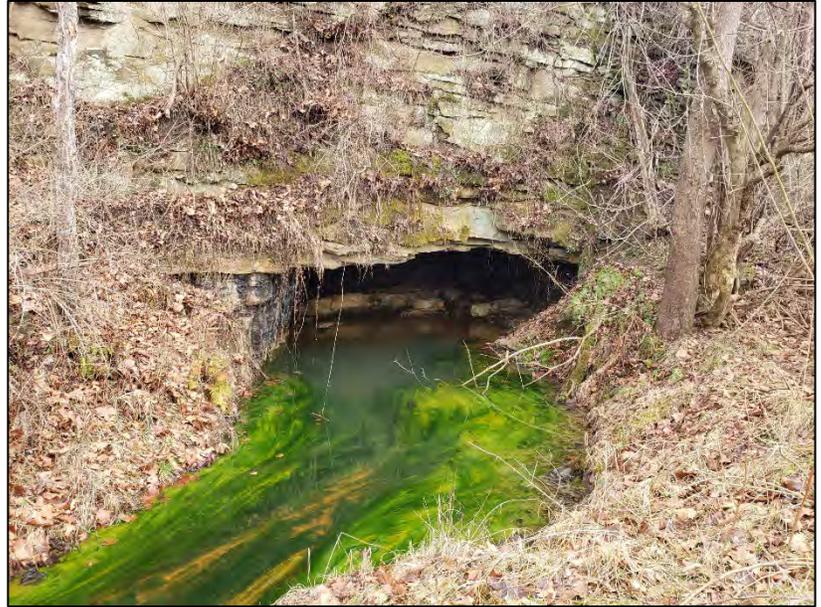
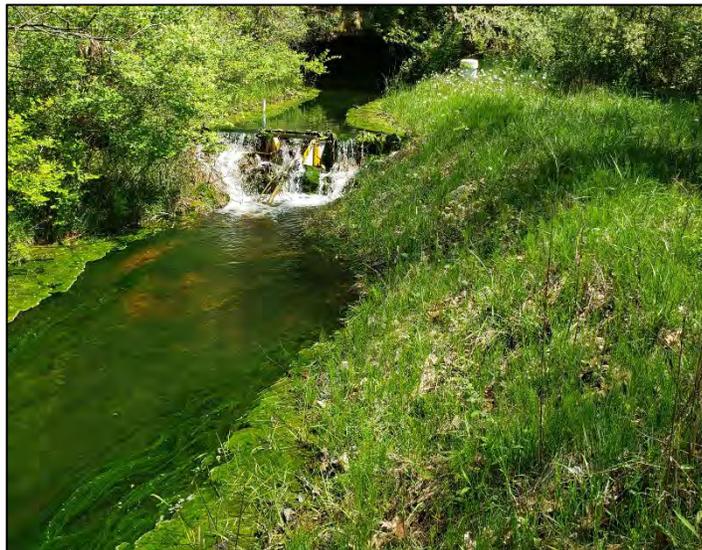
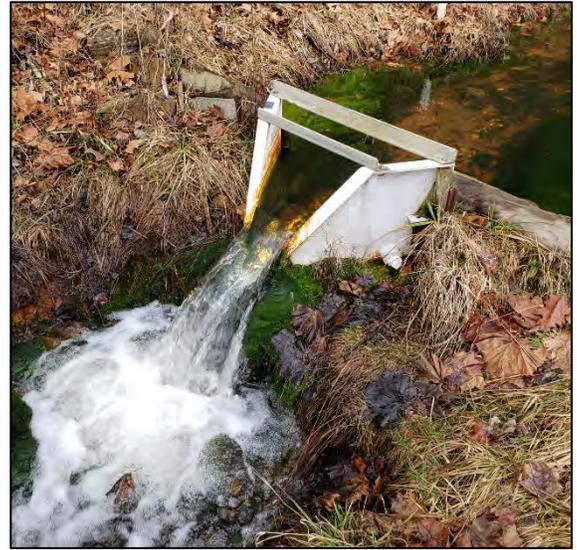
**All Above:** Main raw discharge (117-1) flowing out of the abandoned Maiden #1 Mine.

**Top Left:** Raw, severely degraded discharge (117-1) flowing out of mine and through H-Flume.

**Bottom Left:** Discharge 117-1 flowing out of mine and overtopping flume prompting reconfiguration of the flume (taken prior to other photos above). The algae growth intensified during Spring.

**Bottom Right:** Close-up of H-Flume, which was fixed and made functional during the design phase of the project prior to rehabilitation to allow proper flow measurements to document before/after rehabilitation impacts.

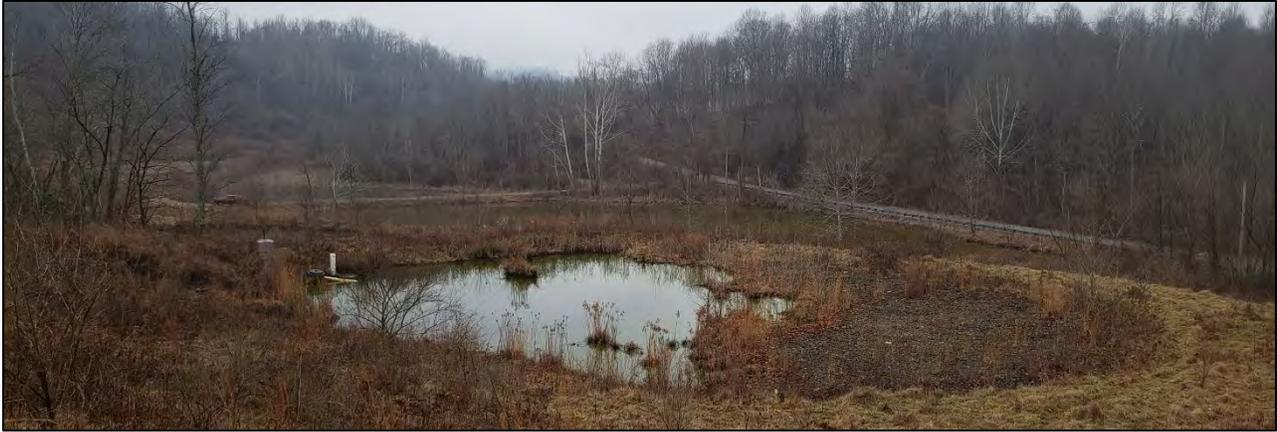
**All Above:** Limestone-only VFP1 photos photographed prior to rehabilitation.

**Top:** Zoomed-out view of VFP1 half-inundated with water and containing algae growth.

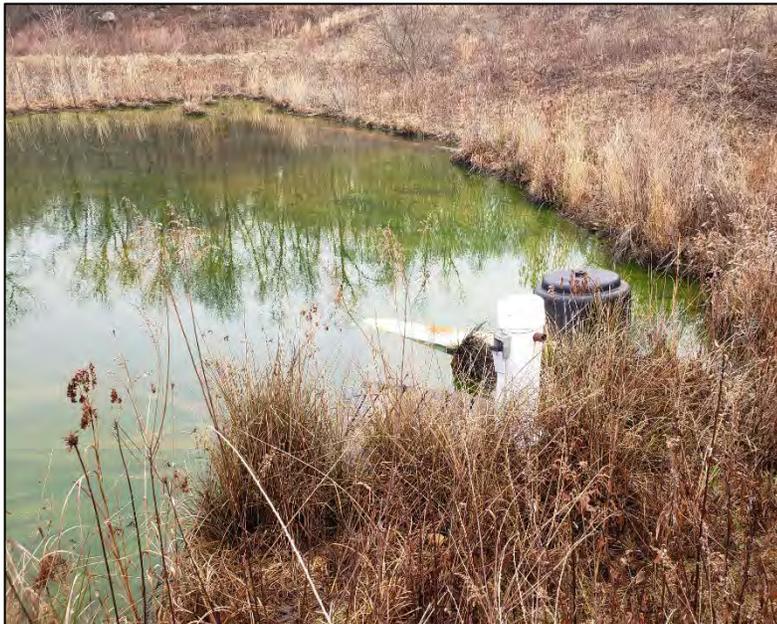
**Bottom Left:** Close-up of what was left of the solar flushing device.

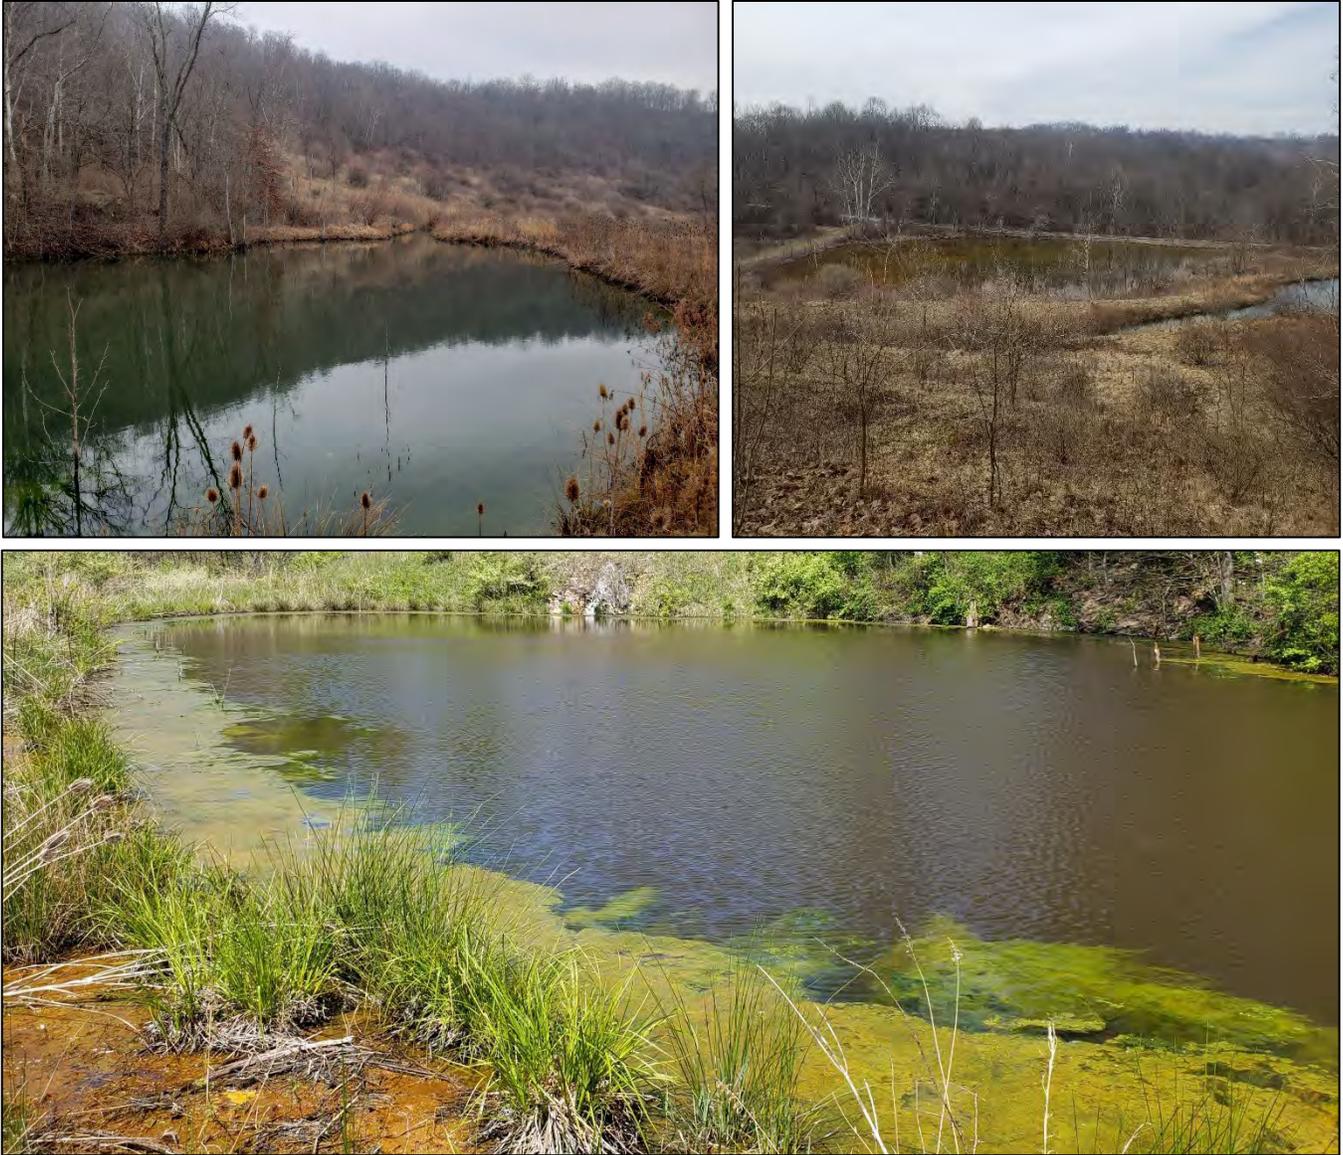
**All Above:** Photos of SP1 prior to rehabilitation. SP1 receives water from discharge 117-1 that has been treated in the first component, the limestone-only VFP1.

**Top Left:** Pre-rehab photo of SP1 from its inlet end. Water discharges through the small channel on the opposite end which formed the OPC.

**Top Right:** Zoomed-out photo taken towards the top of the hill that shows SP1 water flowing into the start of the OPC (on right) with the “natural” degraded wetland in the background.

**Bottom:** SP1 during Spring prior to rehab with algae growth.

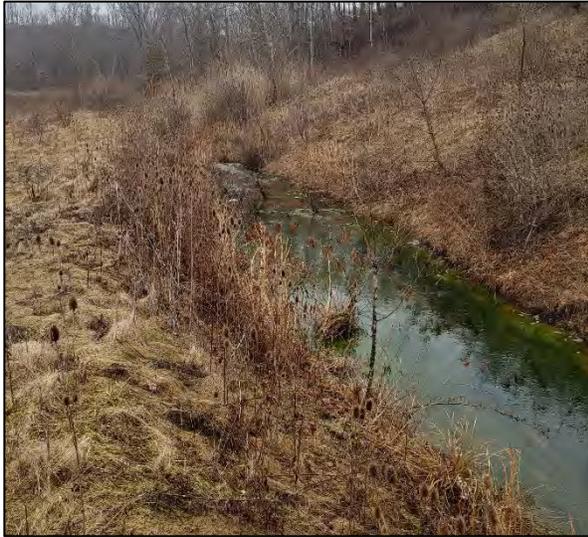
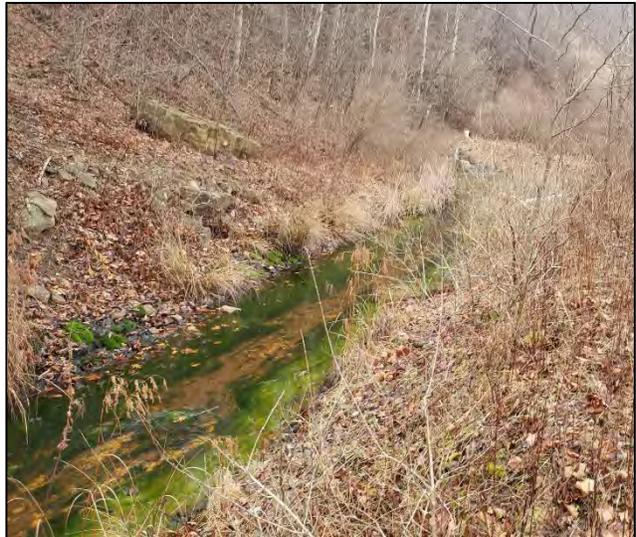
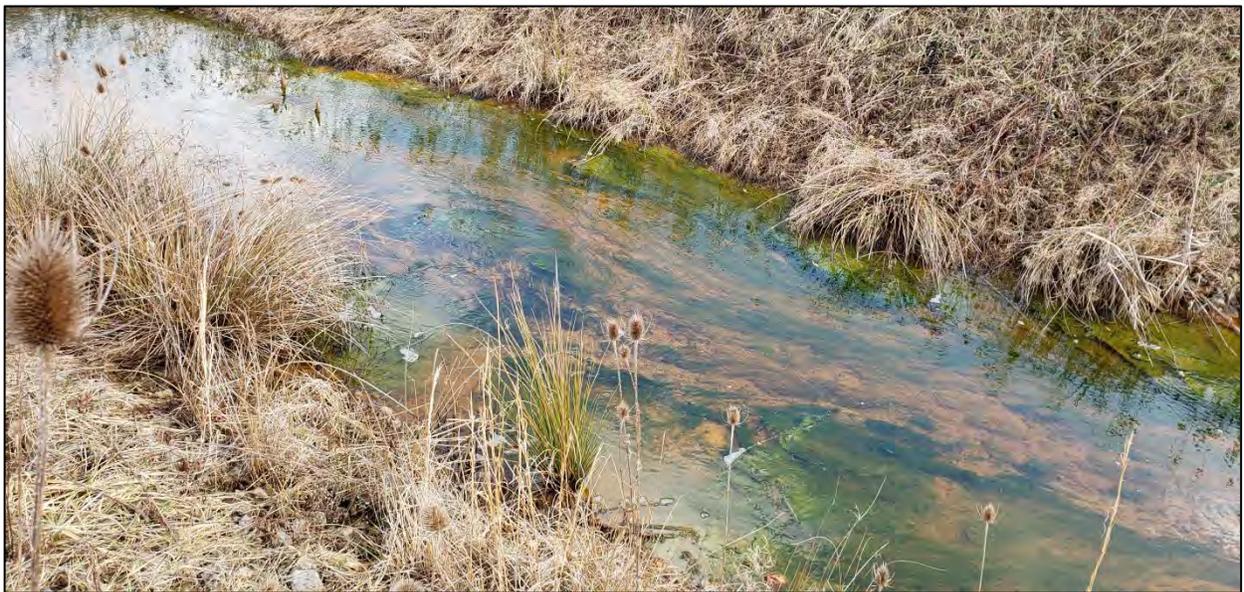
**All Above:** Oxidation-precipitation channel (OPC) at the Maiden Mine PTS prior to rehabilitation, which functioned to convey water from SP1 to VFPs on the other side of the system. The OPC's purpose was also to remove low pH iron, which was documented to not be significant.

**Top Left:** Approximate mid-way of OPC hugging along a steep hillside.

**Top Right:** Tail-end of the OPC before flowing into VFP2B and VFP2A.

**Bottom:** Close-up of algae growth and iron solids in the shallow OPC.

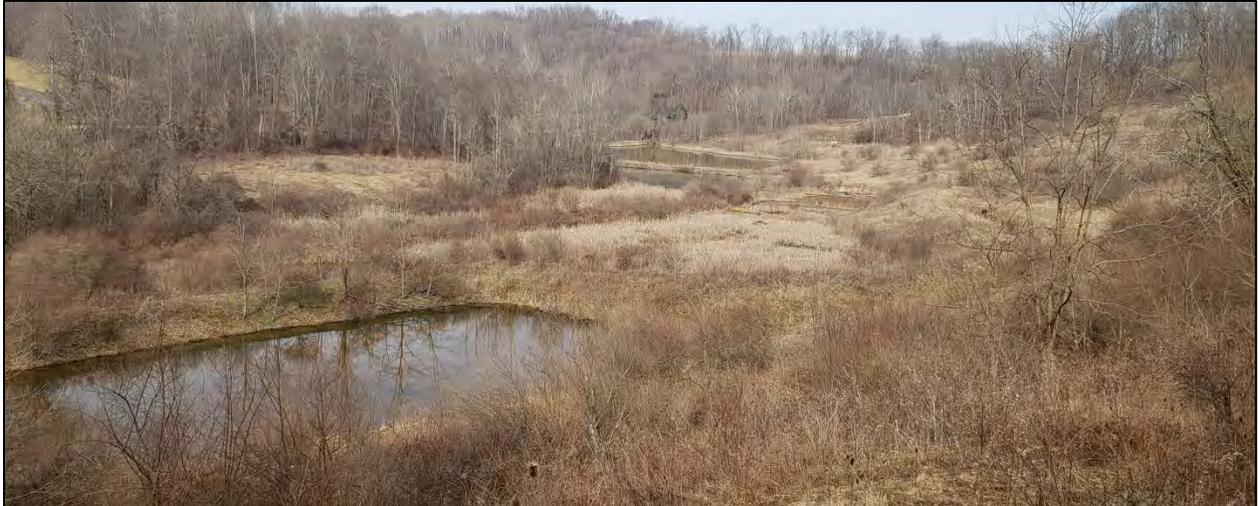
**Top:** Southern-most end of the system prior to rehabilitation showing VFP2A with water cap in the foreground and WL and horizontal flow limestone bed (HFLB) in the background.

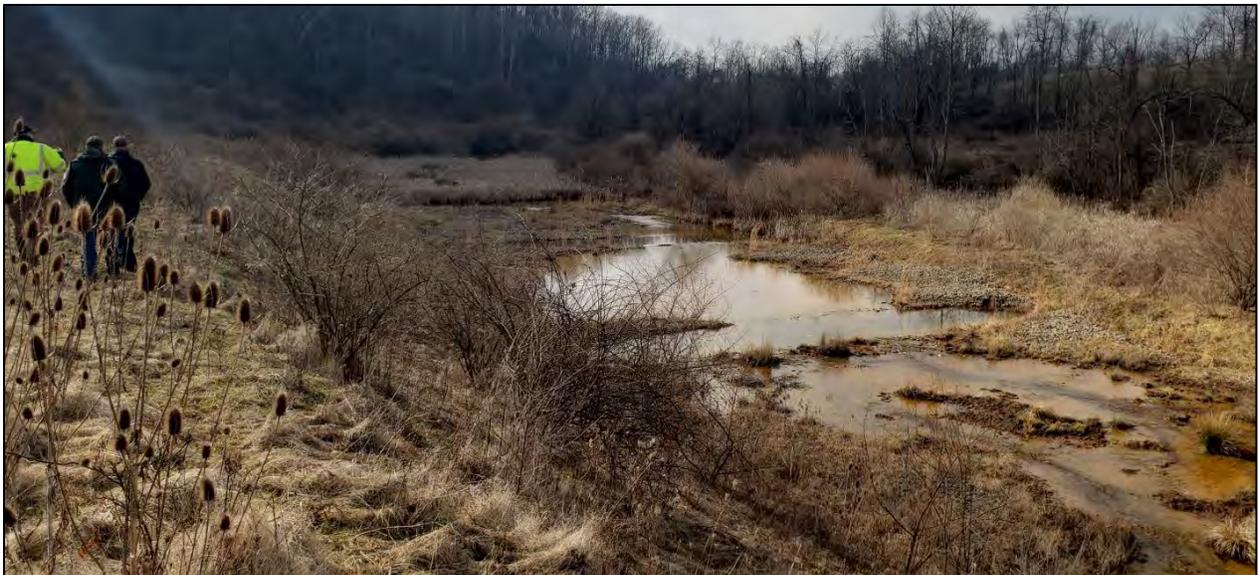
**Bottom:** WL (background) followed by the HFLB (foreground) plugged by metal precipitates prior to rehabilitation.

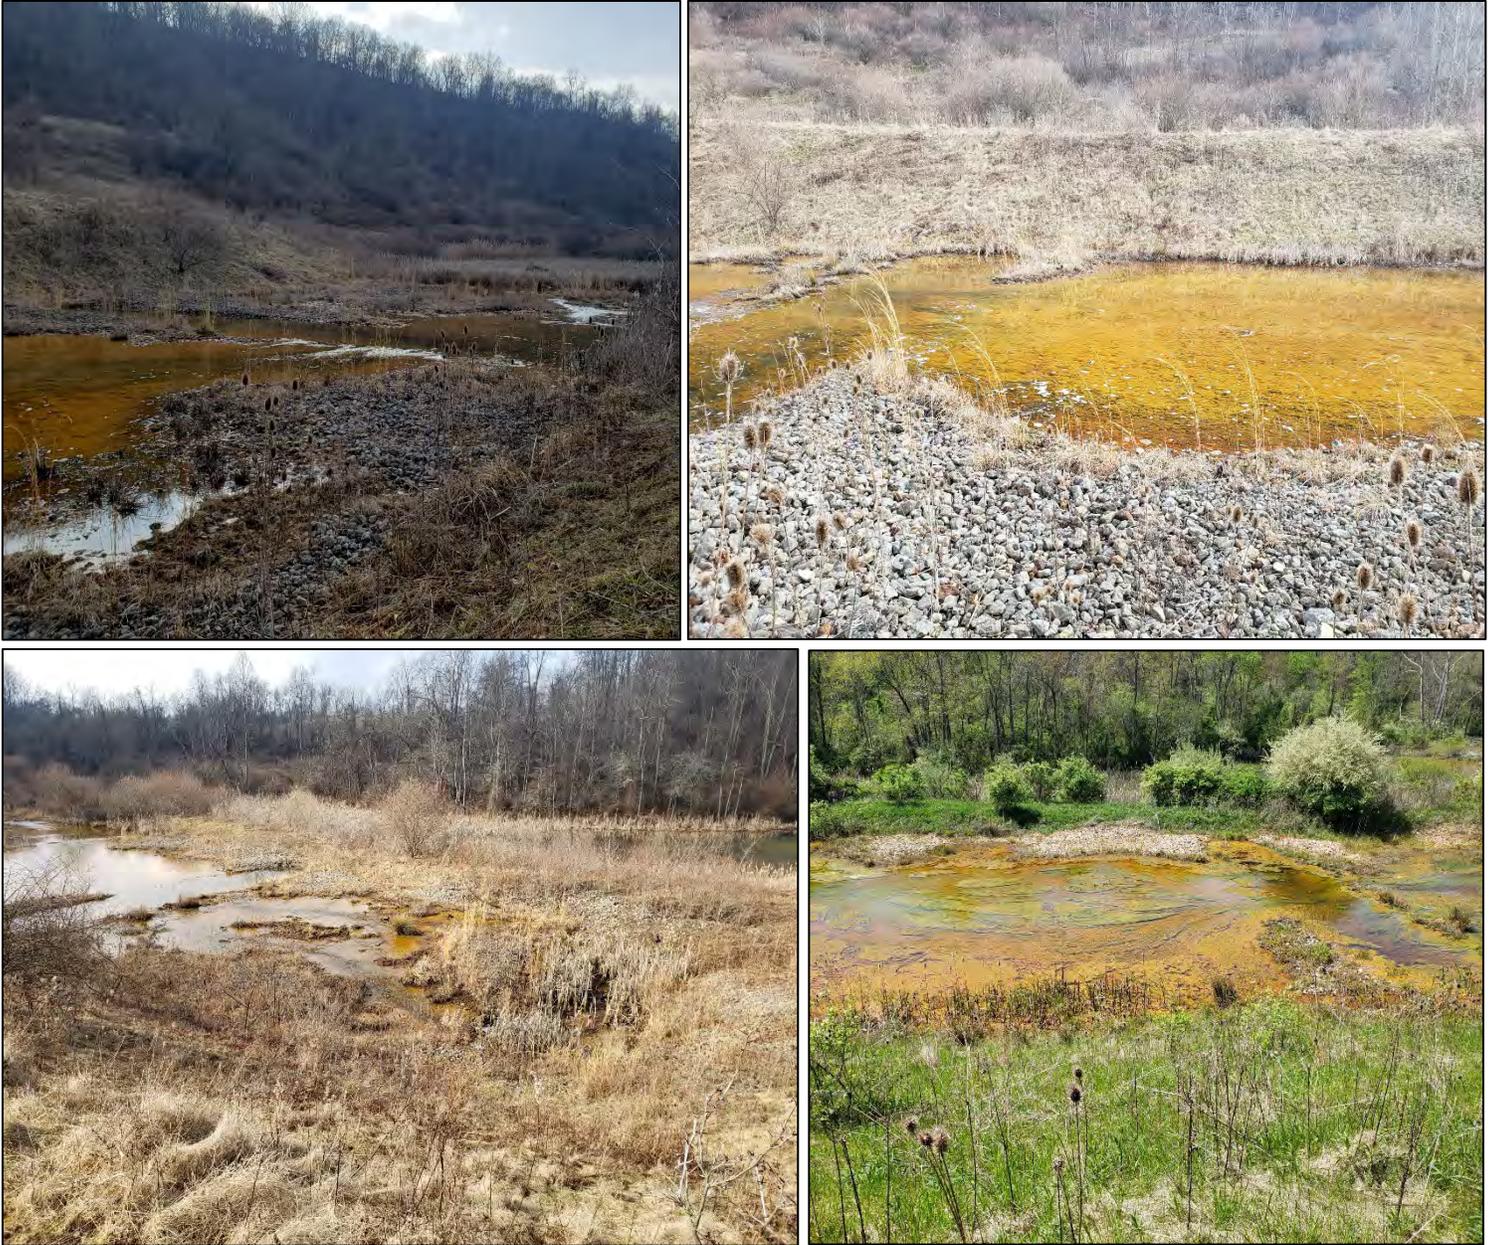
**All Above:** Horizontal flow limestone bed (HFLB) prior to rehabilitation clogged with metal solids. Due to on-going maintenance issues, lack of full treatment, and manganese concentrations being of minor concern, a decision was made to replace the HFLB with a second Jennings-style vertical flow pond to focus on acidity neutralization, alkalinity generation and Fe/Al removal.

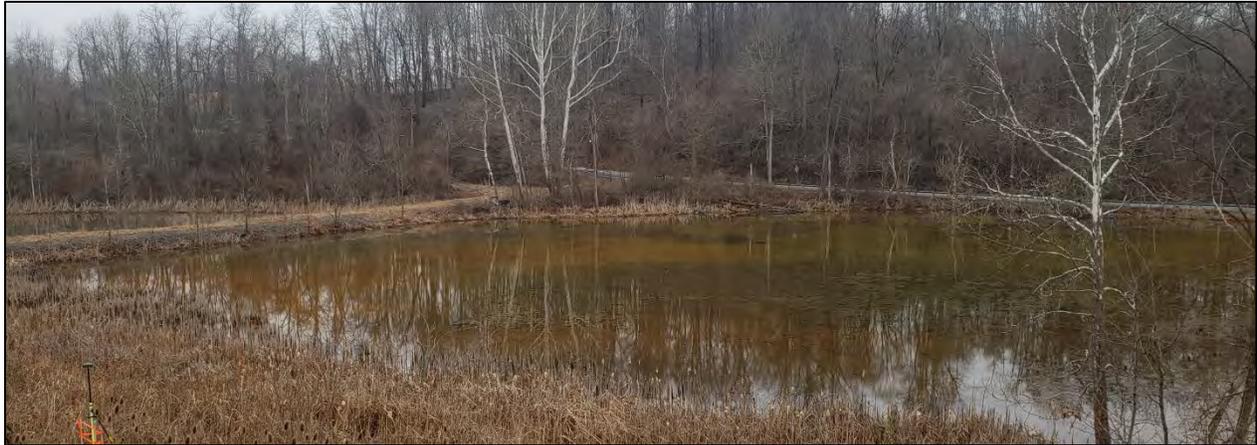
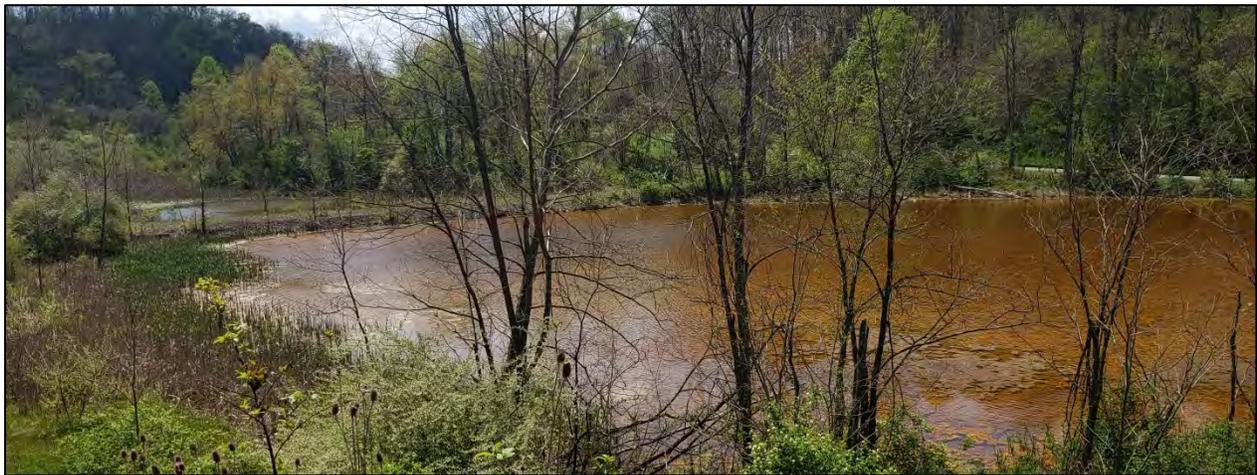
**All Above:** Degraded pre-existing “natural” wetland which receives flow from Maiden passive system components before emptying to the unnamed tributary of Dunkard Creek. Iron precipitates were visible and no vegetation was present in the wetlands

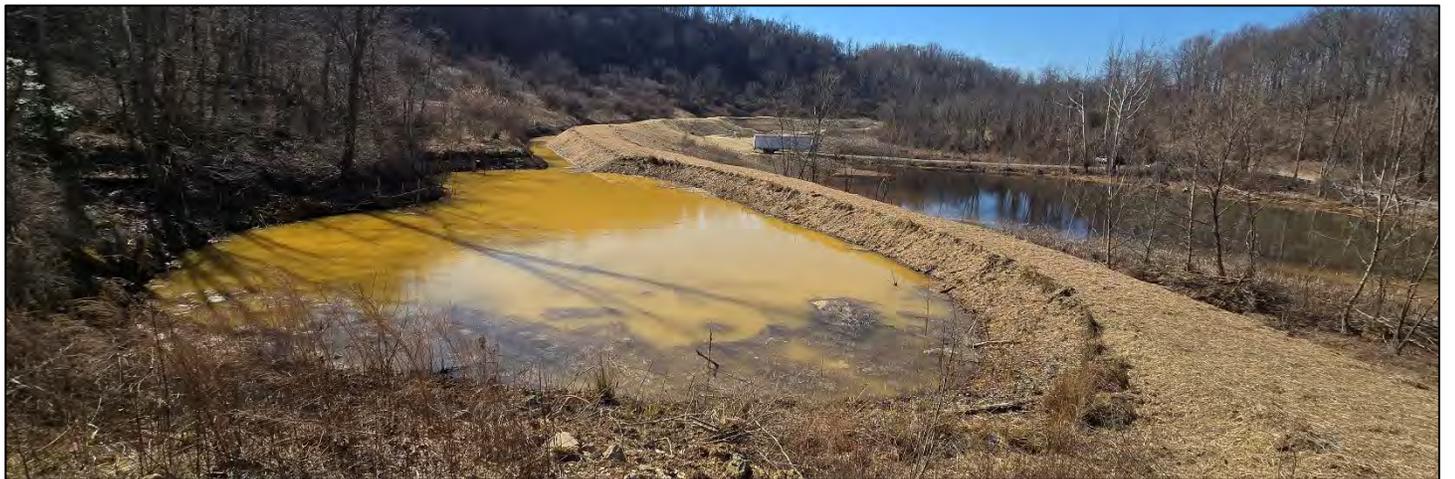
**Bottom:** SP1 following rehab with high suspended iron solids following a flush.

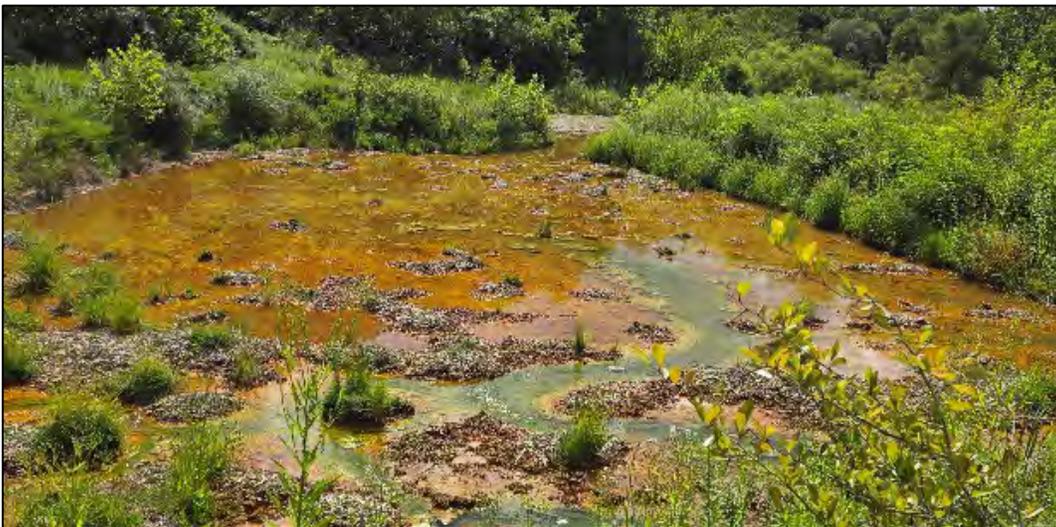
**Bottom:** VFP2A after being placed online for several months taken in August 2025.

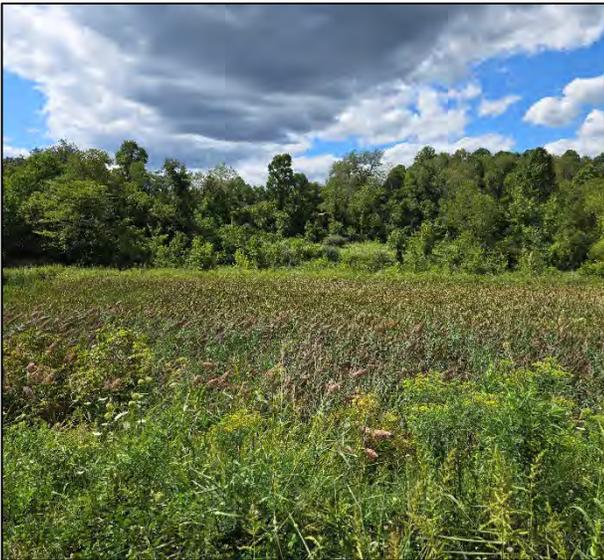
**Bottom Left:** Existing degraded wetland south of the access road taken later in August 2025, with wetland vegetation growth improving filtration without channelized flow paths.
