JB2 Passive Treatment System
SRI O&M TAG Project #28 Request #2
OSM PTS ID: PA-8

Requesting Organization: Independence Conservancy, Washington County Conservation District, Washington County Watershed Alliance

Municipality/County: Smith Township, Washington County

Dates of O&M work performed: 12/1/2021-12-22-2021

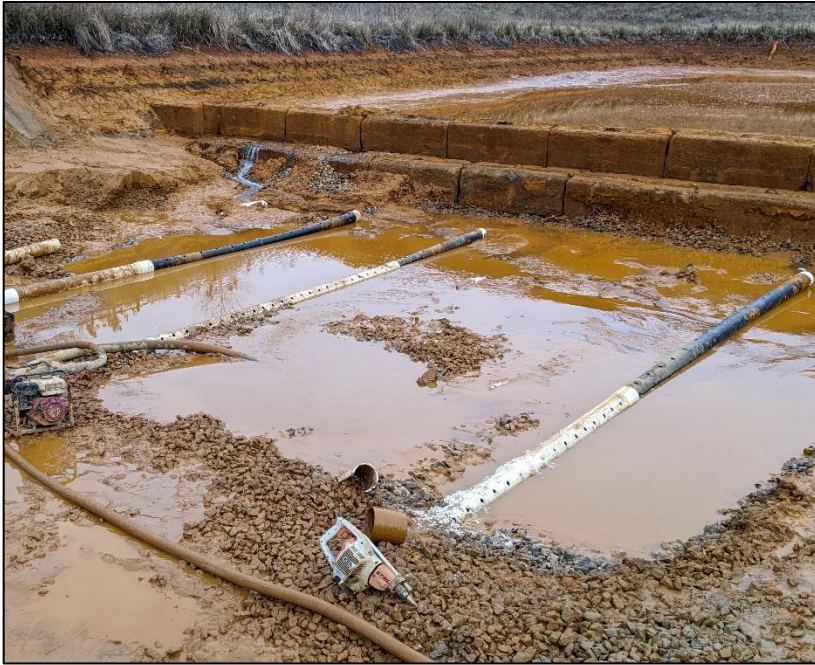
Top Left: VFW pipe reconnected and repaired after washing, new perforated HDPE shown (12/17/21).

The limestone within the FeAlMn bed was washed to re-establish media permeability and the iron sludge was pumped to the settling pond for storage. A portion of the piping was abandoned and the remaining section was reconfigured as a down-flow vertical flow pond. This was done as a stop-gap measure to provide treatment until further funding can be obtained. The settling pond outlet also had various obstructions which were removed to allow flow to exit the system as designed.

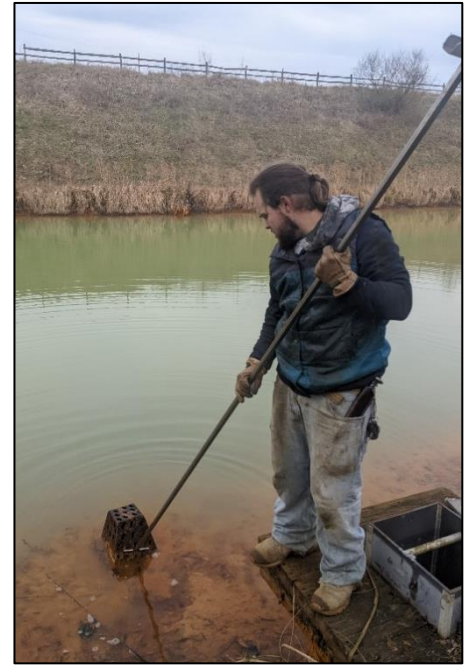
Top Right: Clearing the VFW outlet muskrat cage (12/9/21).

Work Completed: The muskrat cage was unclogged at the outlet pipe. The raw water Forebay collection system outlet pipe was replaced with a Terraced Iron Formation (TIF) channel to promote the precipitation of iron and reduce existing pipe clogging and bypass issues related to the SLB. This work included seeding and mulching the affected area as appropriate. Vegetation was removed from embankments as feasible to establish access for maintenance and maintain long-term slope stability of embankments around the system.

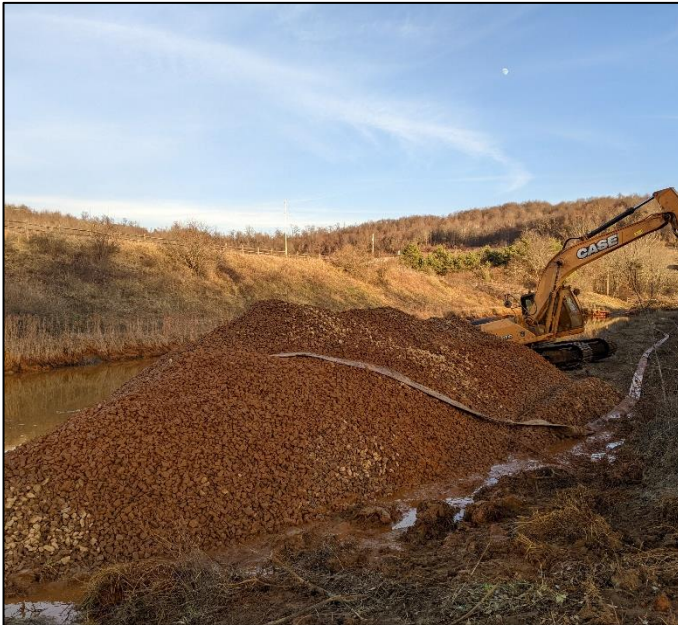
Bottom Left: Limestone was washed, and sediment pumped to the settling basin (12/14/21).

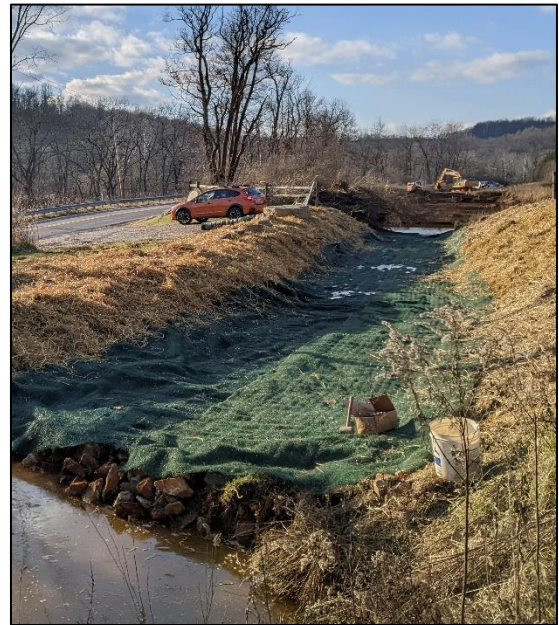
Initial Site Visit, Observations, and Identified Needs: A site meeting and investigation was conducted on 12/1/21 to review site conditions and develop a plan. The forebay (aka collection pond) outlet pipe which conveys the AMD to the FeAlMn style bed was partially clogged, causing the AMD to periodically bypass the system and has been an ongoing concern. Significant amounts of low pH iron sludge could be observed on top of and within the limestone in the FeAlMn Bed (a/k/a Sloped Limestone Bed or SLB) which appeared to prevent flow to the component underdrain. Low pH iron precipitates and vegetation were clogging the FeAlMn outlet pipe (muskrat cage), raising the water level within that component.

Bottom Right: A channel (TIF) replaced the culvert pipe from the forebay to avoid water plugging the pipe and bypassing the system (short circuiting and encourage iron oxidation at low pH (12/21/21).
