Puritan Passive Treatment System
SRI O&M TAG Project #31 Request #2 & #3
OSM PTS ID: PA-245

Requesting Organization: Saint Francis University

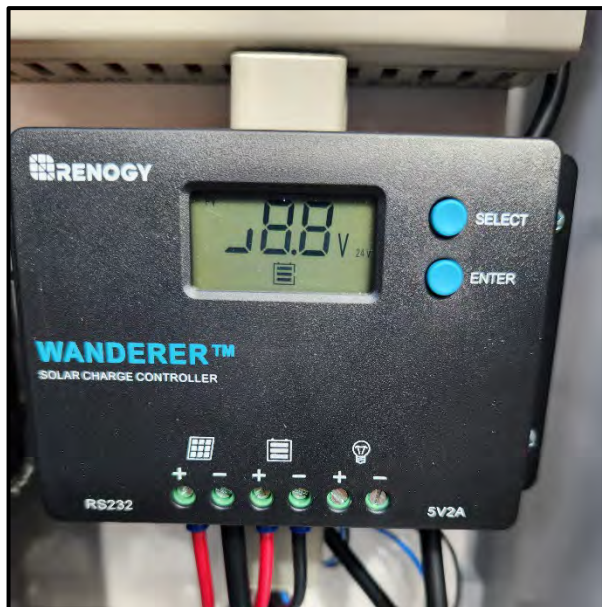
Top Left: Malfunctioning solar controller displaying erroneous data (2/15/23).

Work Completed: Initially, on 2/15/2023, BMI mobilized to the site to replace the battery and solar controller in the Agri Drain control box. The battery was determined to be in good working order; the solar controller was giving erroneous information and was replaced with a new identical component. The new controller functioned properly and began charging the battery as designed. No other issues were noted. The box was tested and appeared to function as designed. During the site visit the skimmer was inspected and an attempt was made to restore function, it was ultimately decided to remove the skimmer inlet assembly and fabricate a new inlet with a revised design. On 3/28/2023 BMI returned to site to install a redesigned skimmer. All components of the old skimmer were disassembled and removed from SP1. The components of the new skimmer were assembled onsite and installed in SP1, consisting of two floats attached with stainless steel hardware to the inlet end of an 8-inch flexible intake suction hose and weights to allow the skimmer inlet to be held about one foot below the water level. The new skimmer was tested by filling SP1 and observing its function, simultaneously the Agri Drain control box was tested when configuring the control box to flush water from AFVFP1 into SP1. The control box and skimmer both appeared to work as designed. On 5/30/24 a site inspection was performed by BioMost personnel to check the function of the Master control box. The box was uninstalled and taken back to BioMost office to troubleshoot the software and reprogram as necessary. On 7/17/24 the Master box was reinstalled and tested to verify function, the box performed as designed. On 6/13/24 BioMost personnel were onsite to address mine water overflowing the area of the mine wet seal and bypassing the system inlet. The pipeline from the mine seal to the system inlet flume was jettered to remove iron oxide buildup and other sediments from the pipeline. Flow was restored after this cleaning and water was no longer observed overtopping the wet seal area or bypassing the system. On 7/31/24 BioMost personnel were onsite to repair the drive pin in the AFVFP1 drain valve. All stop logs were removed and the valve was pulled to the top of the box to gain access to the drive pin. Once repaired, the valve and stoplogs were replaced and set at an elevation just below the emergency spillway.

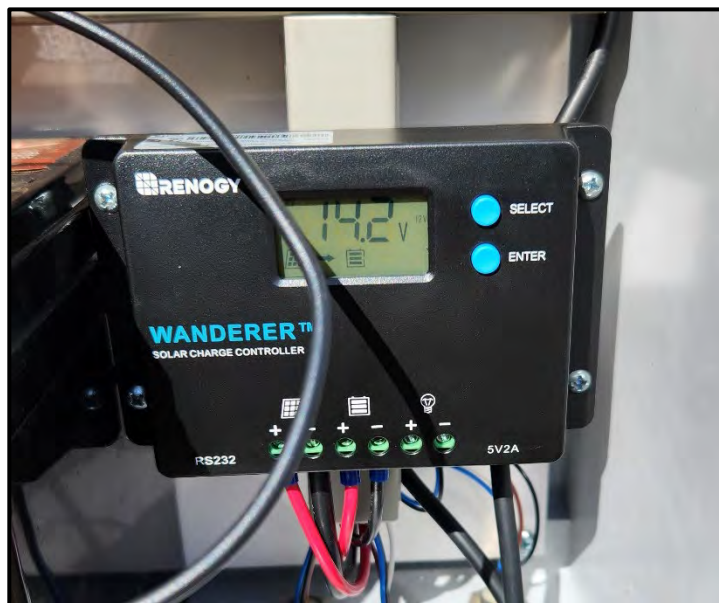
Top Right: Newly installed solar controller displaying appropriate data and functioning as designed (2/15/23).

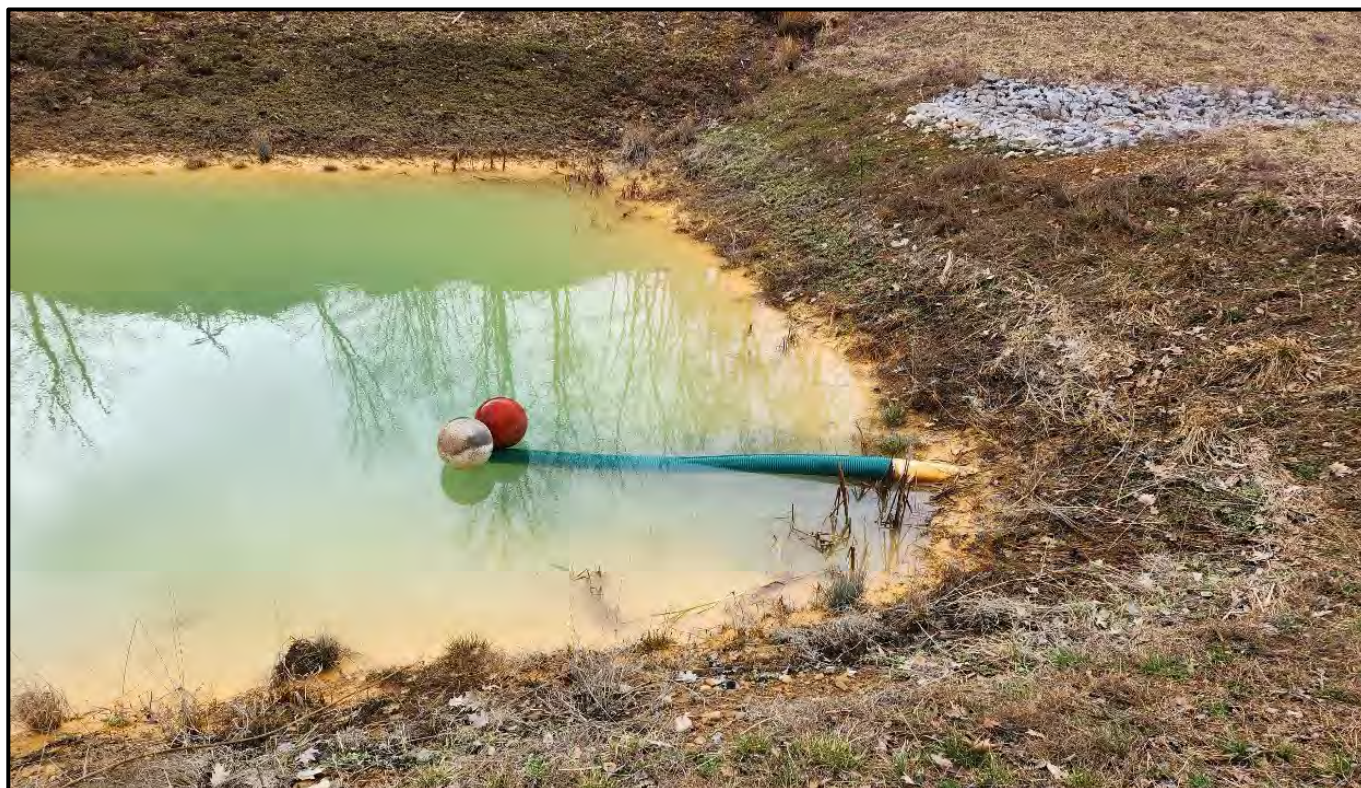
Bottom: Newly installed floating skimmer (3/28/23).

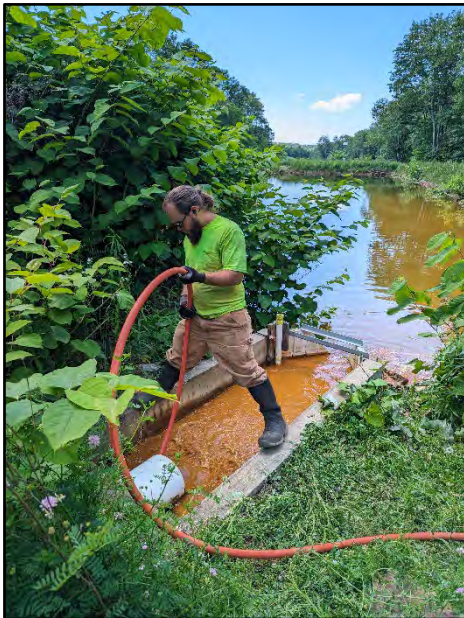
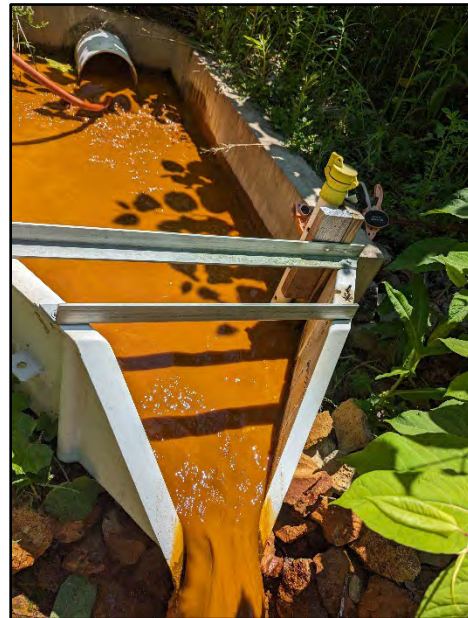
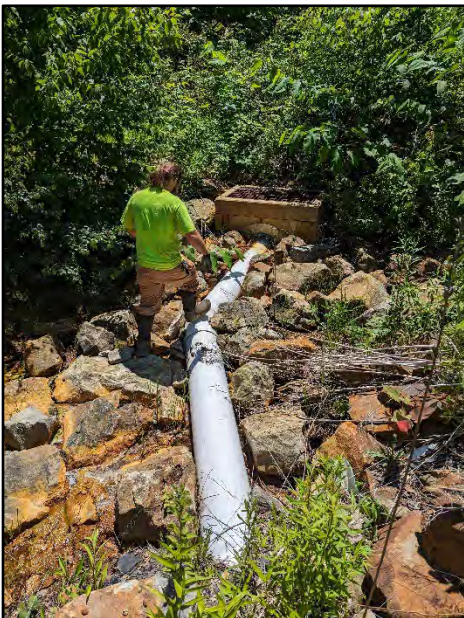
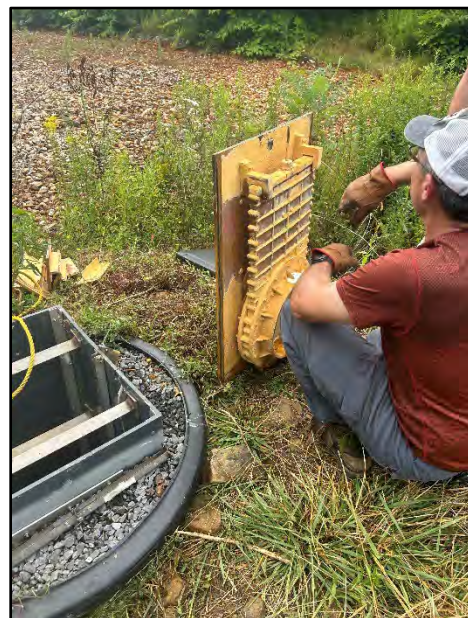
- Top Left:** Using Jetter to remove iron oxide and other sediments from pipeline to mine seal (6/13/24).
Top Right: View of iron sludge actively being removed from pipeline from mine seal (6/13/24).
Bottom Left: BioMost personnel verifying water is no longer overtopping the mine seal (6/13/24).
Bottom Right: BioMost personnel repairing a sheared drive pin on the removed Agri Drain gate valve (7/31/24)
