Dents Run 3895 Passive Treatment System
SRI O&M TAG Project #32 Request #2
OSM PTS ID: PA-278

Requesting Organization: Elk County Conservation District

Dates of work performed: 5/24/2023-6/27/2023

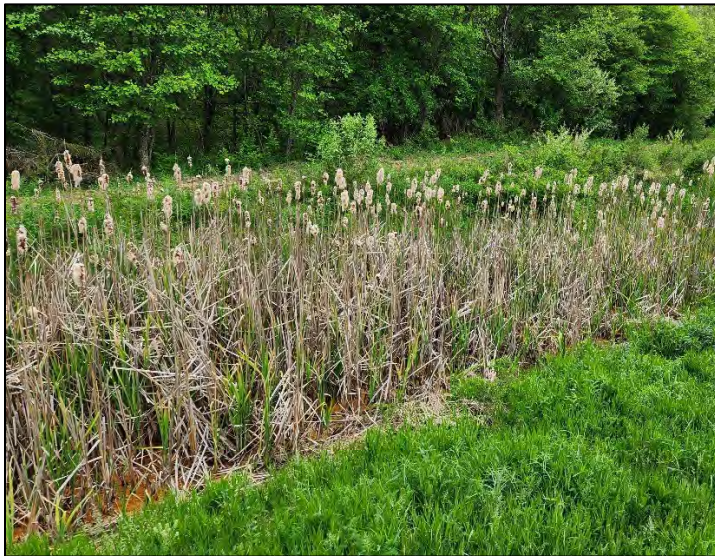
Initial Site Visit, Observations, and Identified Needs: Vegetation and sediment build up within the Oxidation and Precipitation Channel 3 (OPC3), combined with a lower section of the channel embankment created a condition where water was close to overtopping in some areas. The riser extension for the SB1 overflow was dislodged, causing a portion of the system flow to receive only partial treatment and bypass the lower portion of the system.

Top Left : OPC3 full of cattails and sediment prior to removal (5/24/23).

Work Completed: Vegetation and metal precipitates were removed from the OPC3 to ensure water continues to be conveyed within the bounds of the channel. Material was removed from the outlet of the type M inlet box which flows to OPC3 to provide more settling capacity as a “stilling pool” within the system. As the weir from the type M inlet box is typically submerged, it was removed and left on site if installation is desired in the future.

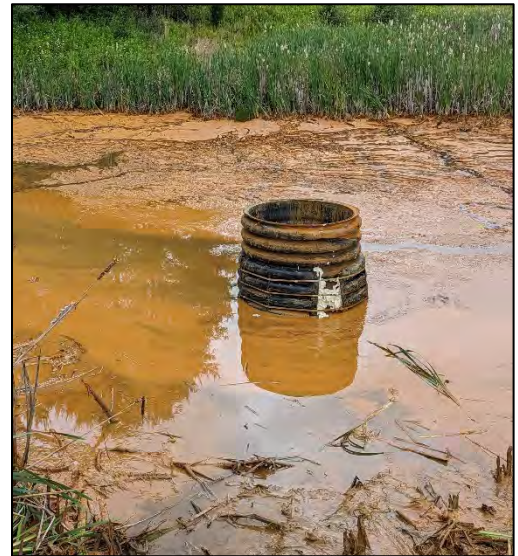
Top Right: Re-attached SB1 overflow extension (6/23/23).

The leaks from the overflow riser within the settling pond has been a challenge since construction of the system. A 42” coupler was obtained and installed with the riser extension using spray foam to attempt to seal any gaps at the union. A minimal amount of water was pumped while performing the repair, but sludge capacity within the pond limited the ability of the pond to drain without a location to pump sludge. Unfortunately, a small amount of water was still leaking into the riser pipe after the repair. An additional effort will be needed to limit overflow and direct all flow into OPC3. Due to SB1 being essentially full sludge removal is needed before a permanent repair to the SB1 outlet riser can be made.

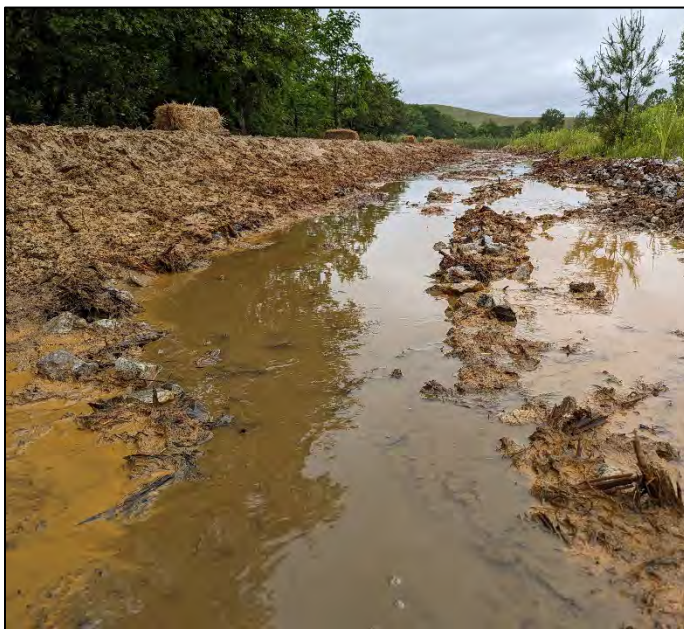
Bottom Left: OPC3 was cleared of material and the embankment height was raised (6/23/23).

To address the low areas of the OPC3 embankment, material was taken from the higher spots and used to increase the berm height of the channel in the lower elevation spots. Combined with clearing material from OPC3, this should provide a long-term solution for sediment retention within OPC3.

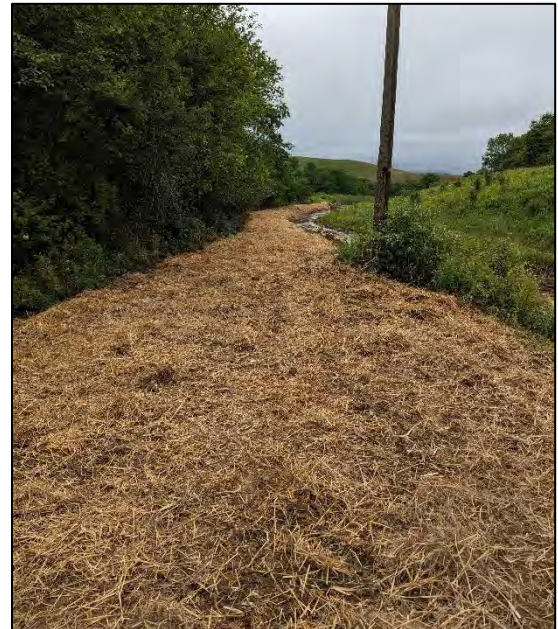
Bottom Right: OPC3 embankment was re-seeded and mulched (6/23/23).

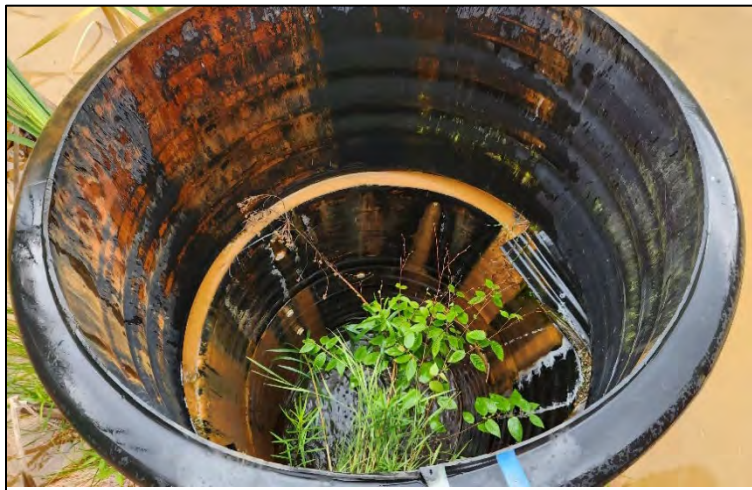
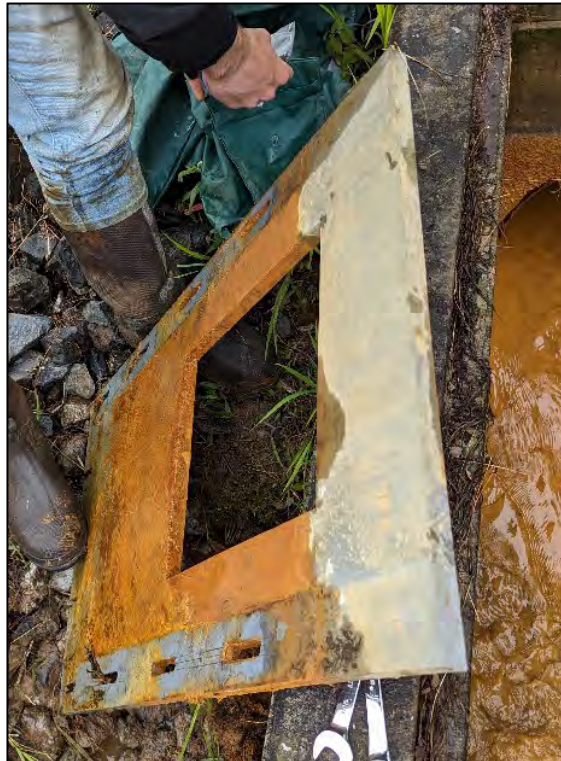
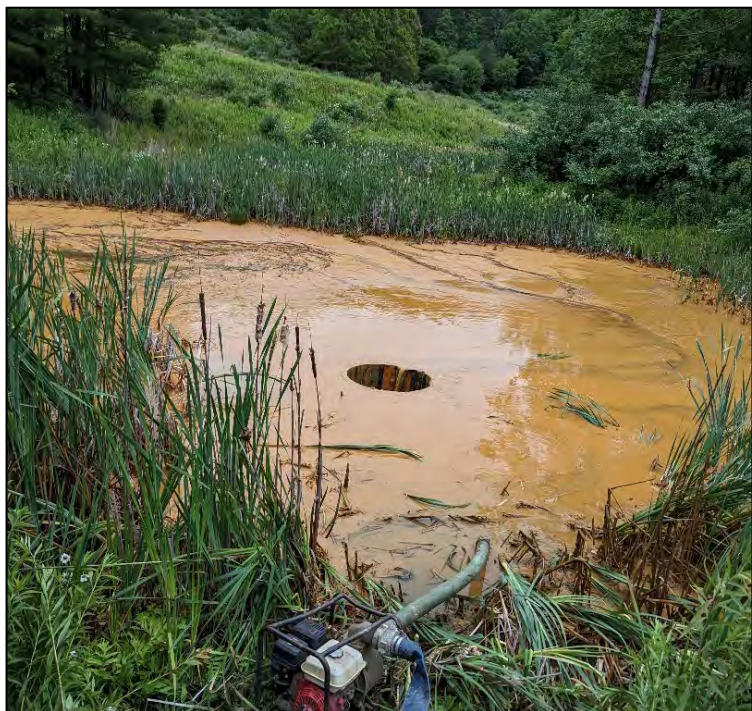
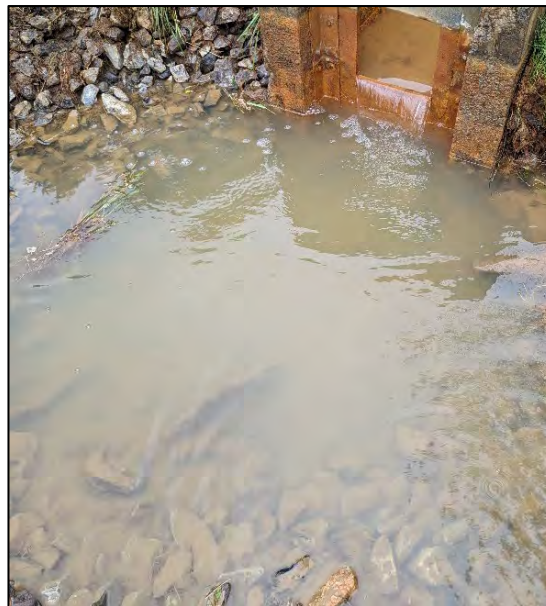
Top Left : Leaking SB1 overflow extension prompted repairs (6/22/23).
Top Right: OPC3 inlet weir was removed due to minimal usability (6/22/23).
Bottom Left: SB1 almost entirely full of sediment and in need of further maintenance (6/22/23).
Bottom Right: OPC3 type M inlet box “stilling pool” was excavated (6/16/23).

Recommendations & Future Considerations: Sediment Basin 1 (SB1) is essentially full and needs to be cleaned in the near future. Geotubes, pumped water filter bags, or sediment pond construction could be considered depending on the site conditions and desires of the landowner and interested parties.
