**Penn Hills #2 Passive Treatment System**  
**SRI O&M TAG Project #35 Request #3**  
**OSM PTS ID: PA-132**

Initial Request: On 3/2/2023, the Blacklick Creek Watershed Association (BCWA) requested a site visit to Penn Hills #2 treatment system to clear a blockage at the mine discharge, Sample Point 436. Additional work was requested in August 2023 that was completed in June 2024.

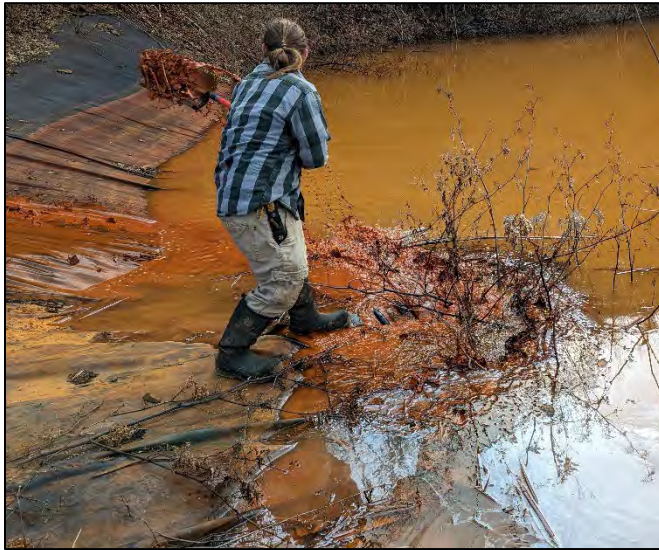
**Top Left:** Mine Discharge Sample Point 436 was occluded with iron precipitates and vegetation (3/2/23).  
**Top Right:** Full flow to Sample Point 439 was restored (3/2/23).  
**Bottom Left:** Flow from the "Unknown Source Discharging to Pond" overflow was allowed to reduce water overtopping the embankment (3/2/23).  
**Bottom Right:** The forebay water level was dropped due to clearing the vegetation blockage (3/2/23).

BioMost, Inc mobilized to the site. Various trees and brush were cleared from the access road in order to assess the mine discharge/treatment system. After inspection of the mine discharge, vegetation and iron solids were cleared by hand using a shovel to restore full flow to the system. The pipe was not completely occluded with material but enough material was present to raise the elevation of the forebay pond approximately one foot. A pipe was removed from the overflow culvert pipe to limit overflow from the “Unknown Source Discharging to Pond” which was overwhelmed by the amount of flow coming from the forebay. Additional trees and debris were cleared from the access road along the access road loop.

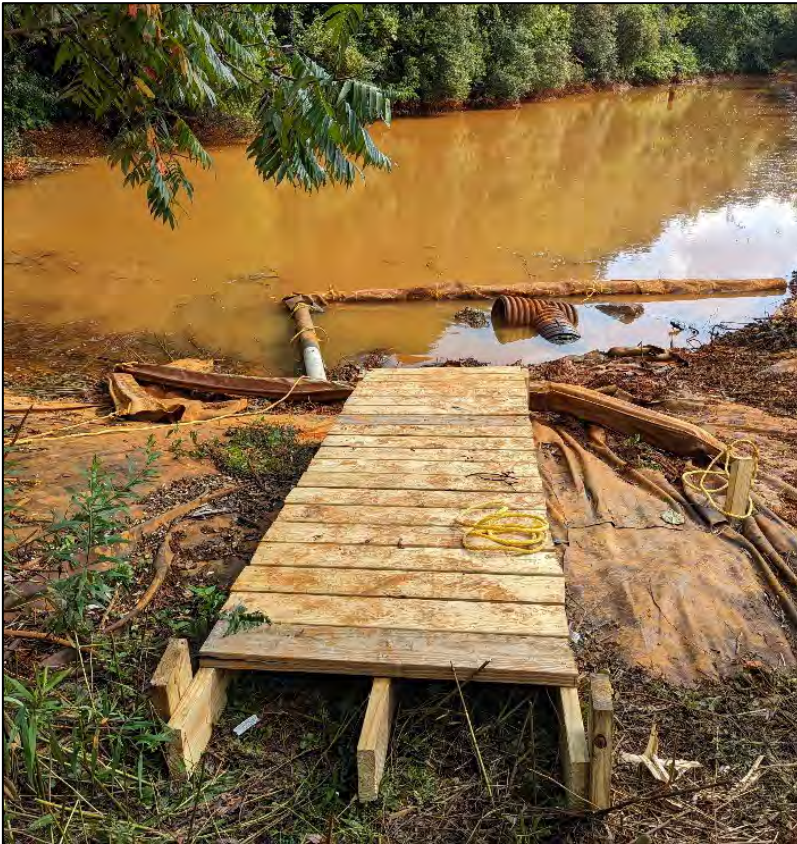
**Top Left:** Mine Discharge Sample Point 436 improved with an access deck and baffles (8/25/23).  
**Top Right:** Pumping water to clear material from forebay outlet pipe (8/25/23).  
**Bottom Left:** Iron occluding splitter box components, noted after flow was restored (8/24/23).  
**Bottom Right:** Various methods were attempted to clear sediment from the system pipes (8/25/23).

- An access ramp was constructed to provide safer access to the overflow pipe.
- Baffles were installed around the overflow pipe to reduce floating debris entering the pipe.

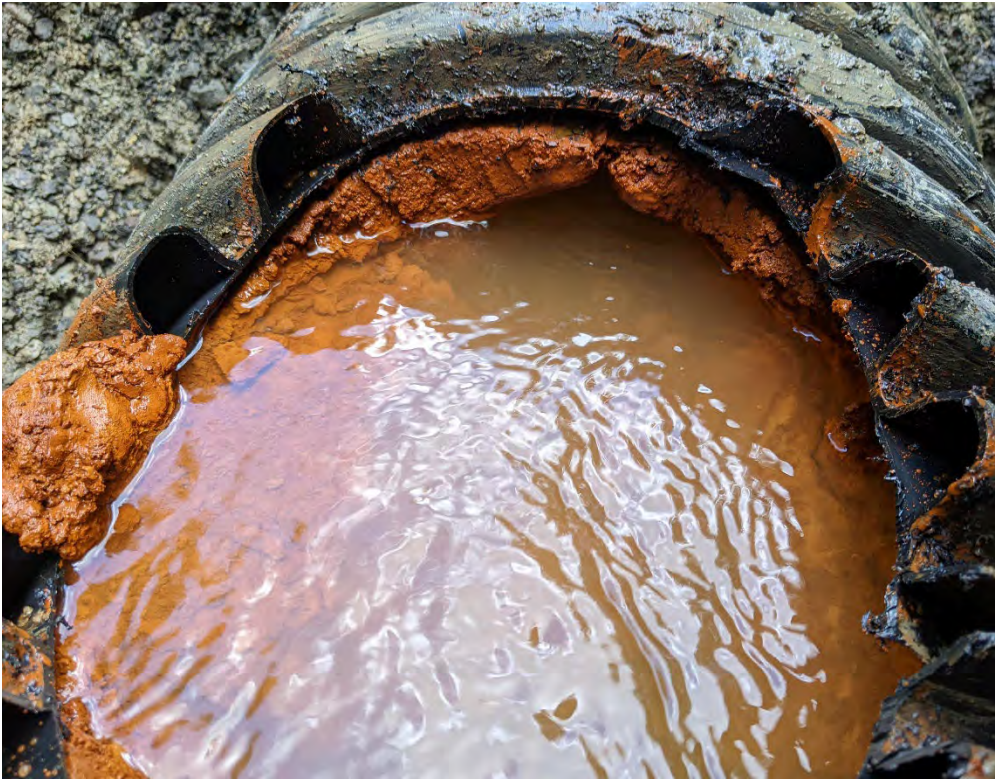
**Top Left:** The 18" N12 Pipe was uncovered and a 12" diameter hole cut into the top to facilitate the installation of a saddle tee. The pipe was found to be filled with varying amounts of iron oxide (low-pH iron), the selected photo shows that the pipe was about 90% filled (5/23/24).

- Jetter the 1,200 feet of 18” N12 pipe from collection pond to splitter box
  - Jetting the pipe generally removed iron to open the 18” N12 pipe from mostly occluded to more than 80% open for the entire length of the pipe

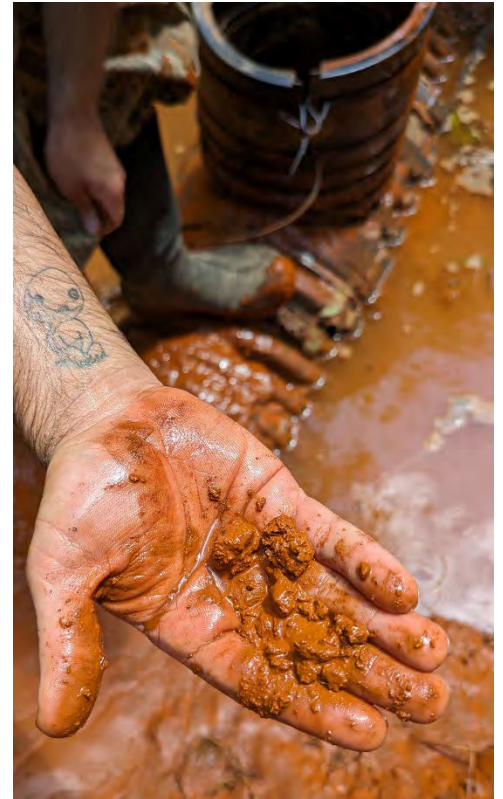
**Top Right:** Dense iron solids were able to be removed by jetting (6/12/24).

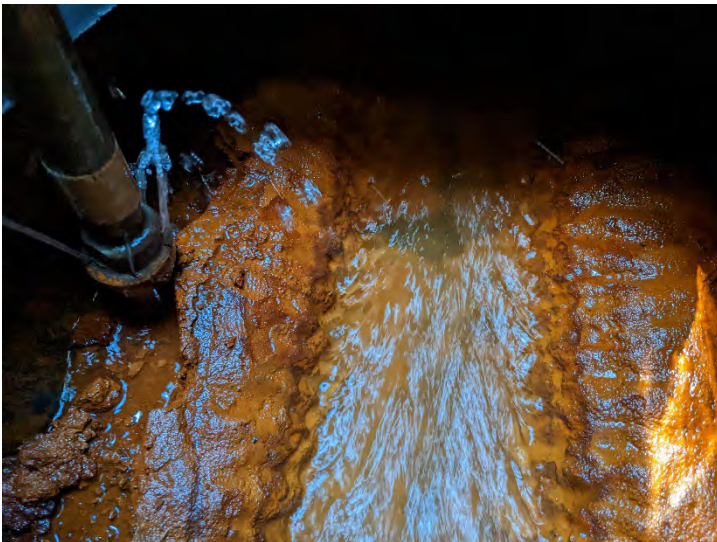
**Bottom Left:** At a different location from top photos the pipe was found to be about 70% filled just prior to jetting, with jetter nozzle and hose shown on left (5/31/24).

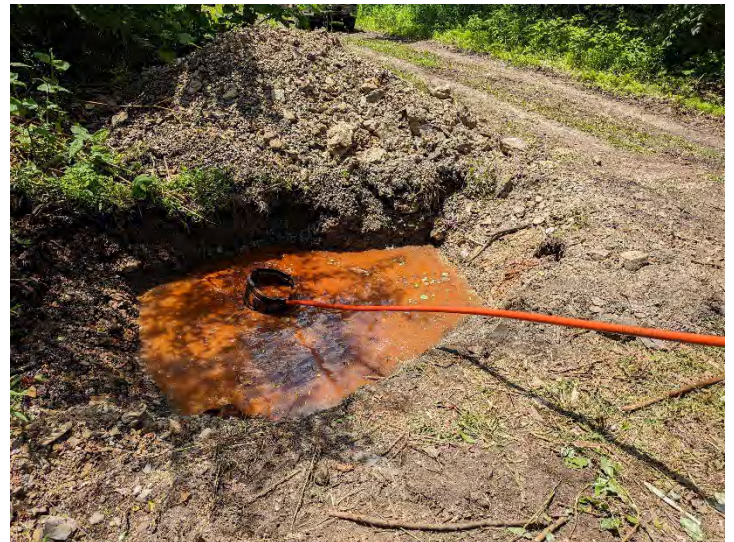
**Bottom Right:** During jetting, as the pipe was unclogged, water flow increased causing the temporary excavation to become filled.

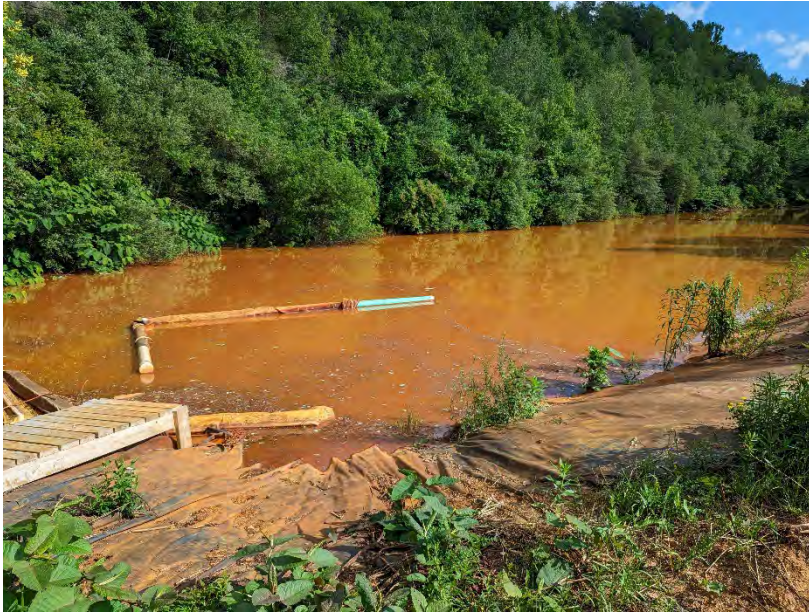
**Top Left:** Prior to jetting, the collection pond was discharging via the overflow pipe (6/11/24).  
**Top Right:** The 18" N12 pipe was uncovered in three locations for jetting and cleanout installation (5/23/24).  
**Bottom Left:** 18" x 12" N12 saddle tees were installed by cutting a hole in the top of the 18" pipe and fastening a tee with hose clamps (5/23/24).  
**Bottom Right:** The cleanout risers extend above final grade with Polylok caps (6/14/24).
