Laurel Run #2 Passive Treatment System
SRI O&M TAG Project #38 Request #2
OSM PTS ID: PA-128

Requesting Organization: Blacklick Creek Watershed Association
Requesting Organization Representative: Dennis Remy
Municipality/County: Center Township, Indiana County
Dates of work performed: 6/23/21-7/13/21

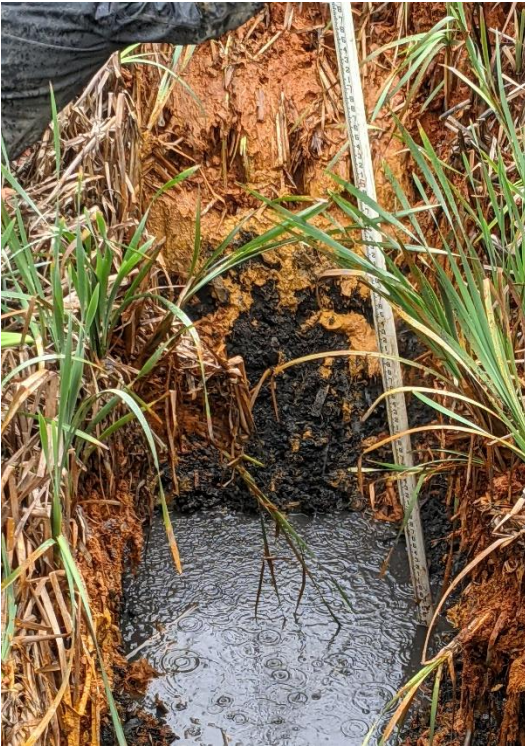
As the Vertical Flow Reactors were older and water quality not always ideal, two test pits were dug in both VFRs to assess the condition of the media. Data is provided in the table below. Between 2-3 feet of iron precipitates and vegetation was found on top of the media surface at the locations chosen for test pits. An average organic mixed media depth of approximately two feet was observed to be in relatively good condition given the amount of additional material in the ponds and the age of the system. The accumulation of sludge and vegetation did not appear to be prohibiting flow through the media. Removing the accumulated iron and vegetation was beyond the scope of this O&M TAG request. There was concern that if the sludge and vegetation was stirred into the media, a permeability problem could be created. Therefore, a decision was made to leave the VFRs in their current condition.

Top Left: Media within the vertical flow ponds was in good condition considering system age (7/8/21).
Top Right: Outlet weir was restored to working condition and a staff gauge was installed (7/13/21).
Bottom Left: Each wetland component was cleared to increase settling capacity and flow (6/25/21).
Bottom Right: Large amounts of iron and vegetation were removed from the wetland (6/25/21)

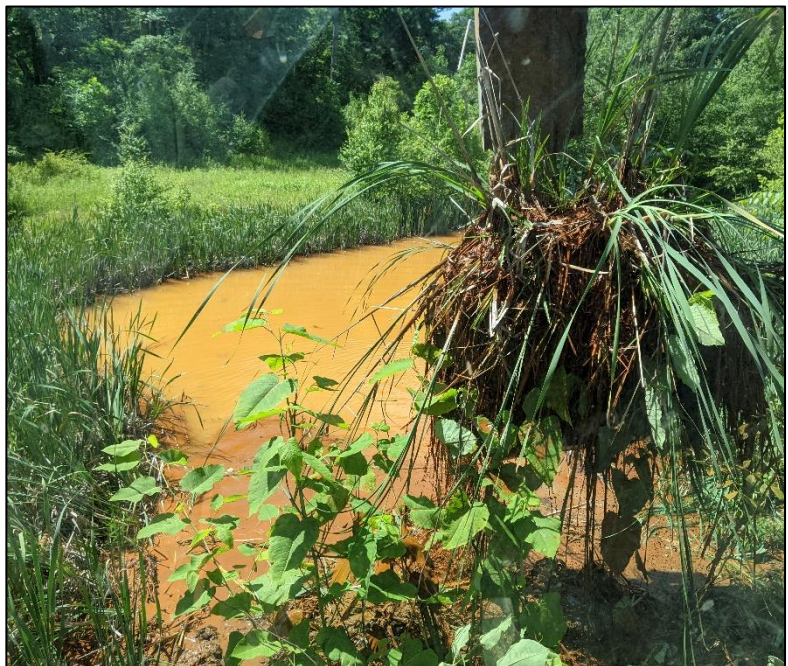
Initial Site Visit, Observations, and Identified Needs: An initial site visit was conducted on 4/15/21. A buildup of cattails and sludge within the wetland appeared to be blocking flow through the wetlands causing a large portion of the water to exit the emergency spillway of the settling/flush pond bypassing the wetland and preventing meaningful treatment. This problem is likely caused in part by the narrow channel wetland design with several “sharp” (~90°) turns that create places for sludge and vegetation to build up. The wetland had a similar issue and had to be cleaned in 2015. At the outlet of the system, the weir was found in need of repair. A field 5.5 pH and alkalinity of 6 mg/L indicated that the water that was flowing through the system did not have sufficient alkalinity which suggests that the media may need to be replaced; However historic water monitoring data also indicates that performance has been variable. A follow up site visit was conducted on 6/18/21 just prior to maintenance to conduct further investigation and discuss actions to be taken.

Work Completed: BioMost, mobilized to the site on 6/23/21. A large amount of vegetation and iron precipitates was removed from the wetland cells to increase both flow through the system and settling capacity. The elevation of the settling/flush pond emergency spillway was raised to direct more flow through the wetland cells and prevent short circuiting. The spillway between the first and second wetland cells was lowered slightly to help prevent water backing up and overflowing at the settling/flush pond. The outlet monitoring weir had been compromised and was repaired. A staff gauge was installed to facilitate accurate weir readings.
