Boyce Park AMD Treatment System
SRI O&M TAG Project #43 Request #2
OSM PTS ID: PA-281

Requesting Organization: Allegheny County Parks (in-kind partner)

Dates Work Performed On-Site: 7/6/2023-8/11/2023

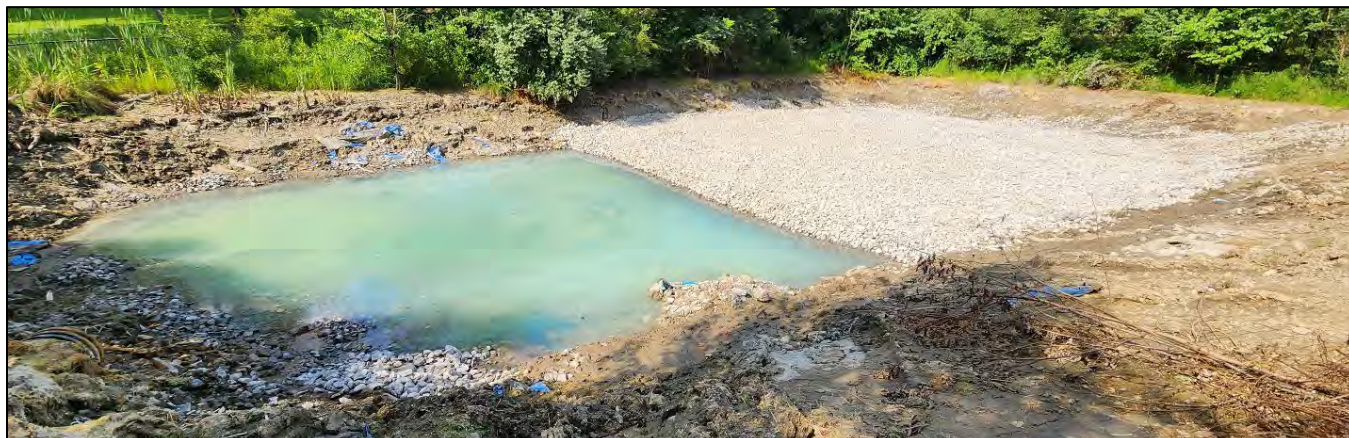
Top: BP3-VFW filling with water after stone cleaning and underdrain improvements (8/9/23).
Bottom Left: BP3-VFW riser outlet and valve installed (8/11/23).
Bottom Right: BP3-VFW raw water inlet box cleared of roots and debris (8/11/23).

A novel approach was taken in the BP3-VFW component. An inlet pool was left in place to better utilize the limestone remaining in the pond at a thickness of approximately three feet. The underdrain piping was shortened to remain within the new media footprint. In addition to the above design adjustment, the following maintenance was performed:

- Removal of degraded compost.
- Stone washing.
- Underdrain perforation improvements.
- Removal of stop logs in Agri Drain structure (abandoned for now).
- Installation of riser pipe at VFW outlet to maintain water level above the media.
- Vegetation cleared from pond embankments as needed.
- Re-set access gate.

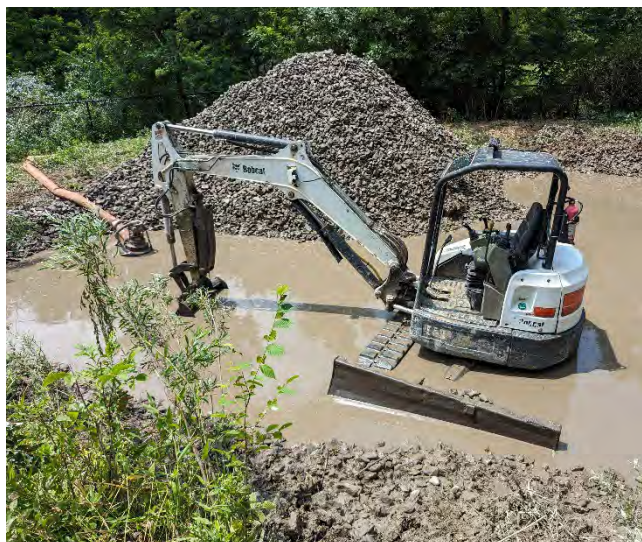
Top Left: Washing stone in BP2 autoflusher (7/19/23).
Top Right: BP3-VFW underdrain pipes exposed during stone cleaning (8/2/23).
Bottom Left: BP2 autoflusher after washing and stone added (8/11/2023).
Bottom Right: BP2 raw water inlet pool added for flow measurements (8/11/23).

- Limestone in the pond removed and washed.
- Underdrain repaired and re-set as appropriate.
- Larger diameter holes drilled in underdrain pipes for increased flow during flush events.
- Siphon vault cleared of sediment and debris.
- Vegetation cleared from pond embankments as needed.
- Placement of additional high-quality limestone to improve system performance/replace dissolved stone.
- Raw water flow measurement pipe and plunge pool installed.

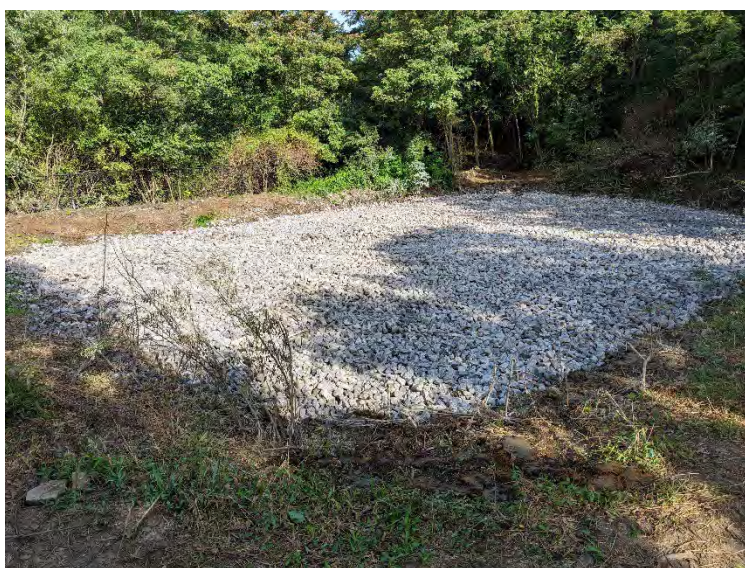
The BP2 Limestone Pond appeared to be entirely occluded with aluminum precipitates and the siphon was not performing adequately for treatment. The following maintenance was performed:

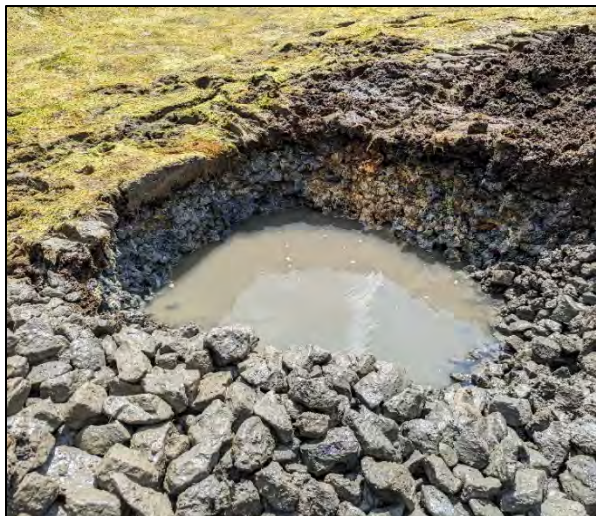
Work Completed: On 7/11/2023, BioMost mobilized equipment to the site. Test pits were excavated in BP4 VFW #1 and it was determined that removal of compost material and washing remaining limestone would improve system performance. The following additional maintenance and upgrades were performed:

Top Left: Test pit to evaluated condition of treatment media in BP4-VF#1 (7/11/23).
Top Right: Flushing and washing BP4-VFW#2 (8/10/23).
Bottom Left: BP4-VF#1 after maintenance completed (8/11/2023).
Bottom Right: After excavation, BP4-VFW#2 flush valve was cleaned exercised (8/4/23).

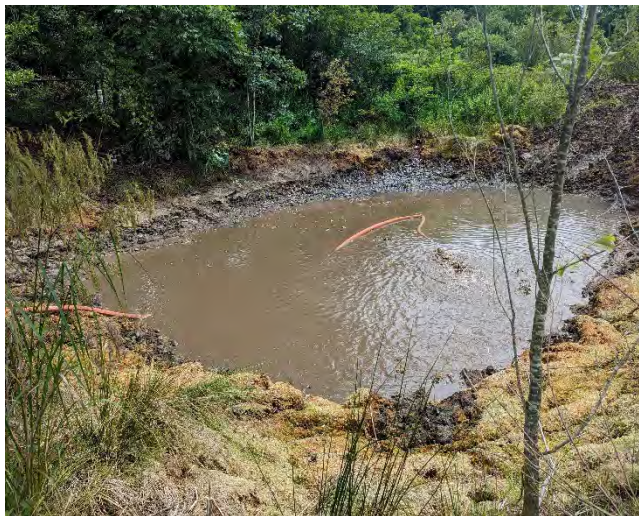
A similar approach was taken for the BP4 VFW #2 component once a test pit was excavated. Similarly, the compost was removed from the pond surface. However, the limestone was not removed as it was still permeable. Instead, the pond was filled with clean water from the system which was flushed several times through Manual Flush Valve #3 into the constructed wetland. The flush valve was also excavated and serviced as it had become difficult to operate. This approach reduced maintenance work required while hopefully extending system life.
