# **Laurel Run #1 Passive System Rehabilitation**

Center Township, Indiana County, PA  
40°30'29.7"N 79°06'46.4"W

## ***A Blacklick Creek Watershed Association Project***

### **Final Report**

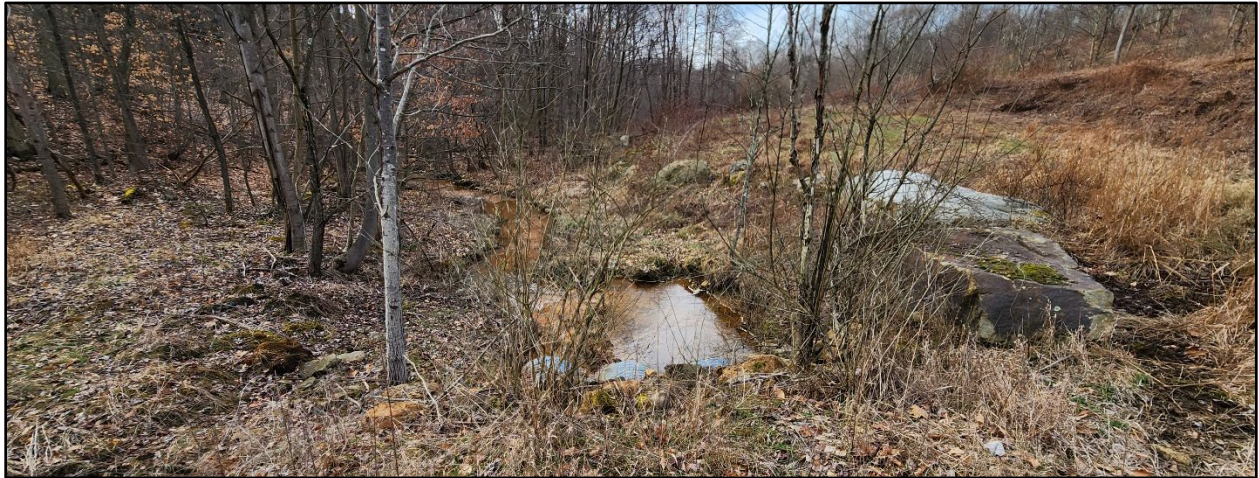
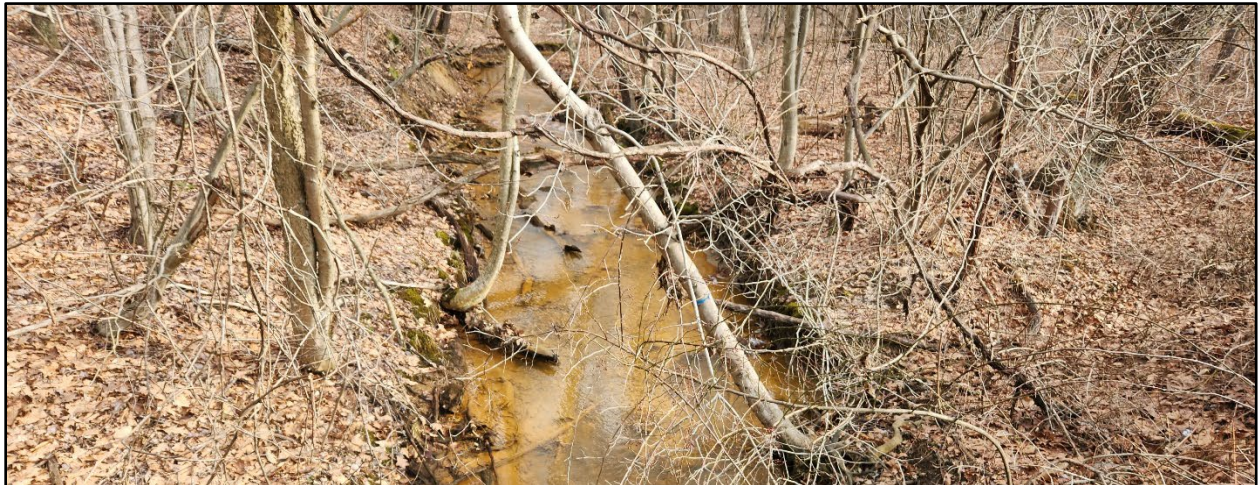
**Middle & Bottom:** Laurel Run (stream) flowing past the treatment system in 2023. The stream was impacted due to a large portion of the discharge bypassing the system.

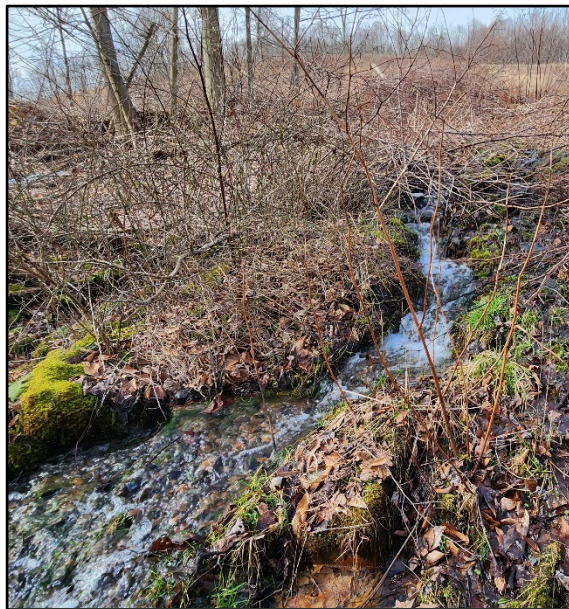
**Bottom Left:** At some point, the original underground mine drain and collection system failed causing multiple AMD seeps to form across the site. One of the AMD discharges that had formed, bypassing the treatment system and entering directly into the stream prior to rehabilitation (2023).

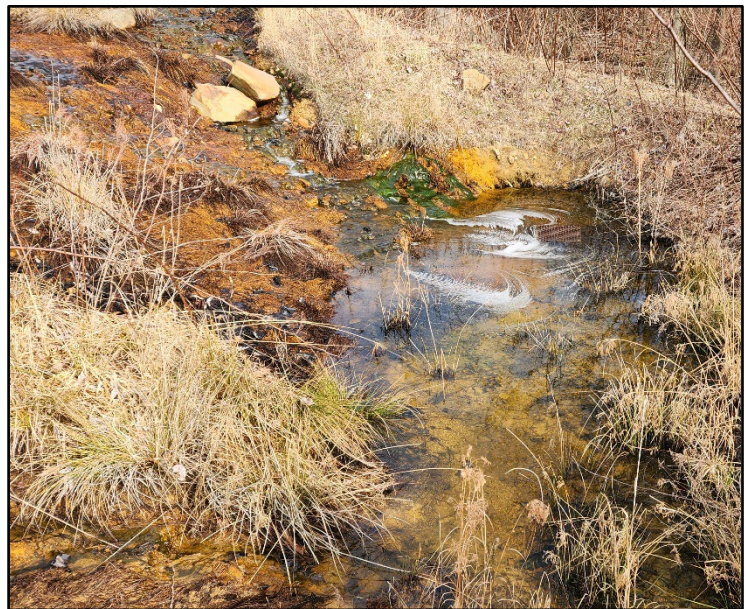
**Bottom Right:** Another AMD seep that had formed at Laurel Run #1. An attempt was made to direct it into the flow splitter box of the system (2023).

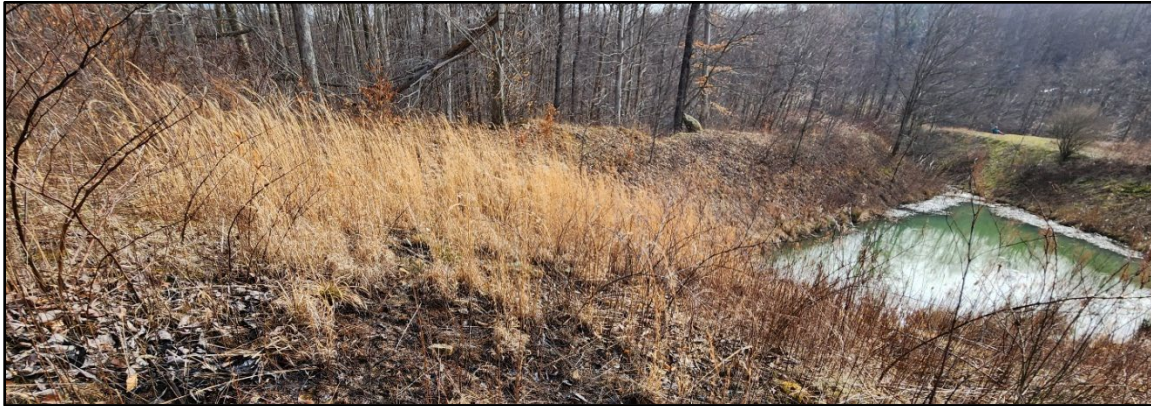
**Top:** Flush pond of the original passive system in 2023. The flush pond was too small to be effective and not useful for Jennings style vertical flow ponds so was removed during rehab. The area was utilized for part of JVFP1.

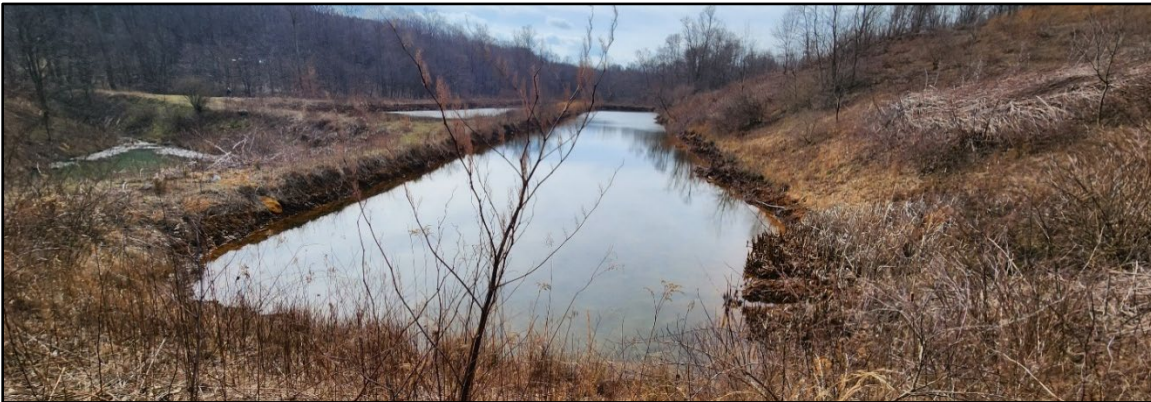
**Middle:** The longer of the two original vertical flow ponds (VFPW aka VFRA) at Laurel Run #1 with the flush pond to the left. The photo taken in 2023 prior to rehab shows the long, rectangular shape which was potentially partly responsible for the cause of gas traps and short-circuiting issues within the VFPs.

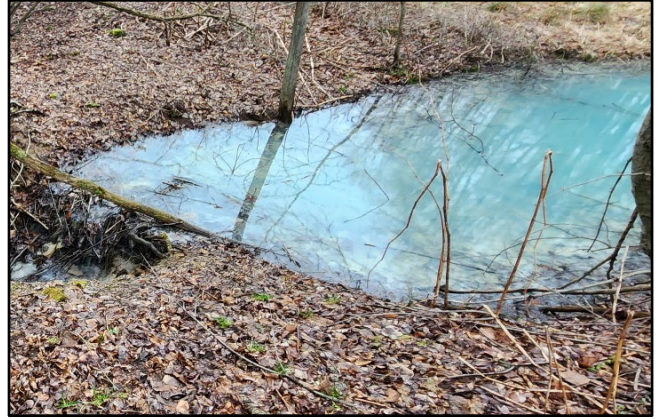
**Top Right:** An unrelated AMD discharge found along the access road downstream of the system prior to rehab (2023).

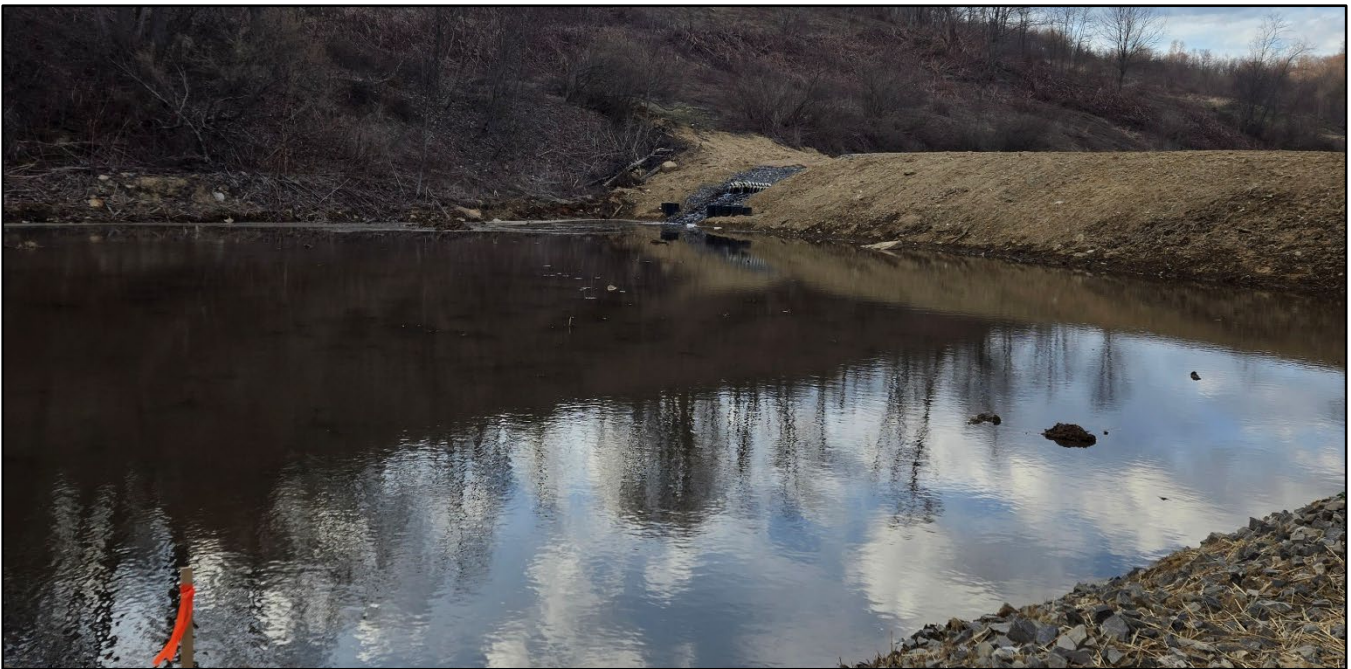
**Bottom:** Final wetland shortly after construction before vegetation established. Note the dark color of the water is likely due to tannins and metals sulfides.

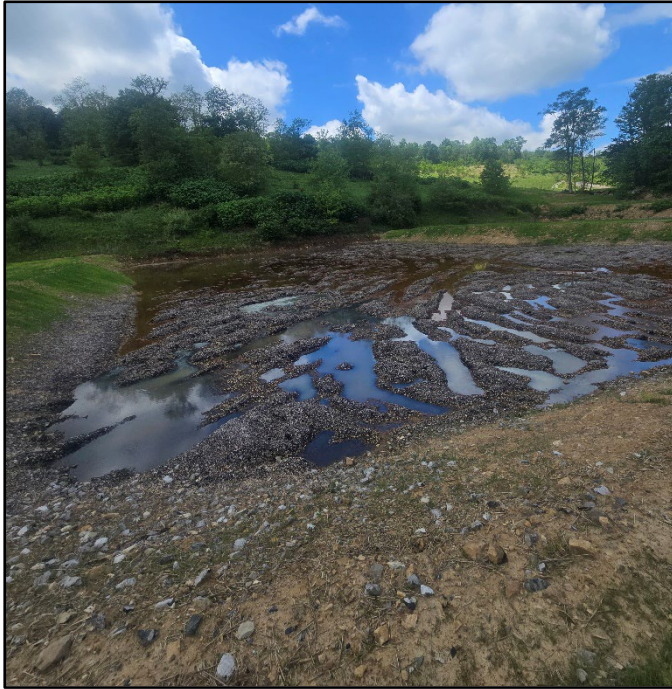
**Top Left:** Months after construction, the reconfigured JVFPs at Laurel Run #1 are working as intended. The white cloudy water on top of the JVFP1 is aluminum precipitating out of solution due to the increase in pH.

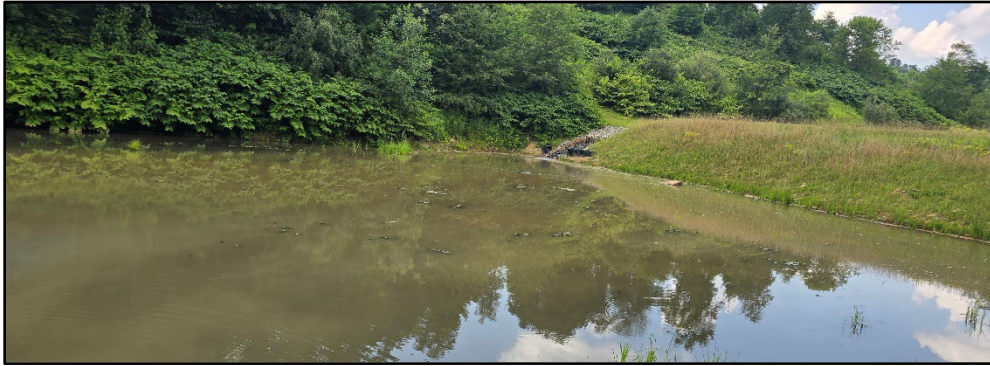
**Top:** First portion of the LR#1 wetland before the rock flow distribution berm was intentionally designed to be deeper for settling of solids.

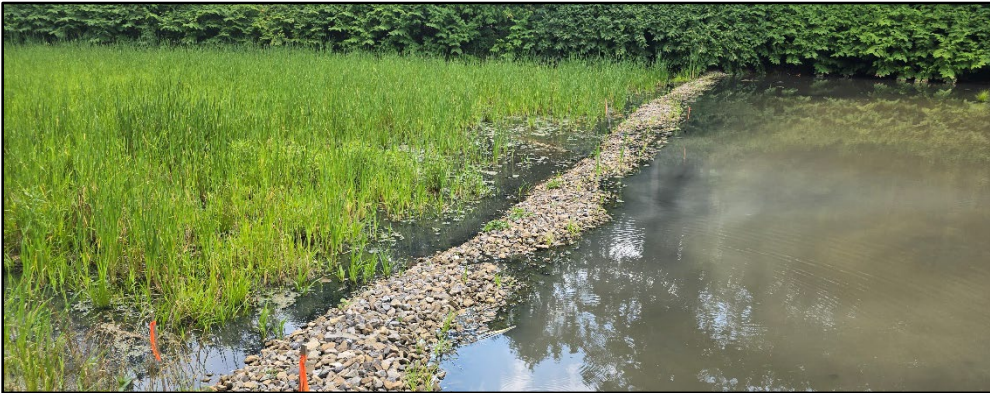
**Middle:** A rock distribution berm was installed to reduce channelization within the wetland. The second half of the wetland contains emerging wetland vegetation, such as cattails.

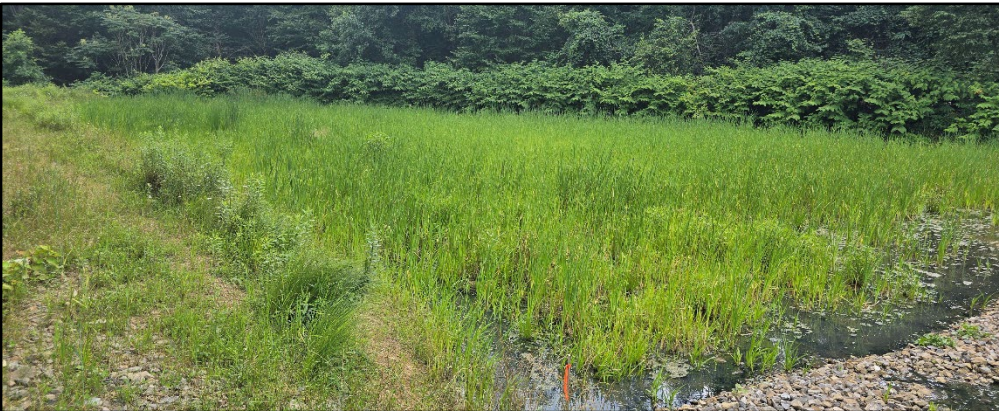
**Bottom:** The entire second half of the wetland now has wetland vegetation growing in it. This is expected to increase oxidation, precipitation and settling of iron.

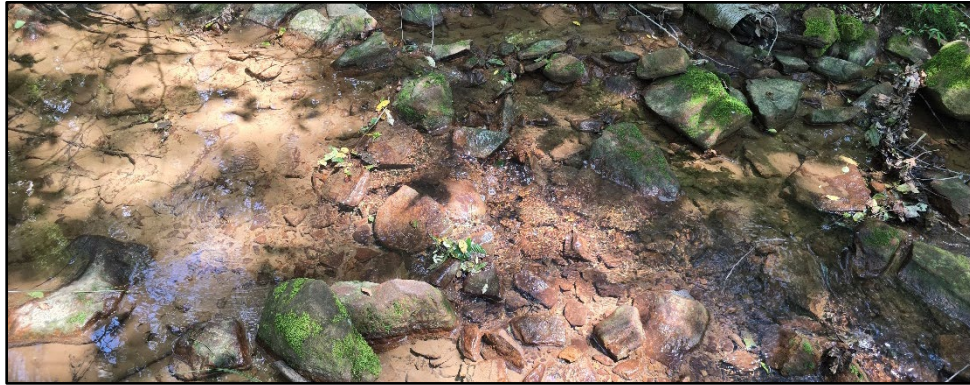
**Top:** Close up of Laurel Run (stream) located upstream near the beginning of the collection channel. Sections of the stream had significant sedimentation that had collected in small pools.

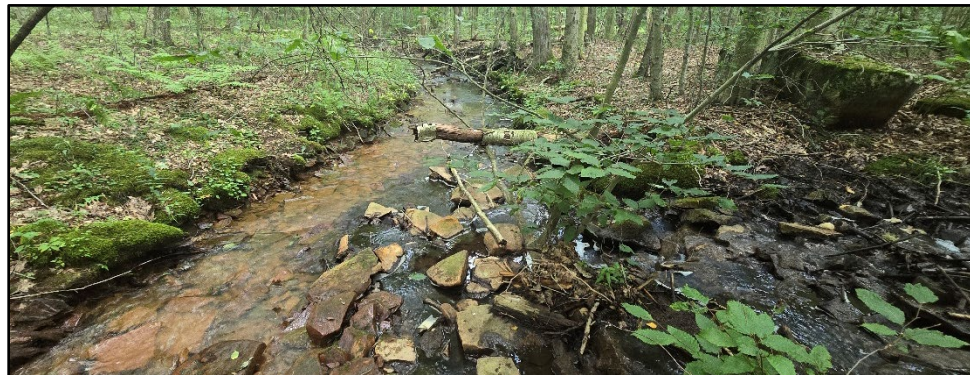
**Bottom:** Laurel Run where the LR#1 system effluent (shown on the right side with black coloration due to the VFP sulfide products) mixes with the stream. Circumneutral pH and low iron were measured at this location, despite evidence of iron staining, likely due to past conditions prior to rehabilitation.
