Yellow Creek 2A/2B Passive Treatment System
SRI O&M TAG Project #52 Request #2
OSM PTS ID: PA-124

Requesting Organization: Blacklick Creek Watershed Association

Municipality/County: Center Township, Indiana County

Dates of work performed: 2/5/20, 7/20/21-7/27/21

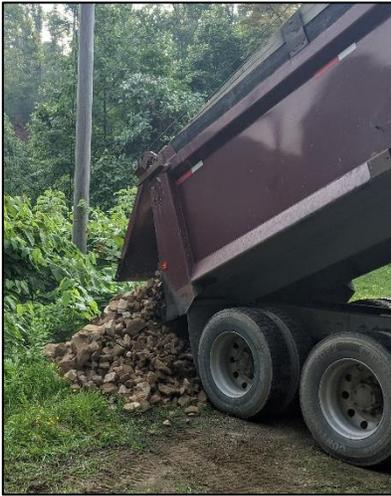
Top Left: Riprap was purchased to place around the Forebay outlet pipe (7/20/21).

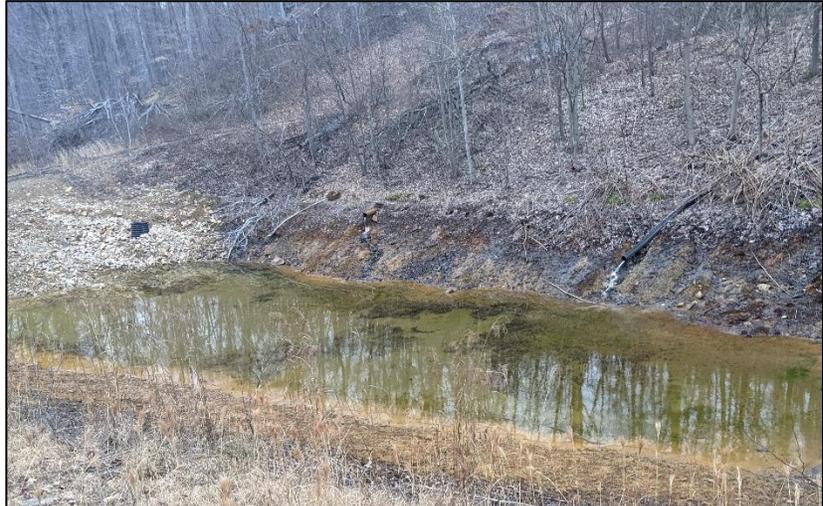
Top Right: The collection system was checked in February 2022 and found functional (2/24/22).

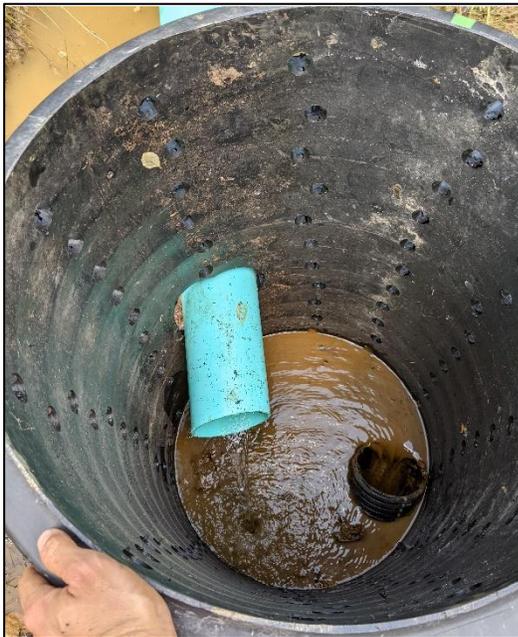
Bottom Left: 2A/2B raw water conveyance pipe had a new pipe and protective culvert riser installed to limit leaf litter entering the system while also capturing AMD from the surrounding seep area (7/22/21).

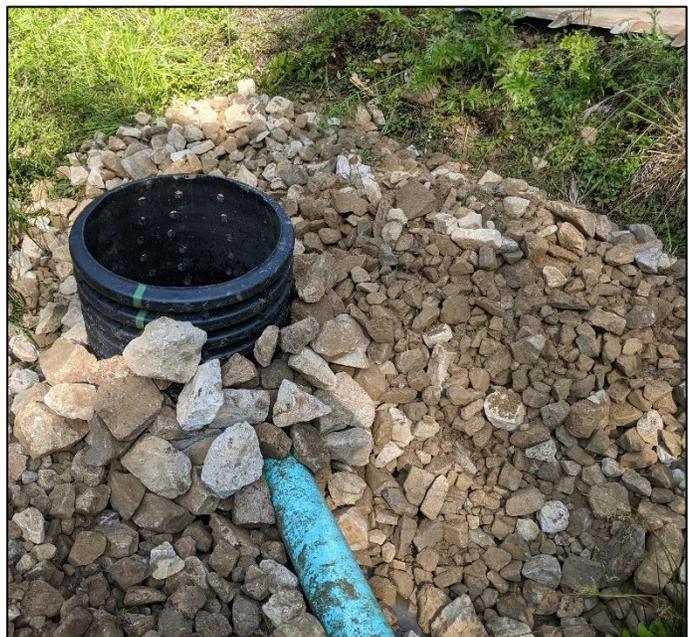
Bottom Right: Riprap was also installed around the 2A/2B raw water conveyance pipe (7/23/21).

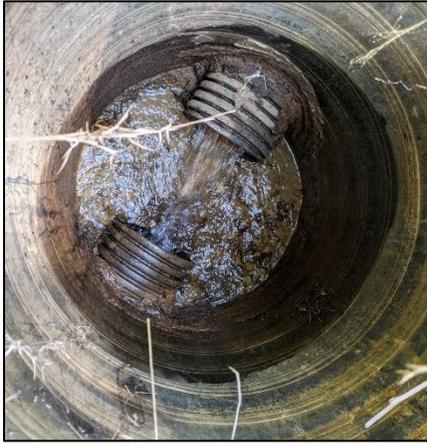
Top Left: 2A/2B splitter box has ongoing issues with leaves and debris clogging the pipes (7/27/21).

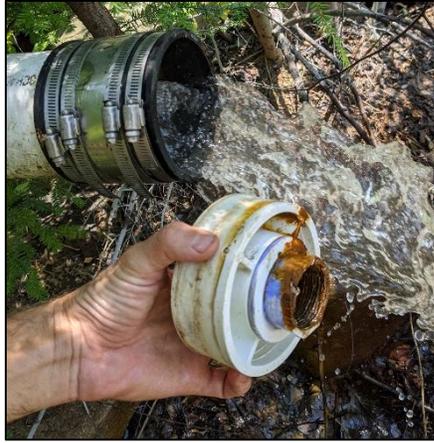
A site inspection of the 2A/2B system revealed that leaf debris was also preventing water from entering the 2B Bioreactor. This material was cleared and flow was restored to the 2B system. The cleanout wye located in the woods between the Forebay and system was inspected and found to be free of leaf debris.

Top Center: 2B Bioreactor inlet pipe was cleaned to maintain functionality (7/27/21).

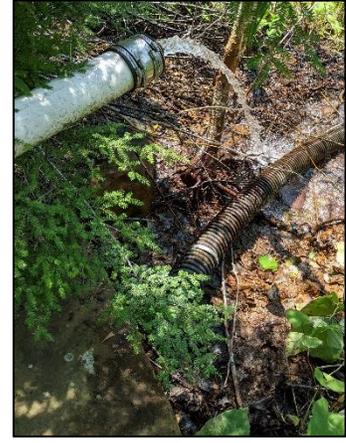
Top Right: 2B Flow reducer re-installed (7/27/21).

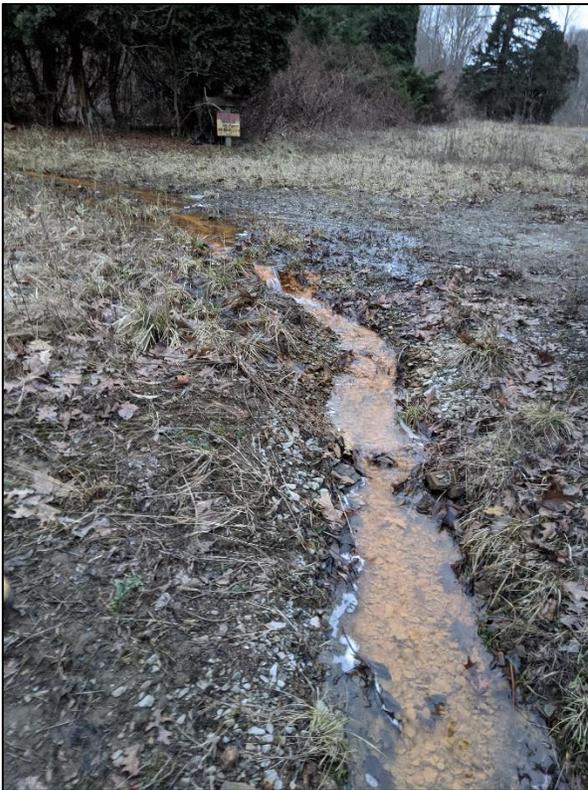
Bottom Left: In February, a portion of the raw water upstream of the forebay was not entering the system due to a clogged pipe which was cleared (2/5/20).

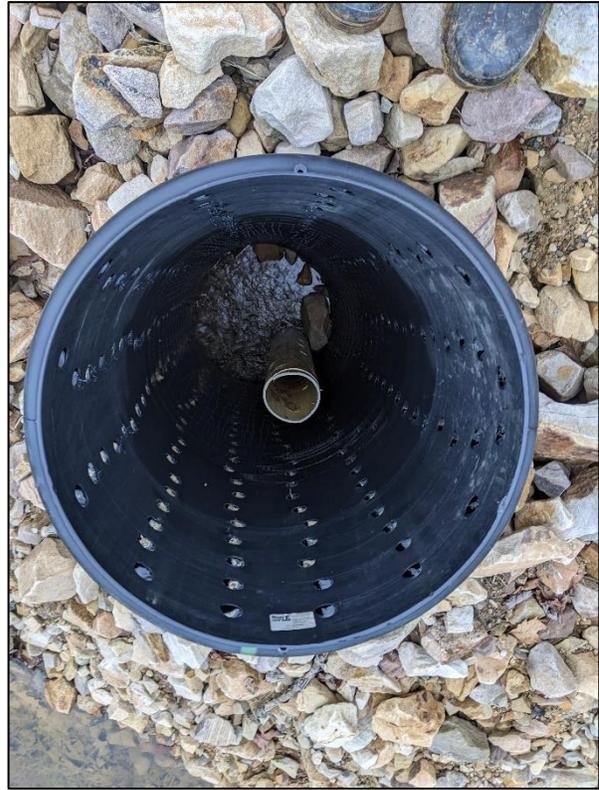
Bottom Right: A perforated 24" pipe and riprap was placed around the 2A/2B Forebay riser pipe to reduce clogging (2/24/22).
