Yellow Creek 2A/2B Passive Treatment System
SRI O&M TAG Project #52 Request #3
OSM PTS ID: PA-124

Requesting Organization: Blacklick Creek Watershed Association (in-kind partner)

Dates of work performed: 3/8/2023

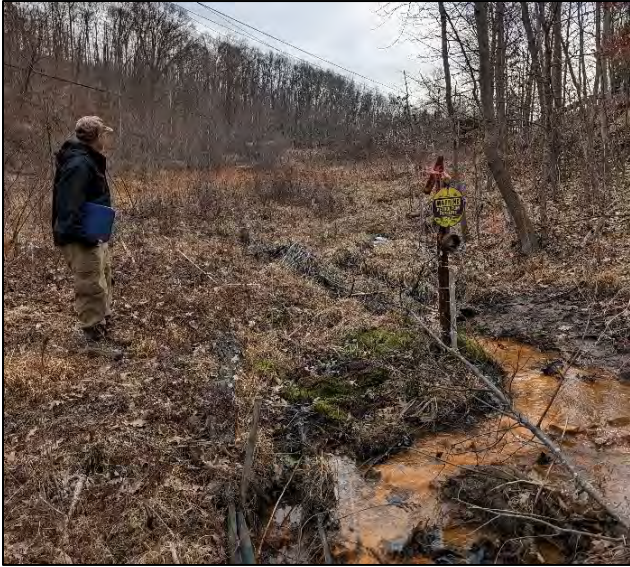
Top Left: Field visit with Cliff Denholm to confirm work to perform (3/2/23).
Top Right: Material was shoveled by hand to divert more raw flow to the system (3/3/23).
Bottom Left: VFP 2A outlet accepting a portion of the water to the system (3/3/23).
Bottom Right: Water overtopping VFP 2A collection pond emergency spillway (3/3/23).

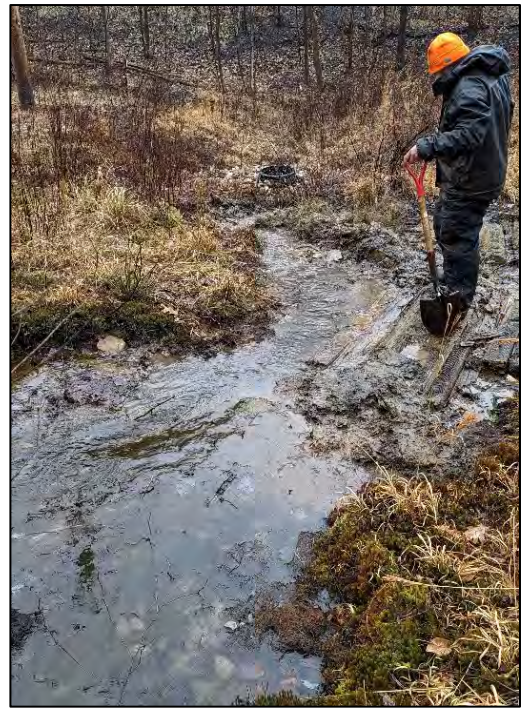
Work Completed: In March 2023, BioMost, Inc mobilized to the site. BioMost personnel joined Cliff Denholm from SRI and observed that water which may be poor quality had the potential to bypass the treatment system. A trench was dug to direct flow to the lower forebay pipe which flows to the splitter mechanism for the 2A/2B systems. Water quality data was obtained to determine the health of the system. It was noted that the 2A settling pond above the VFP was partially flowing through the emergency spillway indicating a hydraulic barrier is present in the VFP. It is known from previous maintenance activities that the media in the VFP 2A system needs replacement due to permeability issues.

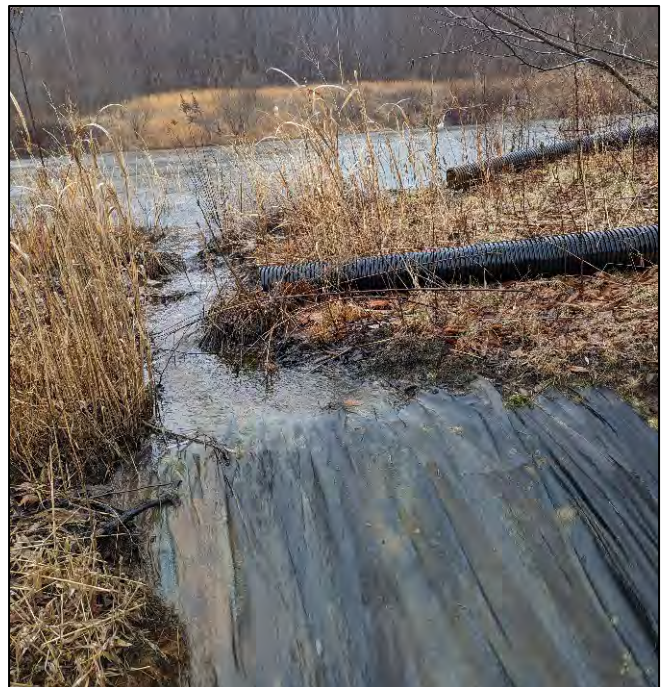
Recommendations & Future Considerations: On-going water monitoring and site inspections should continue. Debris should be cleared periodically from the forebay inlet pipe as needed. Funding for system rehabilitation should be sought if improved treatment is desired. It was confirmed that permeability and short circuiting challenges still exist at this time based on available data.
