## Yellow Creek 2C Passive Treatment System SRI O&M TAG Project #53 Request #3 OSM PTS ID: PA-122

<u>Requesting Organization:</u> Blacklick Creek Watershed Association <u>Requesting Organization Representative:</u> Dennis Remy <u>Municipality/County:</u> Center Township, Indiana County <u>Dates of O&M work performed:</u> 7/16/2021 to 7/20/2021

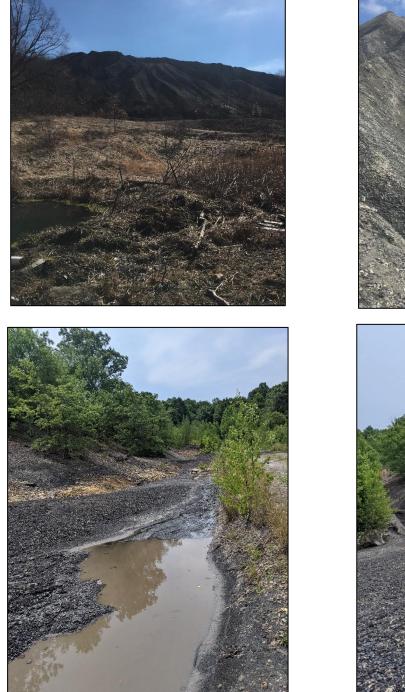
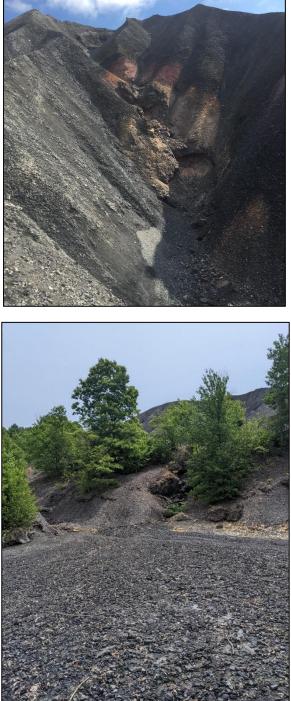
The Tide Coal Refuse pile sits above the Yellow Creek 2C passive treatment system. Channels and ponds had been previously constructed to contain the coal refuse that is eroded during storm events. The BCWA is concerned about the material overtopping and filling in part of the treatment system, which had happened in the past (upper pictures 2/28/19 lower pictures 6/18/21).

<u>Recommendations & Future Considerations</u>: The Tide coal refuse pile will continue to erode and threaten the YC2C passive system. The Tide pile needs to be reclaimed. Once the pile is reclaimed, the YC2C system should be evaluated and likely redesigned and rebuilt. Until then, water monitoring including flow measurements should be conducted on a regular basis to determine the effectiveness of the treatment system. This data will also be important for when it is time to redesign and rebuild the system. In addition, the inlet and outlet of the AMD conveyance pipe should regularly be inspected for the accumulation of iron, leaf and other debris to ensure the pipe remains clear and the AMD able to flow to the VFR.

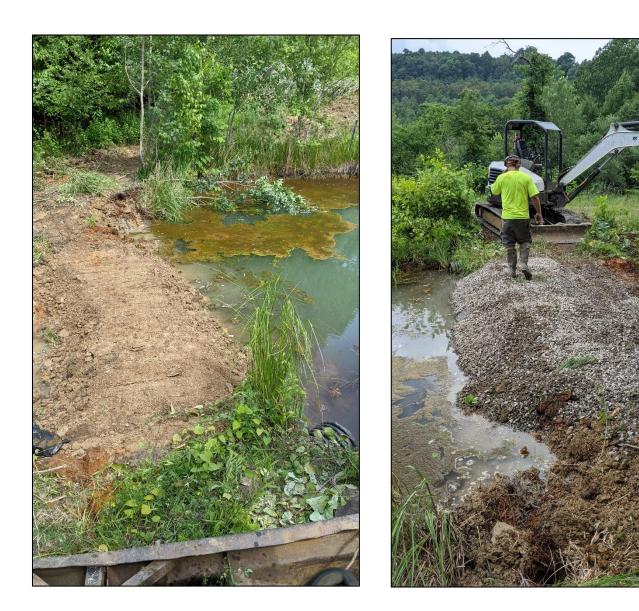
While on site, an inspection of the treatment system was conducted. The inlet area of the raw water inlet and conveyance pipe that had been installed in March of 2020 was clogged with algae and iron precipitates. Water was exiting the forebay emergency spillway and bypassing treatment. It was determined that raising the emergency spillway for the forebay would provide enough head pressure for all flow to enter the treatment system under normal conditions.

**Left:** The forebay emergency spillway elevation was raised (7/16/21). **Bottom Right:** Geotextile and stone was placed on the new emergency spillway grade (7/16/21).

<u>Work Completed</u>: Iron debris and algae was removed from the forebay outlet pipe. The emergency spillway elevation was increased and geotextile and stone was placed for erosion control. Water was once again flowing into the treatment system.
