**Yellow Creek 2C Passive Treatment System**  
**SRI O&M TAG Project #53 Request #4**  
**OSM PTS ID: PA-122**

Requesting Organization: Blacklick Creek Watershed Association (in-kind partner)

Dates of work performed: 3/2/2023-3/15/2023

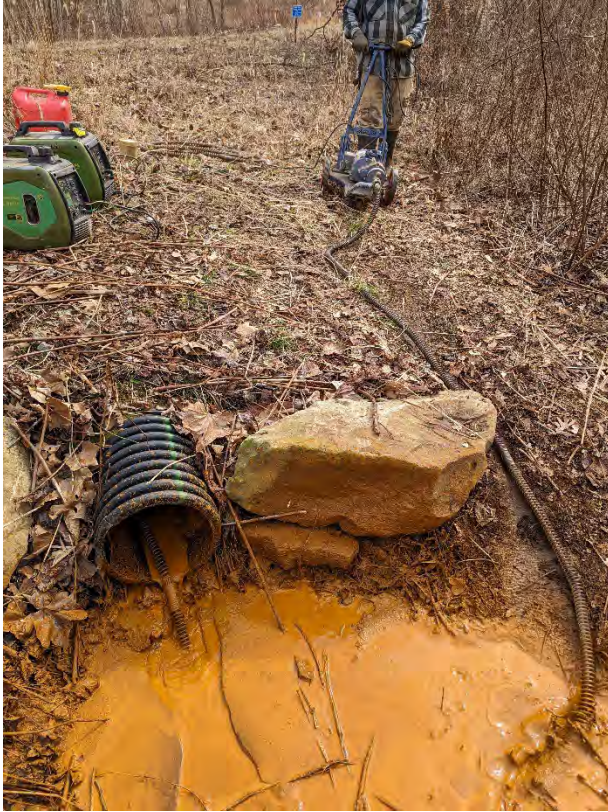
Work Completed: On March 2, 2023, BioMost, Inc mobilized to the site. It was observed that a portion of the flow from the forebay nearest to the access road was flowing with a majority of the flow from that pond flowing over the emergency spillway. An industrial sewer snake was utilized to attempt to clear any material blockages within the pipe with limited success, both from the upstream and downstream ends of the pipe. An apparent blockage was located near the road crossing. On 3/3/2023 an access hole was cut near the road culvert to assess the blockage and it was determined that the pipe was compromised. Further materials were needed to repair the pipe.

**Top Left:** The 12" N-12 pipe was snaked from both ends (3/2/23).  
**Top Right:** Access ports were drilled into the culvert and snaked (3/2/23).  
**Bottom:** The culvert was excavated and damaged sections removed (3/15/23).

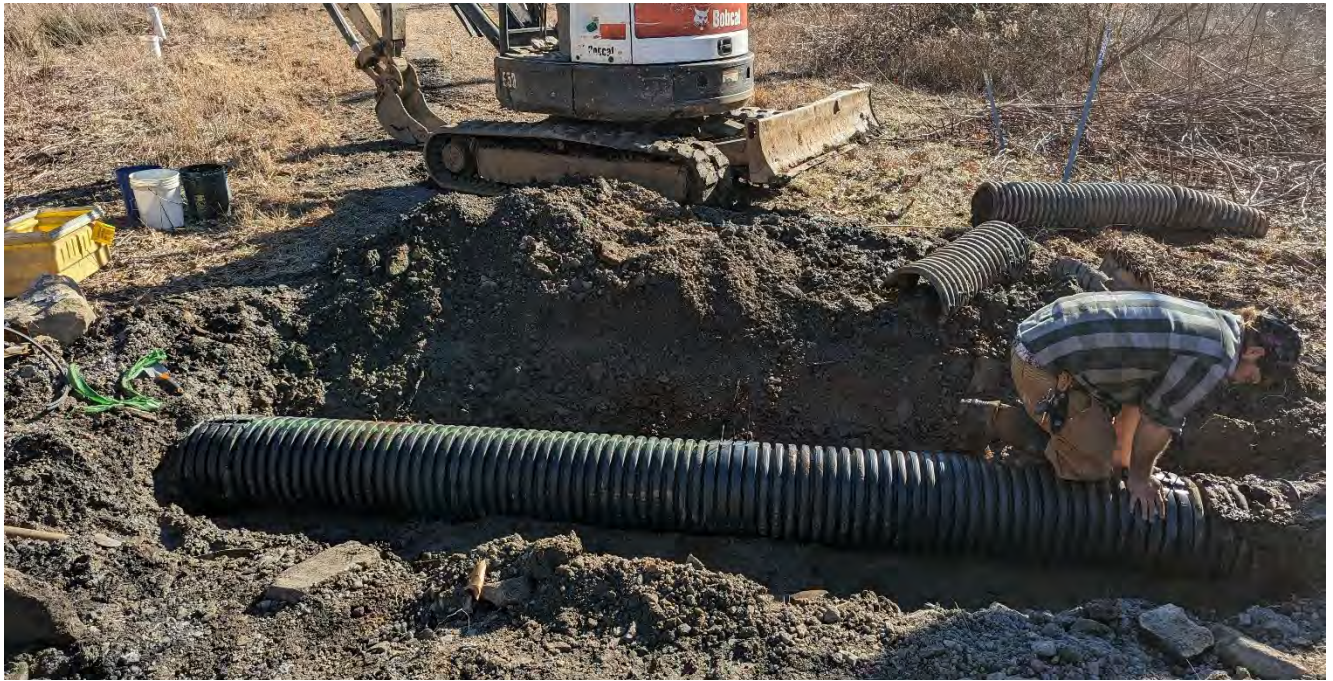
**Top:** A new section of 12" N-12 culvert was installed to replace the damaged sections (3/15/23).  
**Bottom:** The culvert was bedded in concrete and steel plates were installed above the pipes along the tire tracks (3/15/23).

On 3/15/2023 the section of culvert underneath the road was excavated and replaced. Steel plates reinforced with a poured concrete base were placed over the driven sections of the road and buried. Proximity to a gas line on the east side of the road and a water supply line on the west side limited the burial depth of the culvert pipe. Placing steel plates above the pipe should reduce the chances of future damage to the pipe. Full flow from the forebay was observed to exit to the VFR after repairs were completed.
