Dents Run BBWA 3893 Passive Treatment System
SRI O&M TAG Project #60 Request #1
OSM PTS ID: PA-304

Requesting Organization: Elk County Conservation District

Dates of work performed: 5/24/2023-6/15/2023

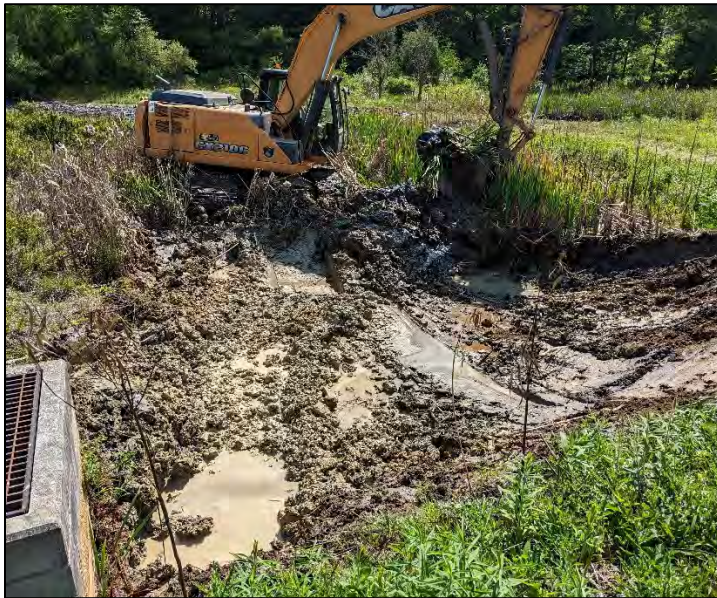
Top Left : Seep 8 forebay on both sides of the access road was cleared of vegetation (6/2/23).
Top Right: All stop logs were removed, cleaned, and lubricated for each applicable component (6/2/23).
Bottom Left: A new OPB outlet was installed (6/15/23).
Bottom Right: Directional baffle installed in OPB (5/24/23).

The Seep 8 forebay on both sides of the access road was cleared of vegetation to the extent the excavator could reach (approximately 20'). Additional deep pools were established near the inlets and outlets of the pond to discourage vegetation growth and reduce clogging.

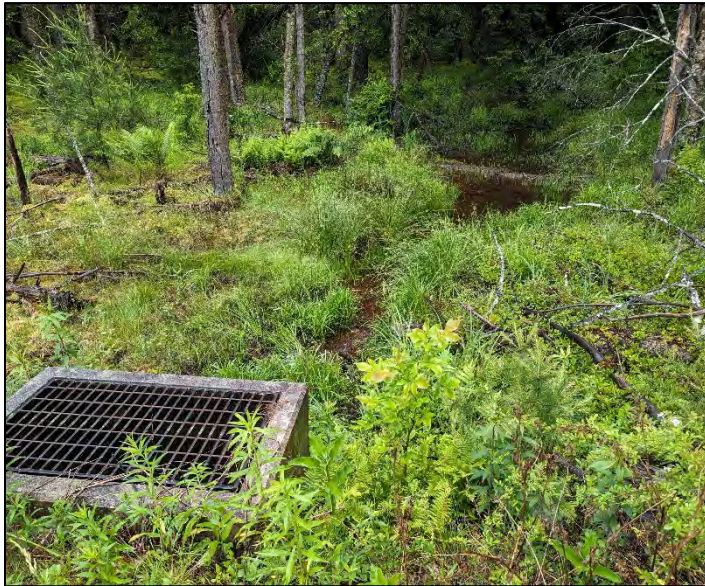
Top Left : Seep 9 inlet before it was cleared of vegetation (6/14/23).
Top Right: Diversion structure was installed to direct flow to the Seep 9 inlet box structure (6/16/23).
Bottom Left: Riser installed at the OPB inlet from Seep 8 to facilitate flow measurements.
Bottom Right: Seep 9 inlet after it was cleared of vegetation and lowered (6/16/23).
