Dents Run BBWA 3888 Passive Treatment System
SRI O&M TAG Project #62 Request #1
OSM PTS ID: PA-277

Requesting Organization: Elk County Conservation District

Dates of work performed: 5/24/2023-6/15/2023

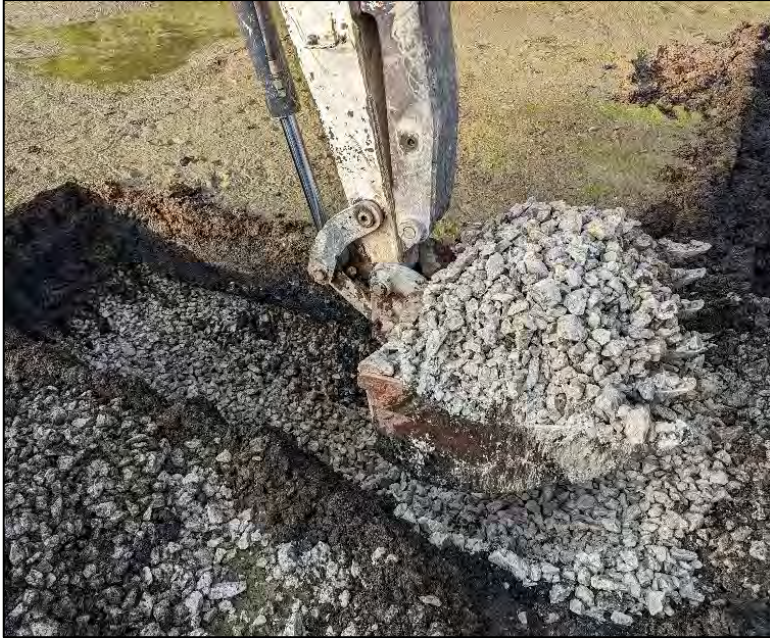
Top Left: Stone from the VFW test pit was generally very clean and free of metal precipitates (5/24/23).
Top Right: Repairs to pond liner completed as needed (6/2/23).
Bottom Left: Compost removed, and limestone leveled in VFW (6/2/23).
Bottom Right: Compost moved from surface of VFW (5/24/23).
