Cottagetown Passive Treatment System
SRI O&M TAG Project #63 Request #2
OSM PTS ID: PA-28

Requesting Organization: Shade Creek Watershed Association (SCWA)

Dates Work Performed On-Site: 11/1/2023- 11/3/2023

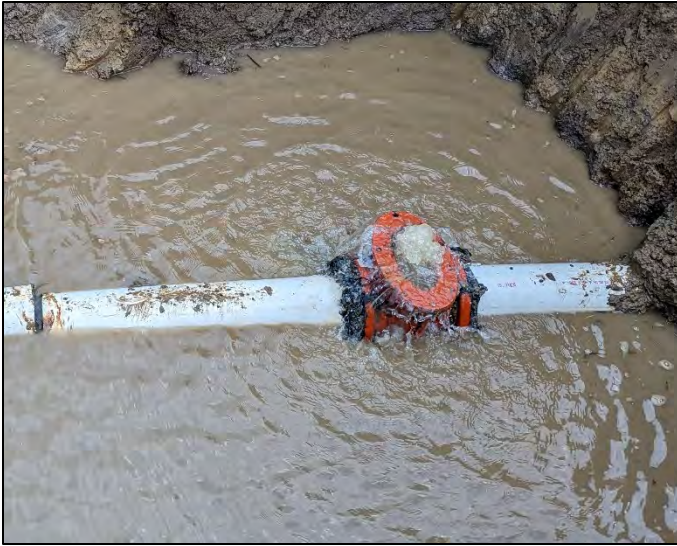
Top Left: Old VFP wetland flush valve was exposed to confirm poor condition (11/1/23).
Top Right: Standing water was visible in the old valve riser casing prior to excavation (11/1/23).
Bottom Left: Installation of replacement valve (11/2/2023).
Bottom Right: Installation of replacement valve completed with T-post re-used as marker (11/3/23).

Work Completed: BioMost mobilized with a mini excavator to remove the leaking flush valve for the VFP 11/1/23. After excavation and removal of the old valve, the pond was flushed overnight. On 11/2/23 a replacement (Valterra) gate valve was installed and backfilled. Functionality of the valve was checked on 11/9/23. Water is now properly flowing through the system.
