**McIntire Passive Treatment System**  
**SRI O&M TAG Project #70 Request #1**  
**OSM PTS ID: PA-249**

Municipality/County: Marion Township, Butler County

Dates of work performed: 4/28/2020-4/30/2020

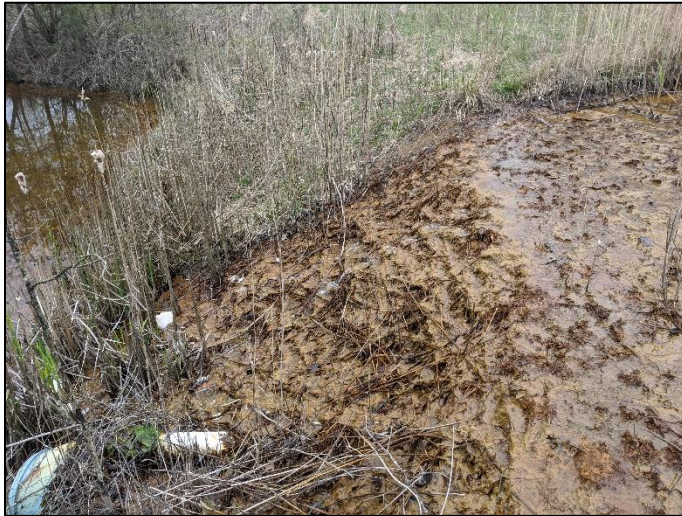
**Top Left:** Flow from collection pond above MC1/MC2 pipes was restricted due to low pH iron causing water to overtop the embankment.

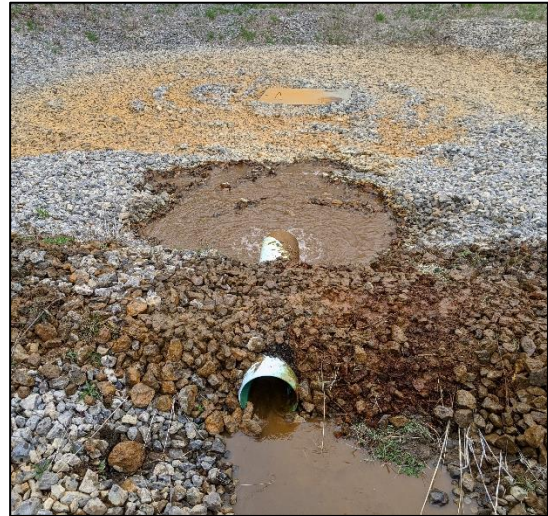
**Top Right:** 902-OPC flow measurement pipe was reinstalled.

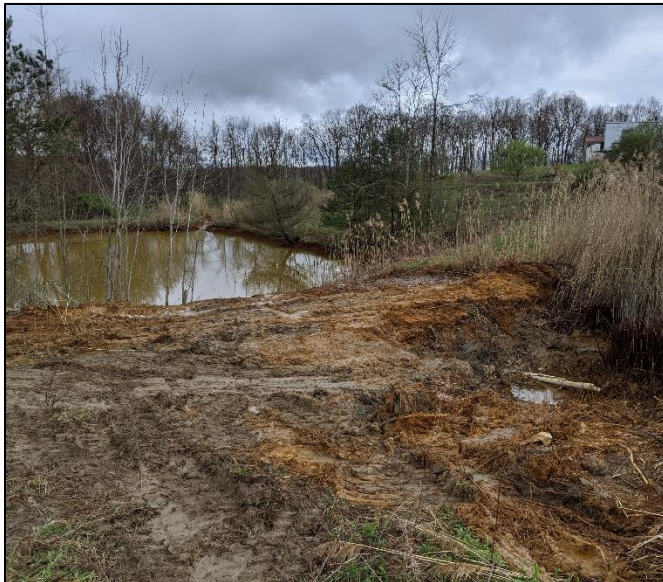
**Bottom Left:** MC1/MC2 pipes were excavated restoring designed flow paths to the Treatment Basin.

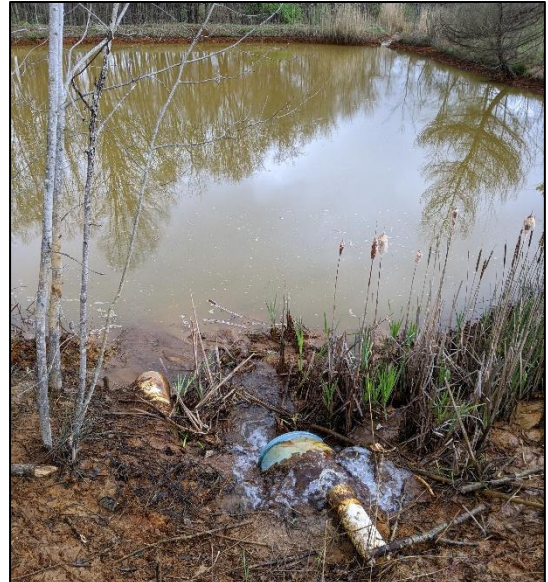
**Bottom Right:** Treatment Basin elevation dropped after clearing iron precipitates from OPC.
