McIntire Passive Treatment System
SRI O&M TAG Project #70 Request #2
OSM PTS ID: PA-249

Requesting Organization: Slippery Rock Watershed Coalition

Dates of work performed: 2/1/2024-3/7/2024

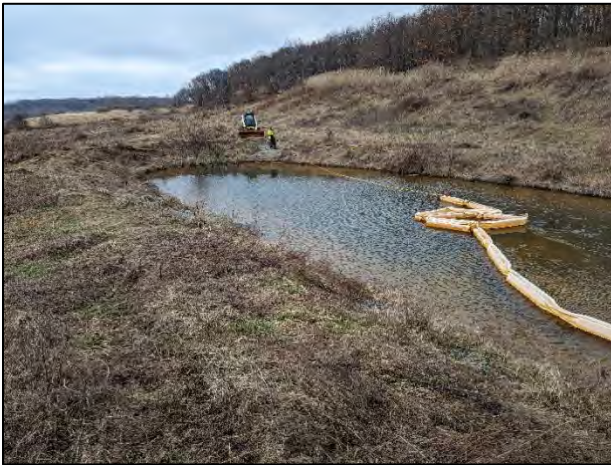
- Top Left:** Replacement of baffle curtain rope and western post (2/1/24).
Top Right: AFVFP stone washing (2/6/24).
Bottom Left: Troubleshooting the AFVFP solar powered valve (2/2/24).
Bottom Right: OPC after leveling and removal of sediment and vegetation (3/5/24).

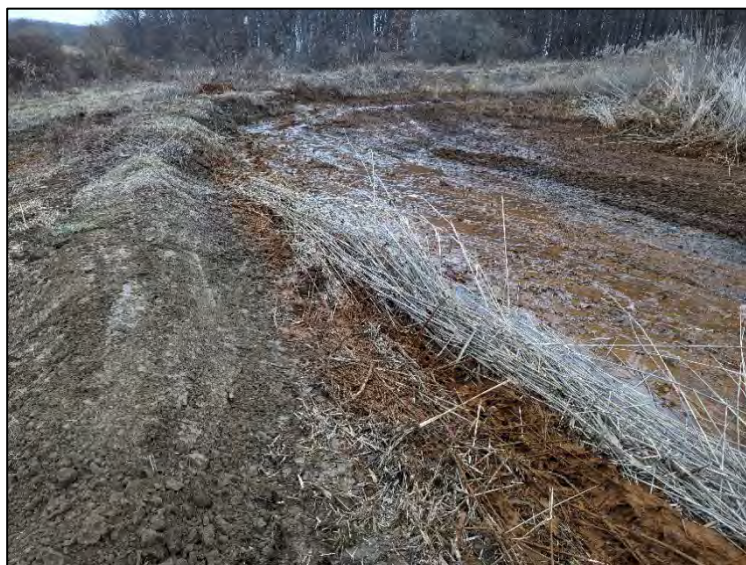
Top Left: OPC embankment fortified and raised as needed (2/13/24).
Top Right: AFVFP siphon vault during maintenance; Note sludge depth below inlets from pond (2/8/24).
Bottom: OPC with improved flow distribution, Settling Pond, and JVFP pictured (3/5/24).
