SR 115 Passive Treatment System
SRI O&M TAG Project #72 Request #1
OSM PTS ID: PA-182

Requesting Organization: Slippery Rock Watershed Coalition and PA Game Commission

Municipality/County: Washington Township, Butler County

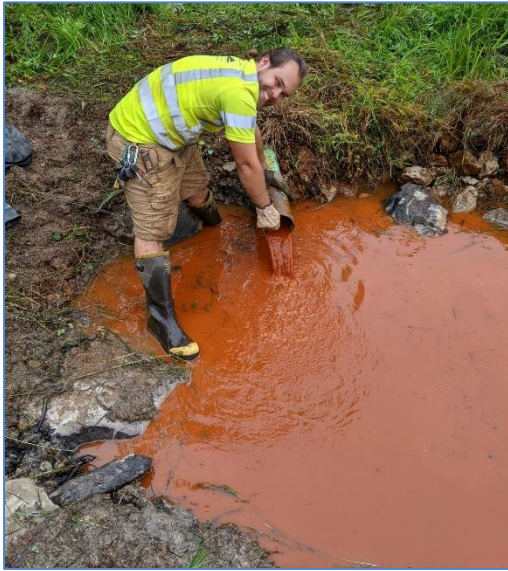
Top Left: The conveyance pipe to the west settling pond was cleaned to restore flow to the west pond (8/10/21).
Top Right: A pipe was added to the mine discharge pipe to convey the discharge into the distribution box where a plywood lid was installed to prevent leaves and debris from clogging the conveyance pipes (8/11/21).
Bottom Left: Elbows and pipe were added to split flow between the two ponds (8/26/22).
Bottom Right: Site evaluation to determine work to be done prior to excavation (04/28/21).

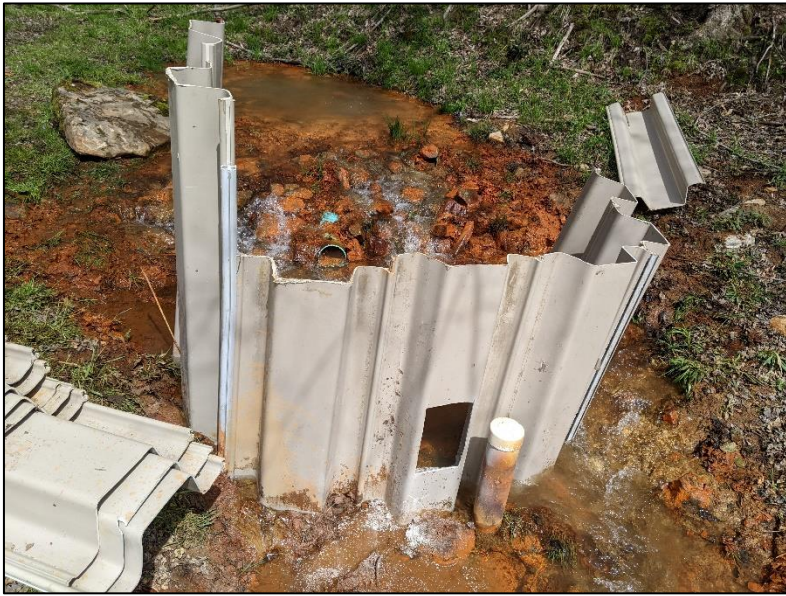
Top Left: A flow containment structure was constructed using PVC Z-pile (5/5/2022).

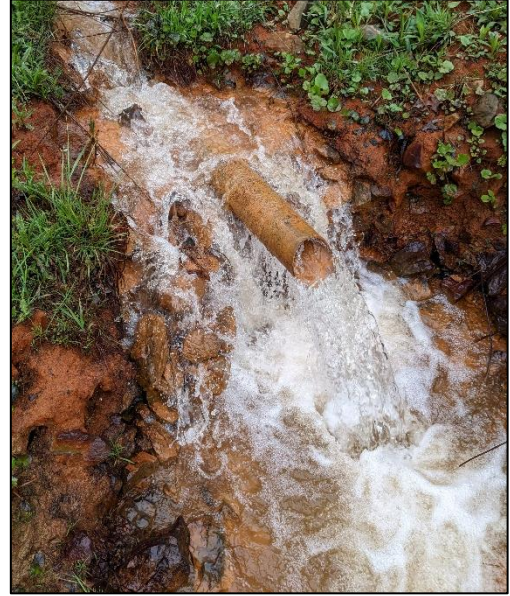
Top Right: During high flow periods, the two 6" conveyance pipes do not have sufficient capacity to carry the full discharge resulting in overflow draining to the older (east) settling pond (5/4/2022).

Recommendations & Future Considerations: Continue to monitor the system including flow measurements on a regular basis. Based on observations during high-flow period (May 2022), the two 6" conveyance pipes do not have sufficient capacity to effectively split the flow between the two ponds and the east settling pond is being overwhelmed during overflow periods. It is recommended that a flow distribution weir box be installed and the conveyance pipes be replaced with new and expanded conveyance channels that will promote better aeration

and result in better iron oxidation and overall treatment effectiveness while eliminating an ongoing maintenance issue. It has been recently noted by several passive treatment practitioners that channels can be effective in iron oxidation and precipitation. The older (east) settling pond should be assessed for sludge capacity and plans to clean should be developed if needed. The installation of baffle curtains may also improve overall treatment effectiveness.

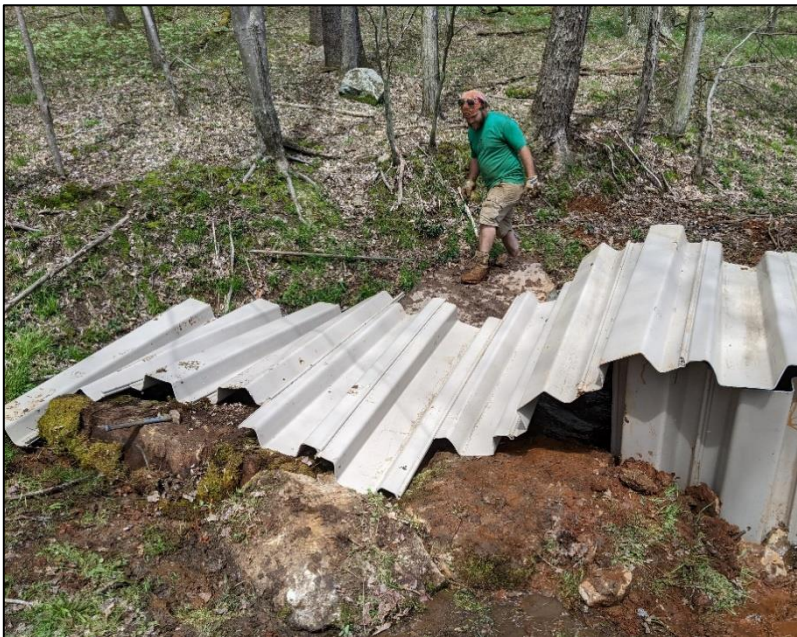
Bottom Left: A Z-pile cover prevents leaves and debris from entering the distribution box (5/5/2022).

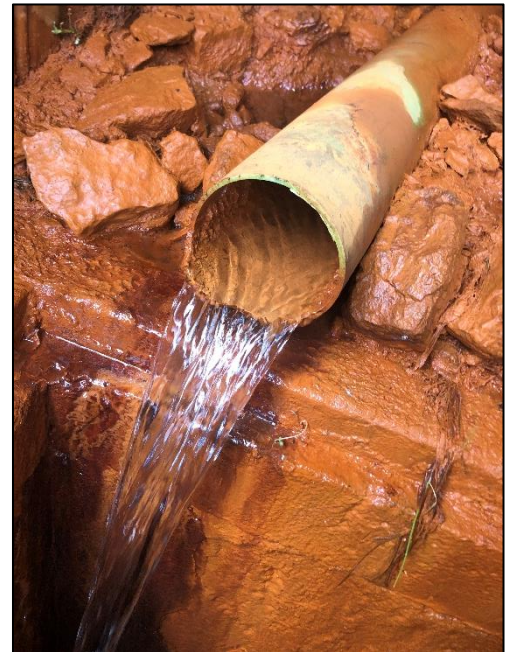
Bottom Right: During lower flow conditions, the majority of the discharge enters the distribution box via a 6" PVC pipe (8/26/2022).
