**Harbison Walker Phase I Passive Treatment System**  
**SRI O&M TAG Project #75 Request #1**  
**OSM PTS ID: PA-193**

Requesting Organization: Ohiopyle State Park

Dates of work performed: 3/24/2023-5/2/2024

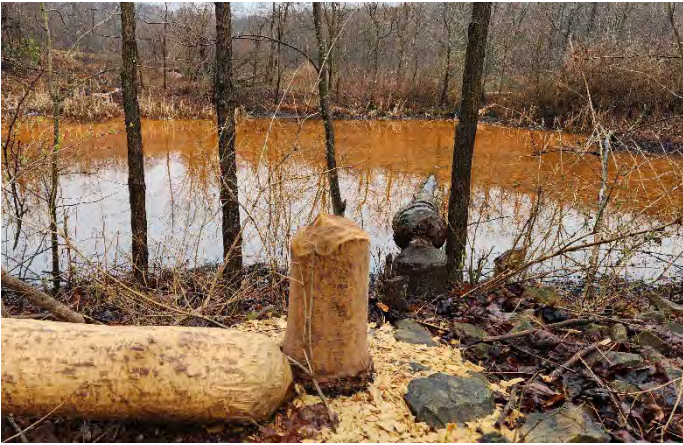
**Top Left:** Beaver activity was observed throughout the site causing short circuiting (3/24/23).

- Re-stabilized embankments with tree damage as needed.
- Removed dams appearing to be constructed by beavers from spillways as appropriate.
- Installed “beaver deceivers” within channels to discourage future dam building and maintain design water levels.

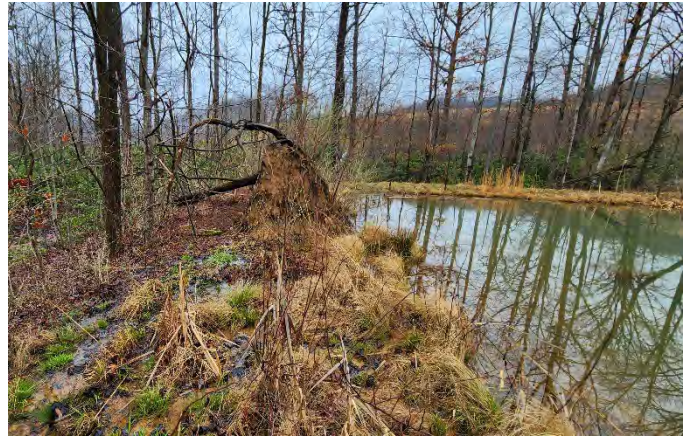
**Top Right:** Heavy woody vegetation was also observed and several larger trees had fallen and lifted roots caused low spots in pond embankments (3/24/23).

- Cleared significant amount of woody vegetation from constructed embankments including mature trees which had caused embankment instability after falling.

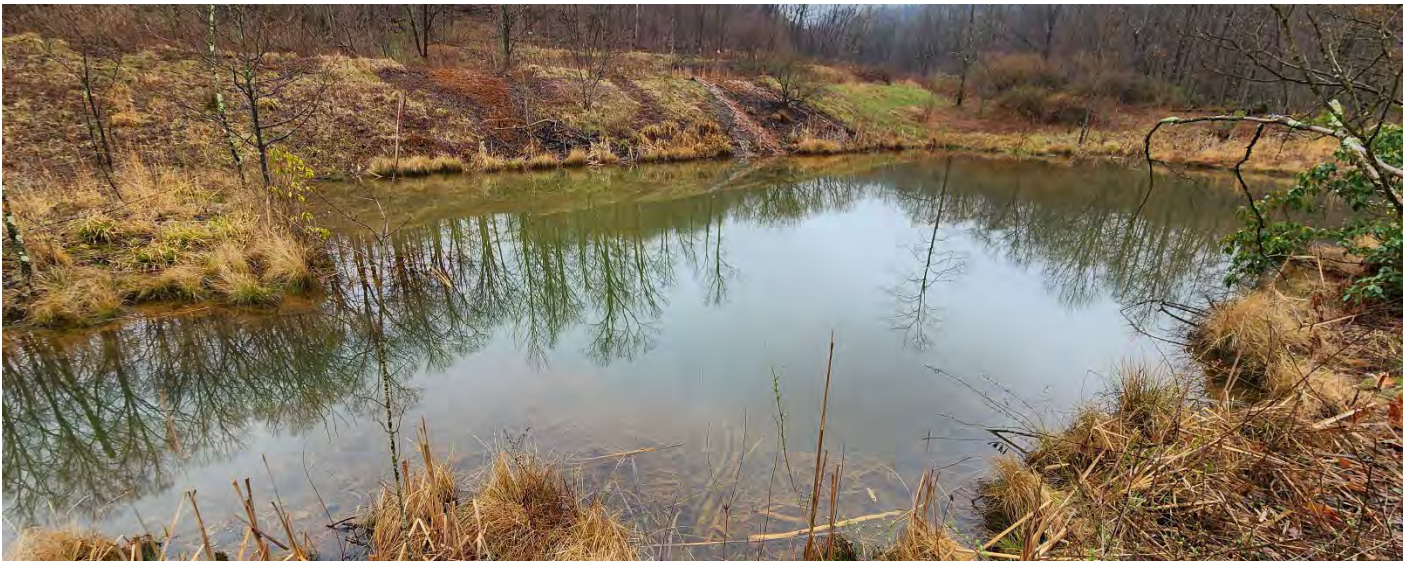
**Top Right:** Beaver dam installed in SP1 spillway caused water to flow over embankment and into the wetland, short circuiting the VFP, SP2, and the majority of the wetland (3/24/23).

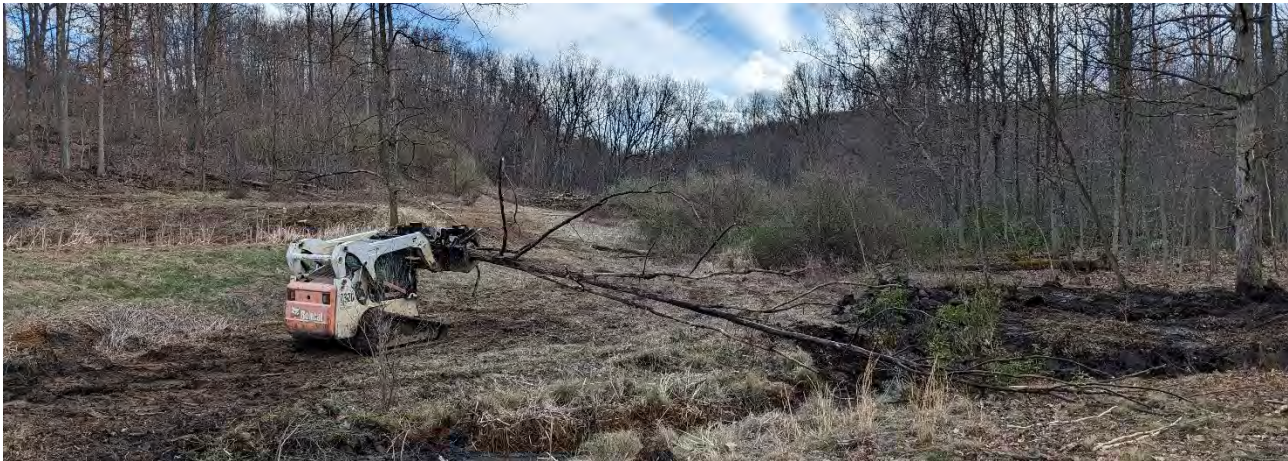
**Top:** Woody vegetation and beaver dam material was removed from throughout system (3/27/24).

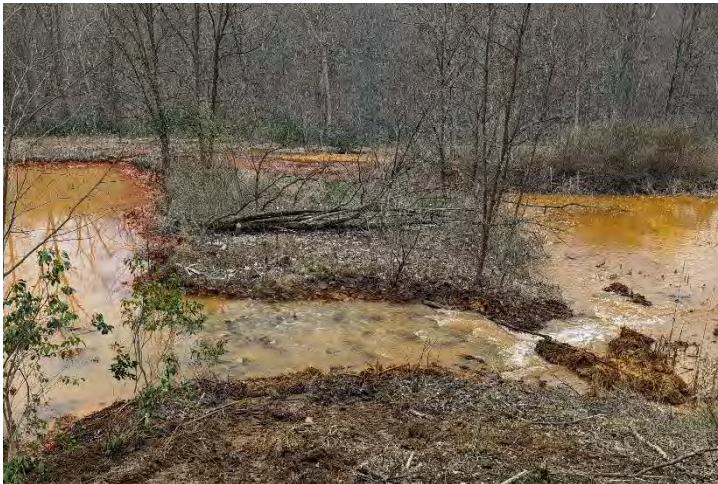
**Middle Left:** Beaver dams were removed from between several components (3/22/24).

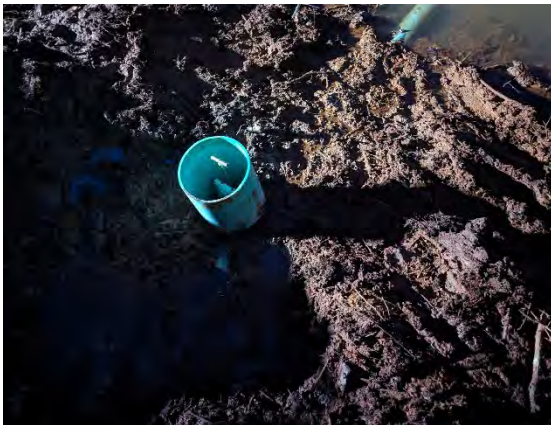
**Bottom Left:** 4" Valterra VFP drain valve was replaced.

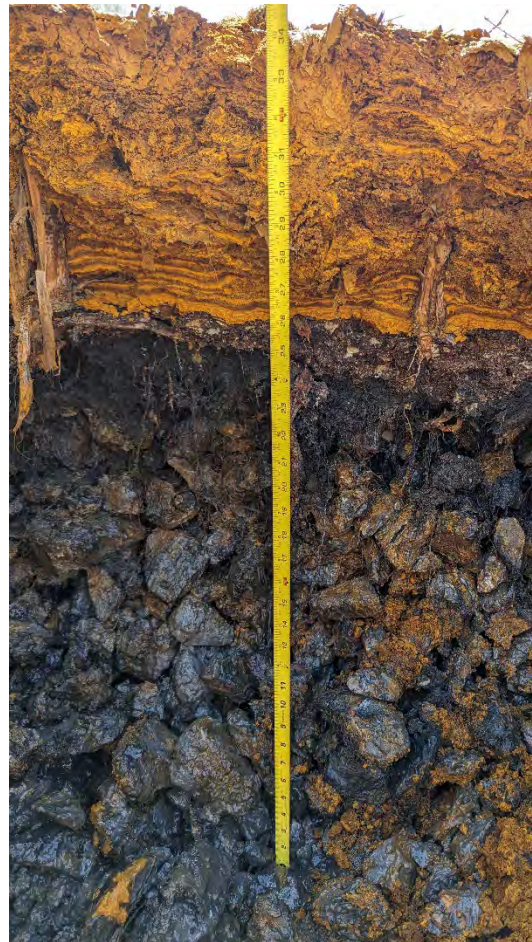
- Test pit excavated within VFP; found good permeability still existed within media and stone was clean for a 25 year old system underneath approximately 13” of iron on media surface.

**Right:** VFP was drained and a test pit excavated. Though about one foot of iron precipitate was found on top of the half-foot compost and three-foot limestone layers, VFP permeability was found to be adequate and cleaning was deemed unwarranted (3/29/24).

- Remaining VFP material left in place to limit disturbance since the component was still functioning as intended with no evidence of the emergency spillway being used.

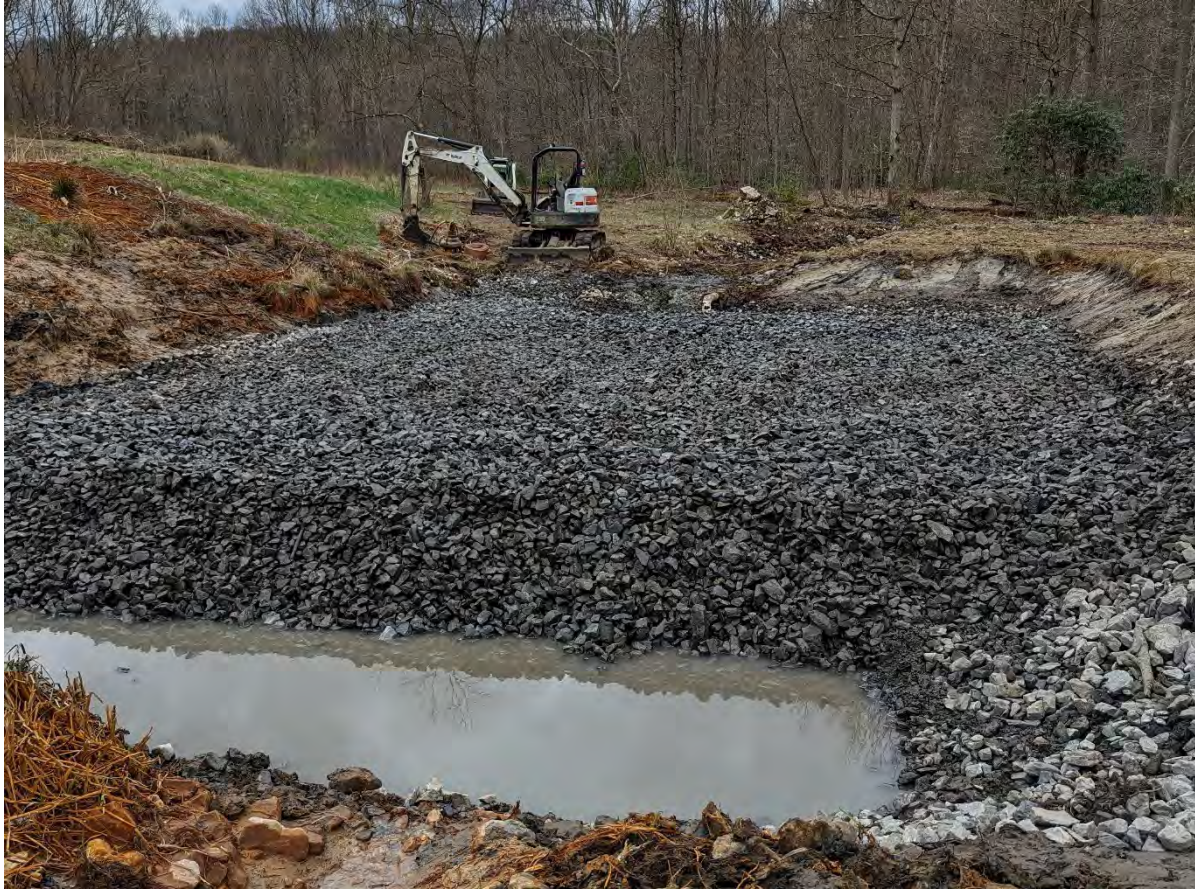
**Top:** HFLB limestone was washed and the outlet pipe reset and extended (4/10/24).  
**Bottom:** SP1 (top left) and VFP (top right) cleared of woody vegetation and beaver dams. The upslope diversion ditch (foreground) was cleared of vegetation and cleaned as needed (4/11/24).

- HFLB outlet channel beaver dam cleared and accumulated vegetation and sediment removed; Beaver deceiver retrofitted and installed onto existing HFLB outlet pipe.

- HFLB limestone media washed and consolidated to the center of the pond to raise the stone height and improve contact with water flowing through the stone.
