BC 16 Passive Treatment System SRI O&M TAG Project #76 Request #1 OSM PTS ID: PA-246

Requesting Organization: Slippery Rock Watershed Coalition Requesting Organization Representative: Cliff Denholm Dates Work Performed On-Site: 2/8/2024-3/7/2024

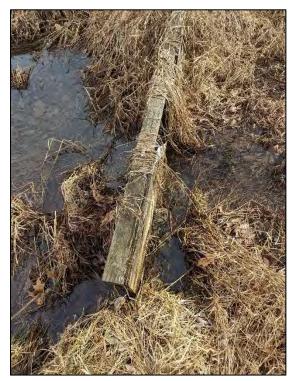
Top Left: Outlet weir was compromised prior to maintenance (2/8/24).

- Removal of vegetation and sediment from surface of HFLB.
- Washed stone within HFLB and pumped sludge to Blacks Creek Maintenance Pond.
- Re-built embankment around the system outlet weir for more accurate flow measurements, armored with stone.
- Repaired embankment of wetland where it was noticed to be breached and overtopping.

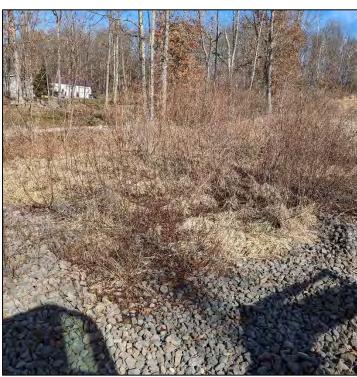
Top Right: A portion of the HFLB was flowing at the surface due to vegetation and sediment prior to maintenance (2/21/24).

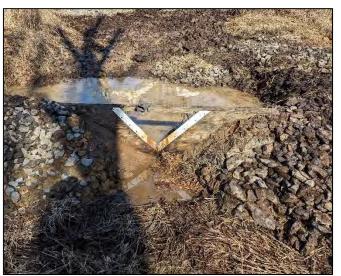
Bottom Left: Outlet weir after improvements and maintenance (2/21/24).

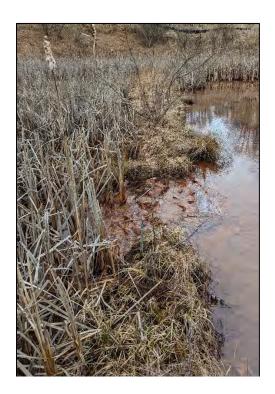
Top Left: Breach in wetland embankment (3/7/24). **Top Right:** Repaired wetland embankment (3/7/24).

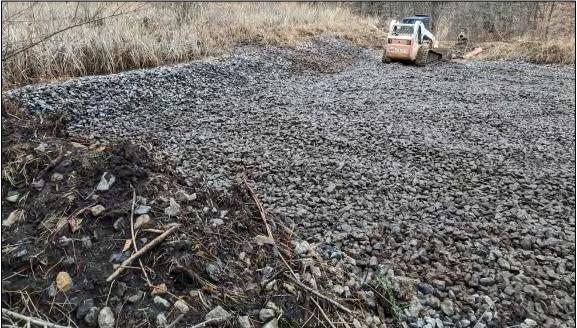
Bottom: Cleaned HFLB limestone (3/7/24).
