**Morgan Run Passive Treatment System**  
**SRI O&M TAG Project #77 Request #1**  
**OSM PTS ID: PA-280**

Dates of work performed: 3/21/2024-5/2/2024

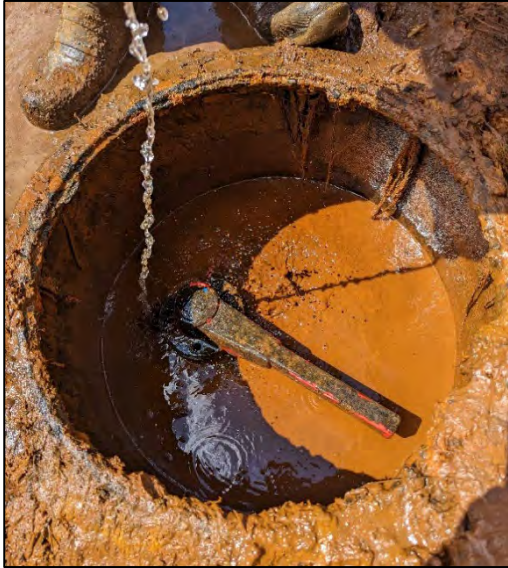
**Top Left:** Morgan Run 1 vertical flow pond flush valves were located and exercised (4/18/24).  
**Top Right:** Morgan Run 1 media within the vertical flow pond was stirred on the surface and sludge pumped to the settling pond (4/19/24).  
**Bottom Left:** Morgan Run 1 flow monitoring pipe installed for additional discharges (5/2/24).  
**Bottom Right:** Morgan Run 1 flow monitoring pipe installed for main discharge (4/19/23).

- MR1 A-2 VFP valves located, and treatment media washed, pumped, and flushed multiple times to reduce clogging due to sediment accumulation.
- MR1 A-2 VFP emergency spillway cleared of vegetation.

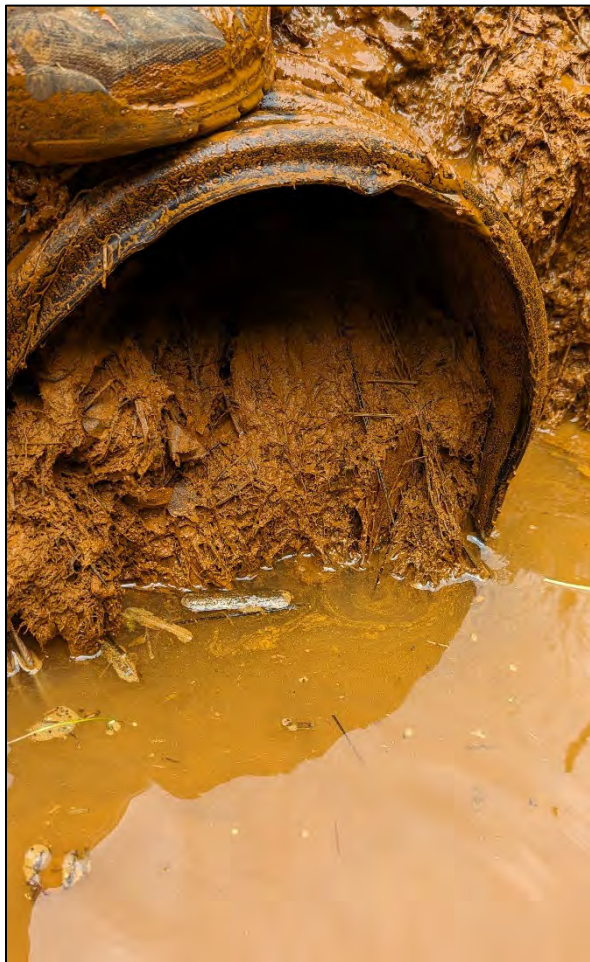
**Top Left:** Morgan Run 2 bypass pipe from Collection ditch to C-1 clogged (5/16/24).  
**Top Right:** Morgan Run 2 bypass pipe from Collection ditch to C-1 was jetted (5/16/24).  
**Bottom:** Morgan Run 2 bypass pipe inlet from Collection ditch to C-1 exposed and jetted (5/16/24).
