Reitz #1 Passive Treatment System
SRI O&M TAG Project #9 Request #3
OSM PTS ID: PA-13

Requesting Organization: Shade Creek Watershed Association (SCWA)

Dates of work performed: 11/1/2023- 11/10/2023

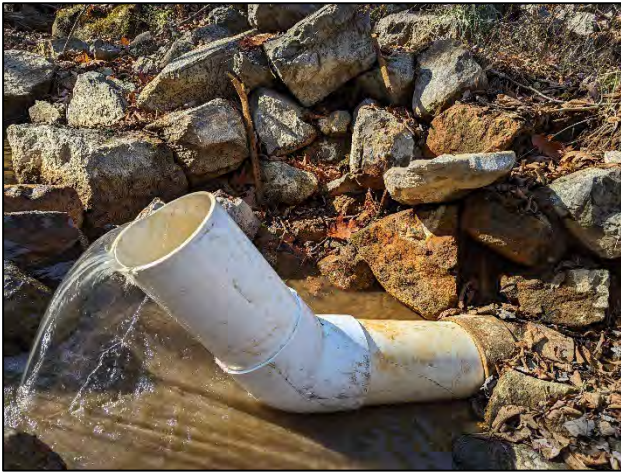
Top Left: 45° elbow was installed with a stub of pipe to measure flow at the bioreactor outlet (11/3/23).
Top Right: Media within the bioreactor was observed to contain shredded wood and logs (11/3/23).
Bottom Left: Pumping to existing geotube from settling ponds (11/8/2023).
Bottom Right: Limestone beds re-established between settling ponds after washing (11/8/23).

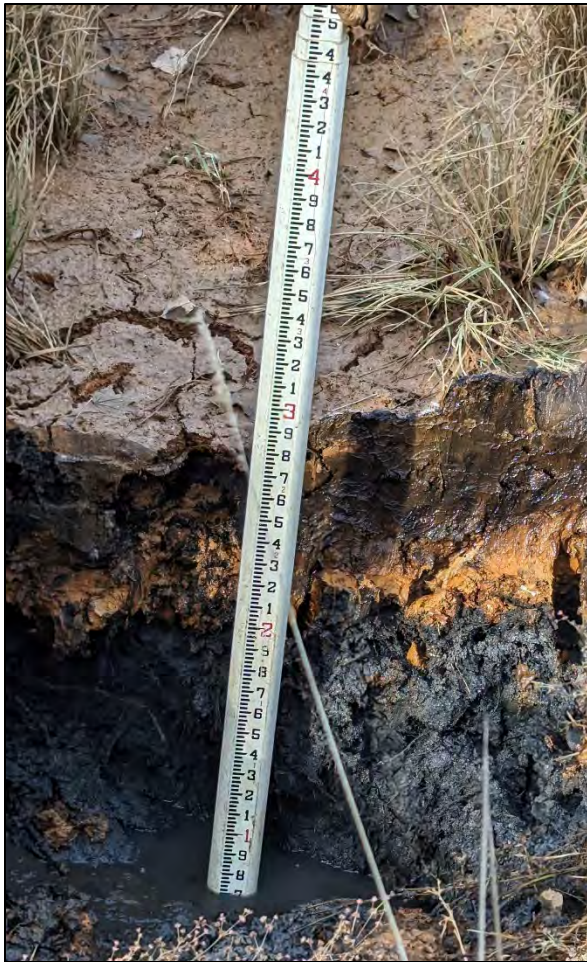
Top Left: Test pit in bioreactor shows approximately 0.7 feet of material on top of the media (11/8/23).
Top Right: Test pit in VFP showing significant accumulation of metals within and above media (11/8/23).
Bottom: Newly installed secondary VFP outlet riser (11/8/23).
