Oven Run B

Township/City: Shade Township

County: Somerset

The Oven Run B passive treatment system was constructed by the PA Department of Environmental Protection in 1999 to treat mine drainage emanating from three sealed deep mine entries. The system was designed by Gwin, Dobson and Foreman, Inc., with modifications by BAMR. The treatment system consists of a collection pond → SAPS → Settling Pond → SAPS → Settling Pond. According to a Passive Treatment System Evaluation report prepared by the PA DEP in May of 2008, the system was designed based on an average flow of 350 gpm, but capable of handling a maximum flow of 1,100 gpm. In October 2001, a flow distribution pipe was installed on top of SAP1. In October 2001, iron sludge and compost was removed from SAP1 and SAP2 and new compost was added.

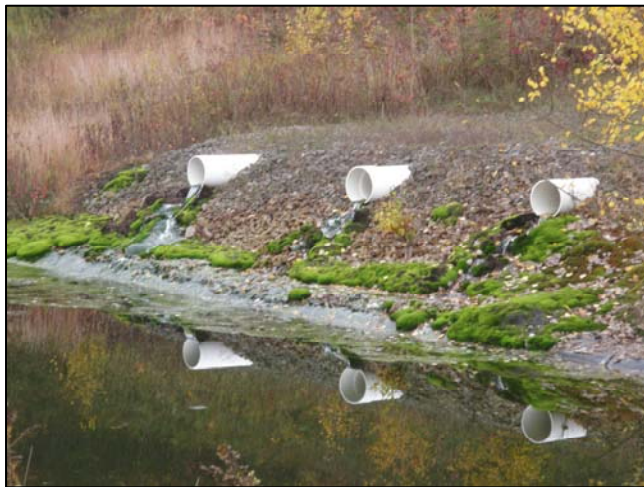
At the Oven Run B system, AMD enters through three sealed deep mine entries (Top Left) which flows into a collection pond (Top Right). It may be possible to convert a portion of the collection pond into an OPC for low pH iron removal, which might be able to be extended along the eastern side of SAP1 (Bottom Left), but the length and width would likely be limited by a rock outcropping (Bottom Right).

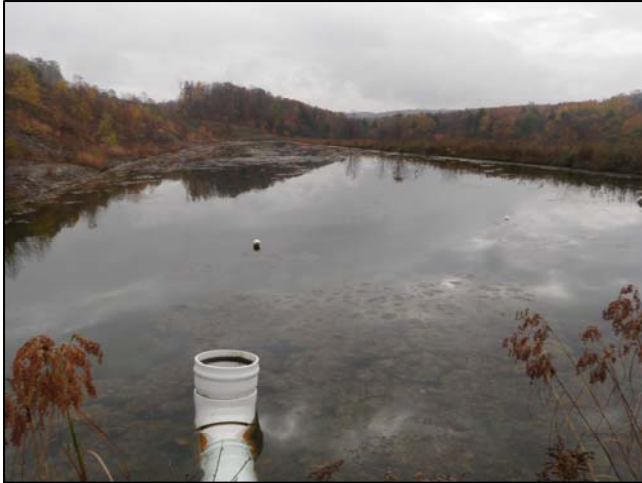
SAP1 (Top Left) is a huge pond which is susceptible to short-circuiting, especially along cleanouts that extend through the treatment media. The permeability of the media is now so low (likely due to low pH iron) that the water discharges to Pond 2 through the emergency spillway instead of the outlet (Top Right). A dye test of SAP2 was attempted (Center Left) but not conclusive; however, it indicated that the water appeared to flow along western side (Center Right) where the flush header was located. Final effluent of the system is currently discharging mainly over the emergency spillway with some flow through the pipe, indicating the outlet pipe is partially plugged or valve is broken.

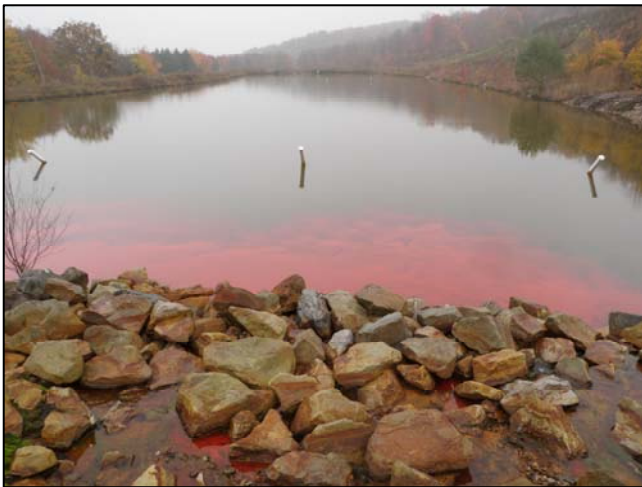
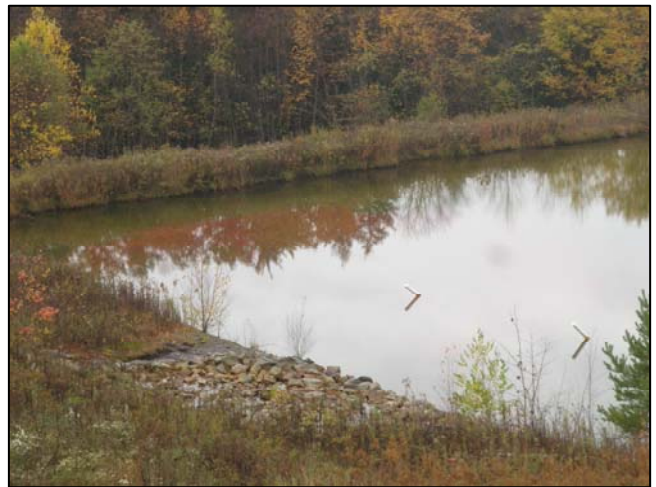
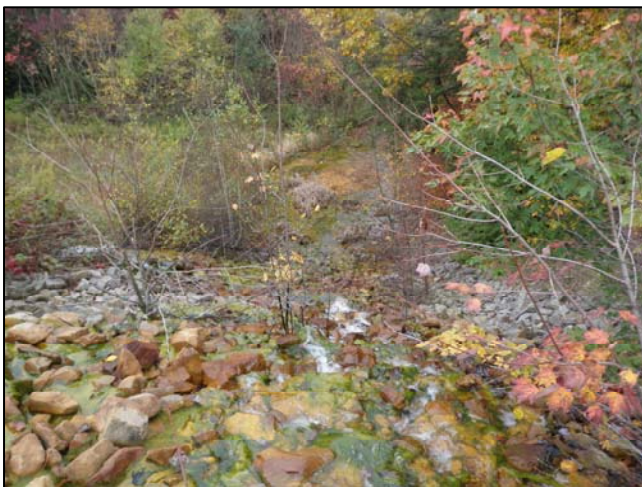
An initial short-lived dye test of SAP2 was conducted to see if short-circuiting could be easily observed. Due to time constraints and the size of the pond, the dye test could only be observed for a short period of time. During the approximately 1.5 hours, no dye was observed in the effluent pipe. Observations of the dye plume on the surface of the pond indicated that the flow was moving towards the western 1/2 of the pond and not flowing through the eastern 1/2 of the pond. This may be due to the location of the flushing pipe, which is also located on the same side of the pond. In addition, water from the final settling pond (Pond 3) was flowing out of both the emergency spillway and the effluent pipe indicating that the pipe may be partially plugged with low pH iron and/or debris or the valve is broken.
