CAMBRIA AMD TASK FORCE  
PASSIVE TREATMENT  
SYSTEM EVALUATION

AMD 56(2524)102.1

OVEN RUN SITE "B"

KOONTZTOWN  
AMD 56(2524)102.1  
OVEN RUN SITE “B”  
MARCH 17, 2008

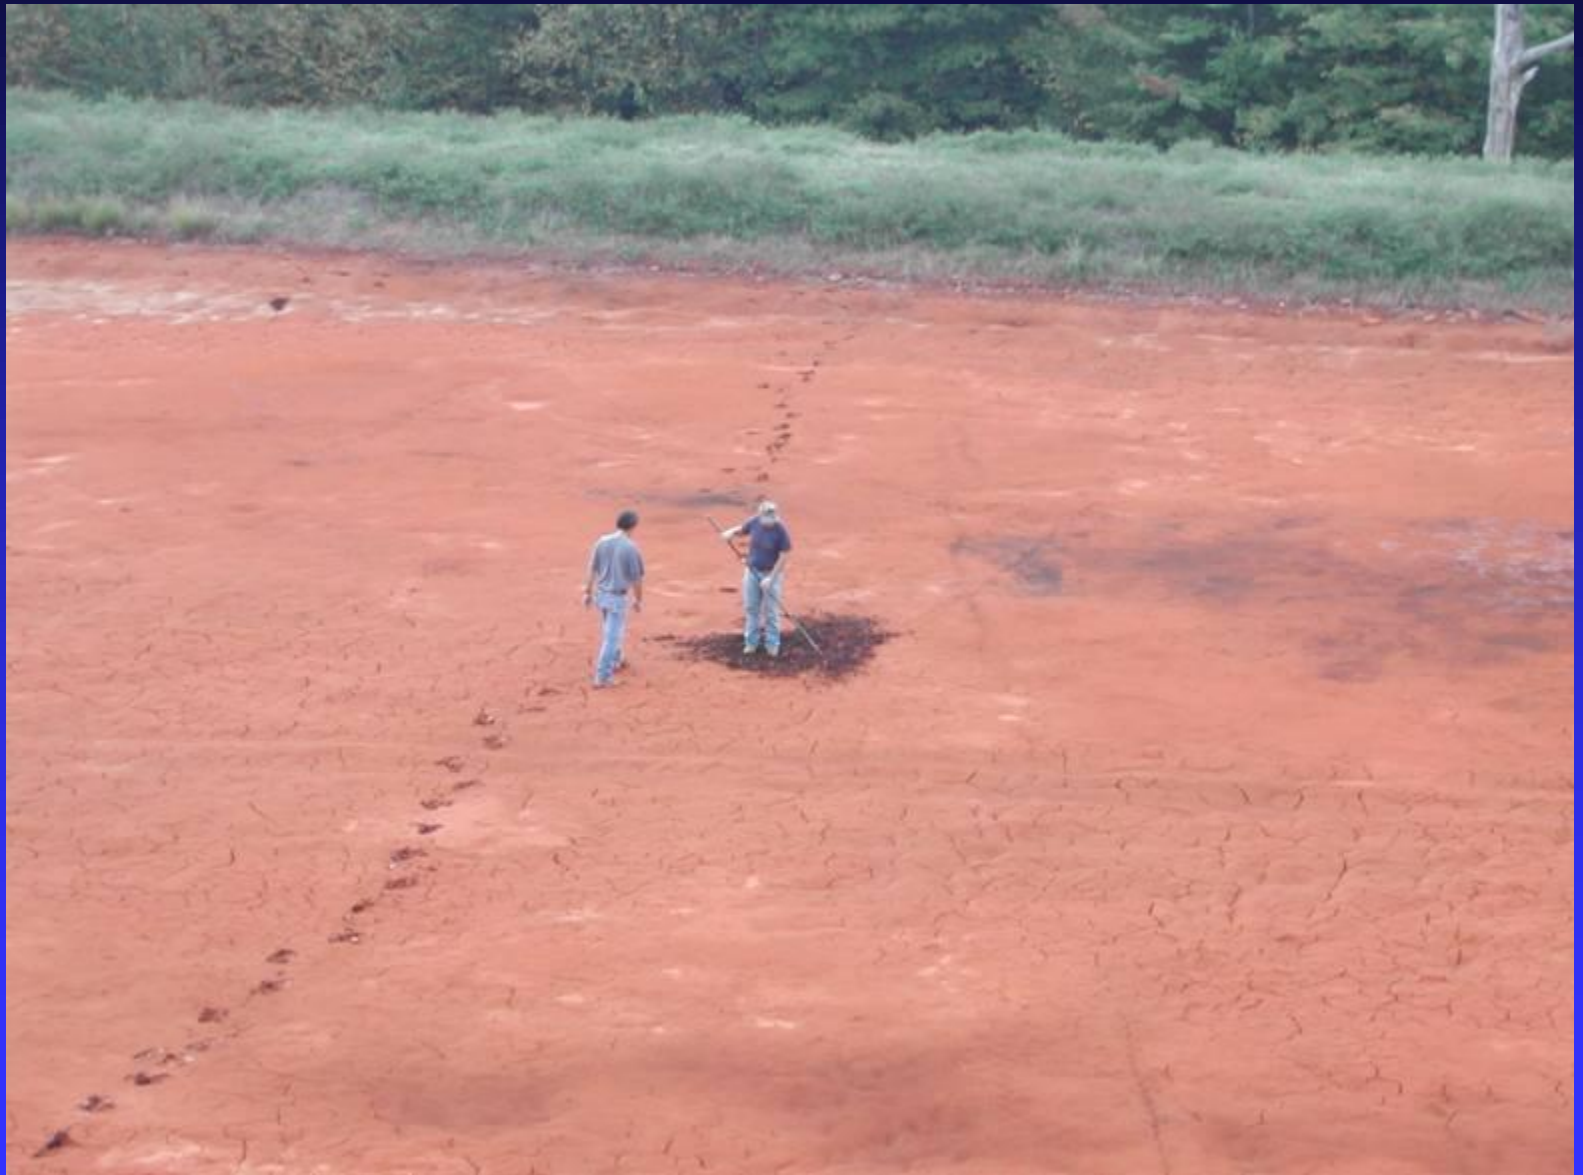
## 2001 - IRON CRUST ON TOP OF SAP #2 COMPOST LAYER

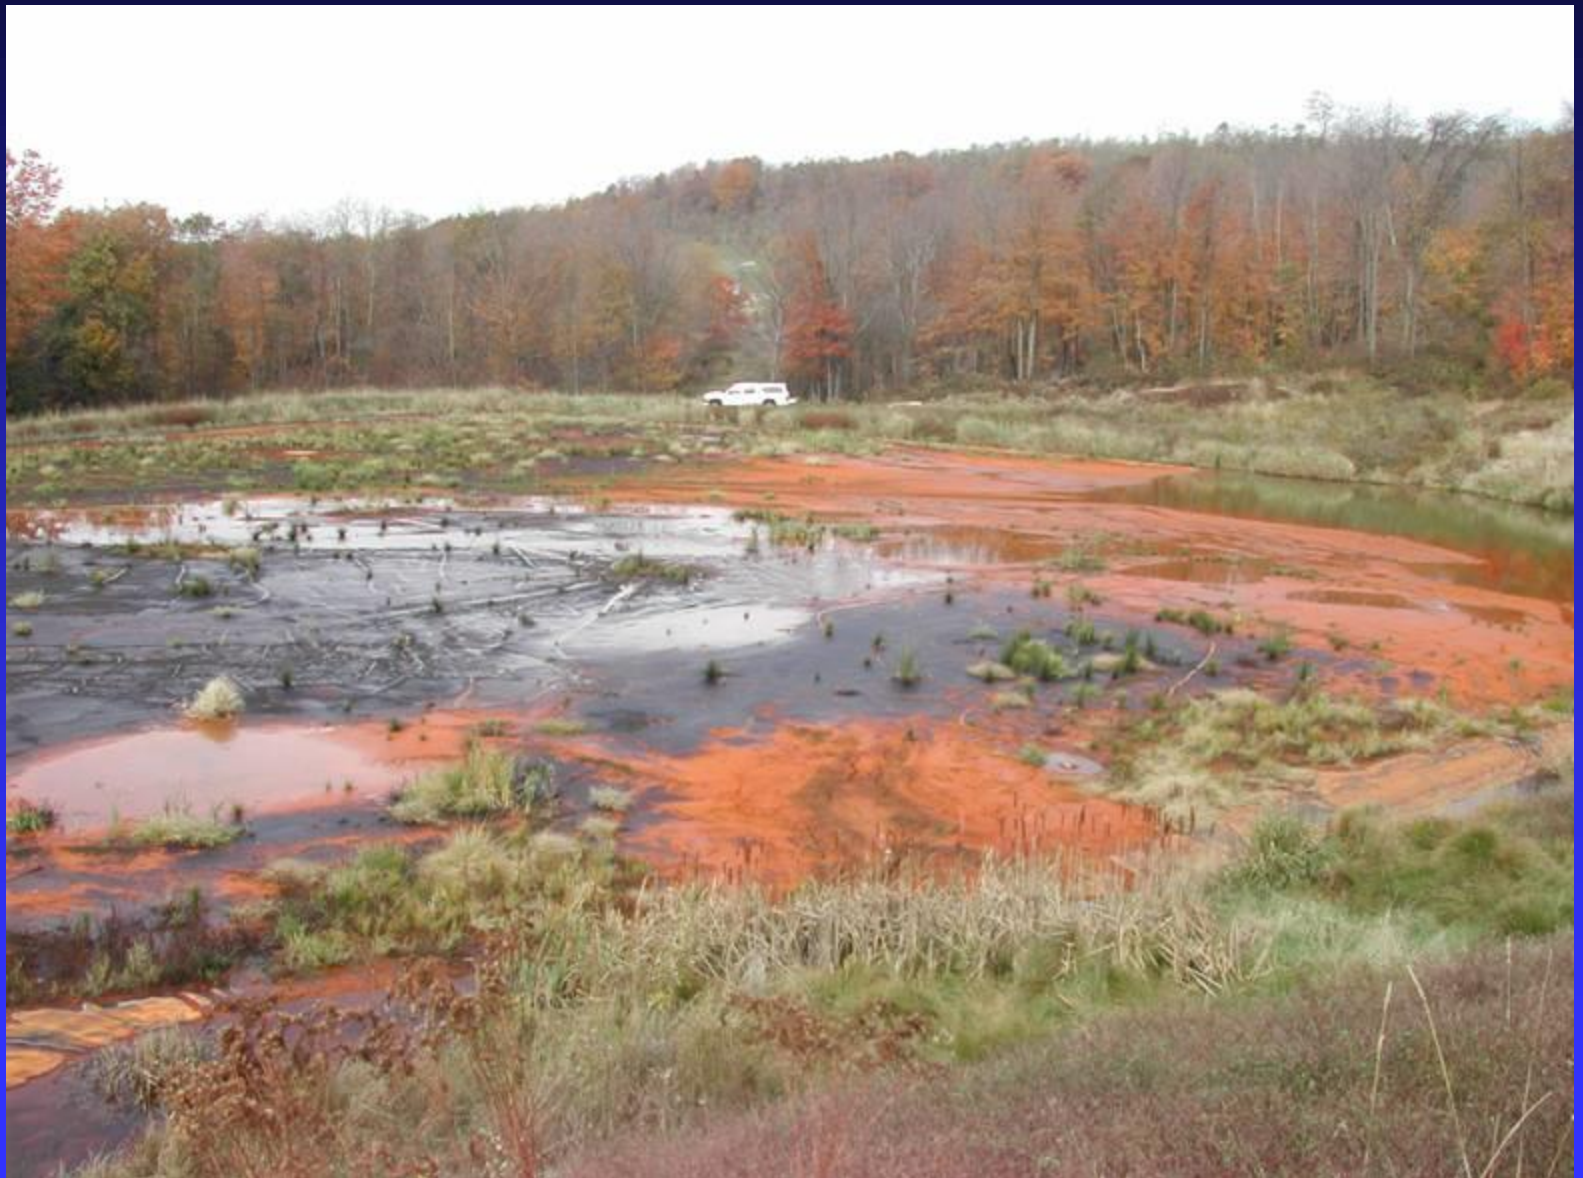
## 2006 - FLOATING LINER ON POND #3

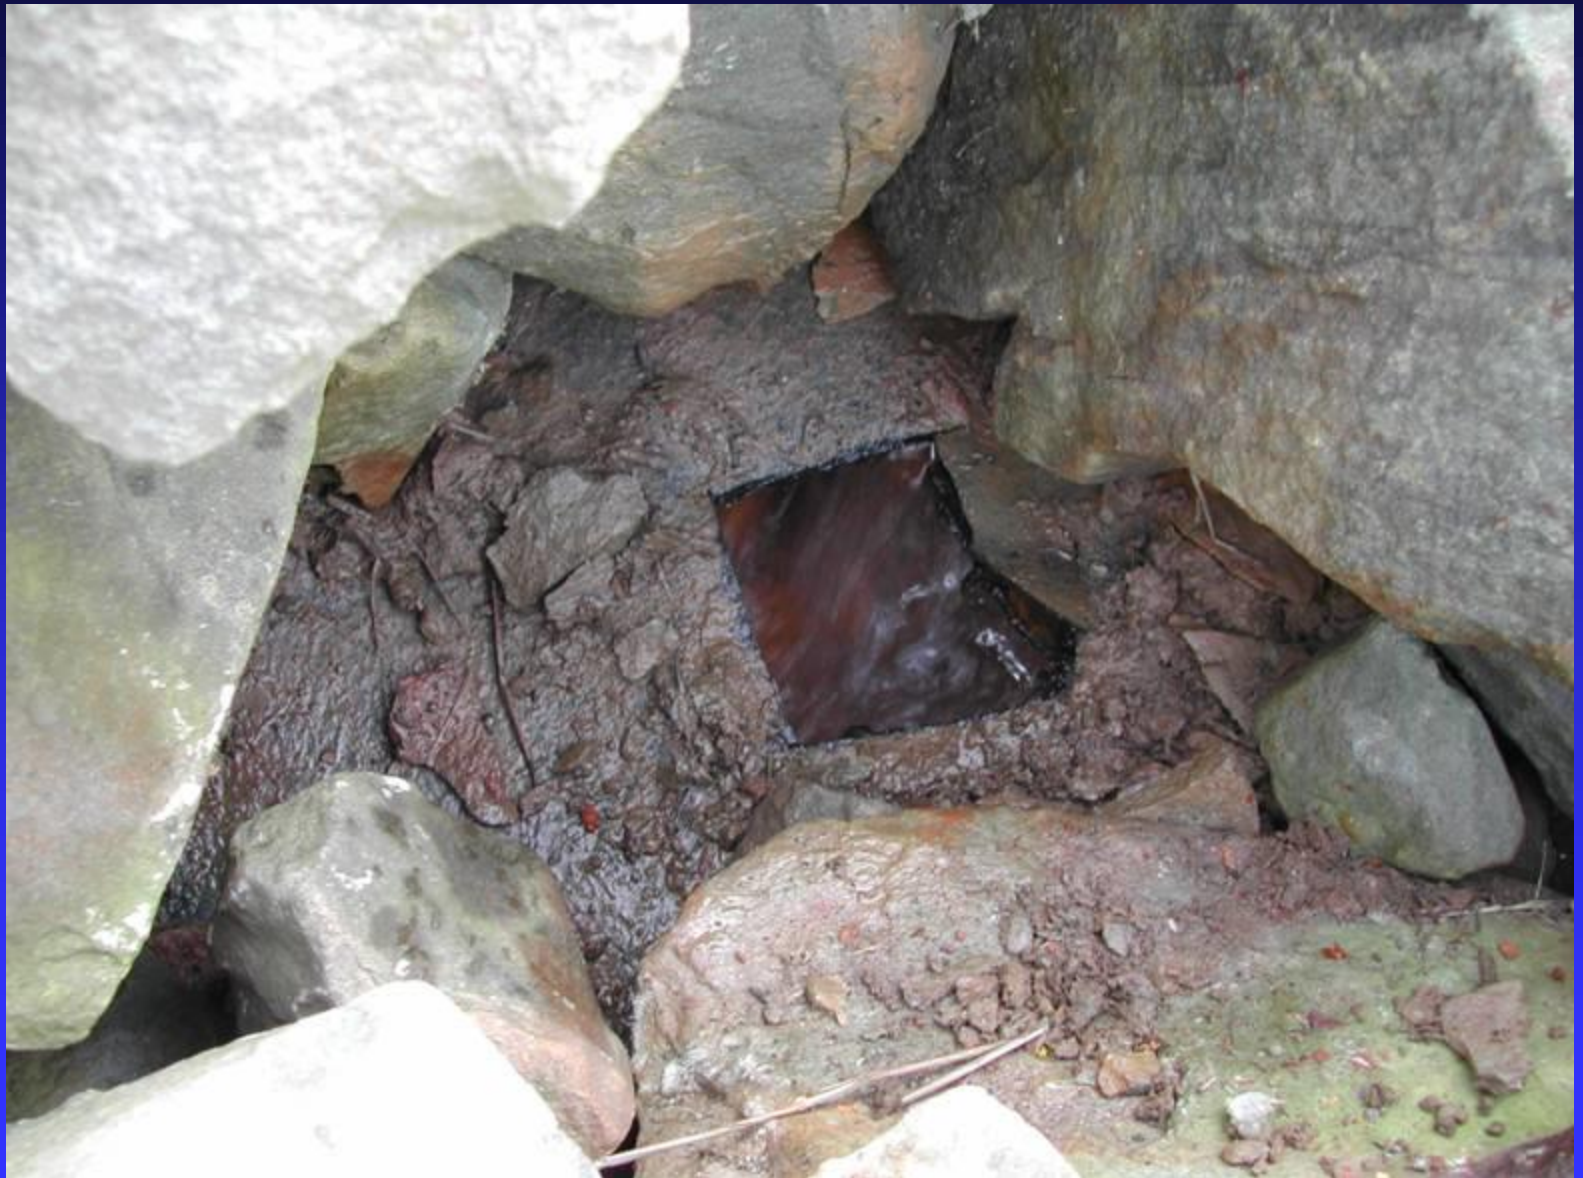
## 2006 - WATER RUNNING UNDER LINER ON POND #3

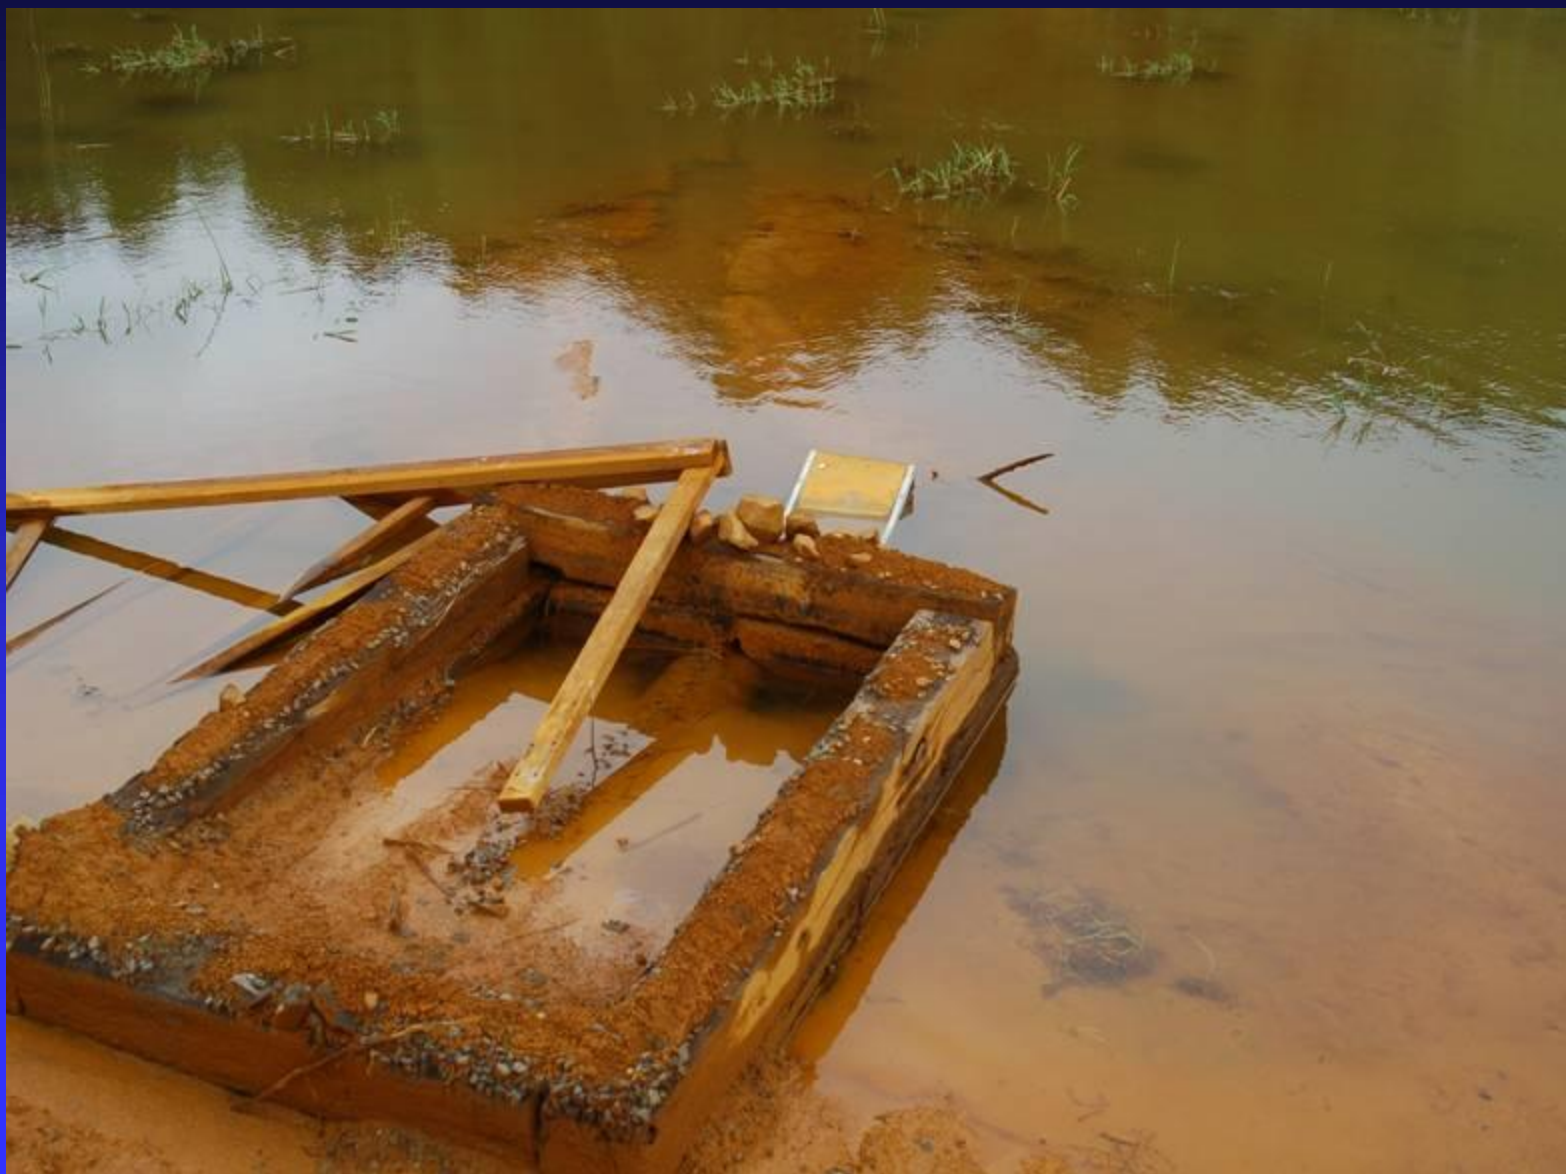
## 2007 - BROKEN FLOW CONTROL STRUCTURE ON POND #3

- Dewater Pond #3 and replace the broken butterfly dewatering valve with a PVC **GATE** valve
- Build up the height of the access ramp to the flow control structure on Pond #3 approximately two feet

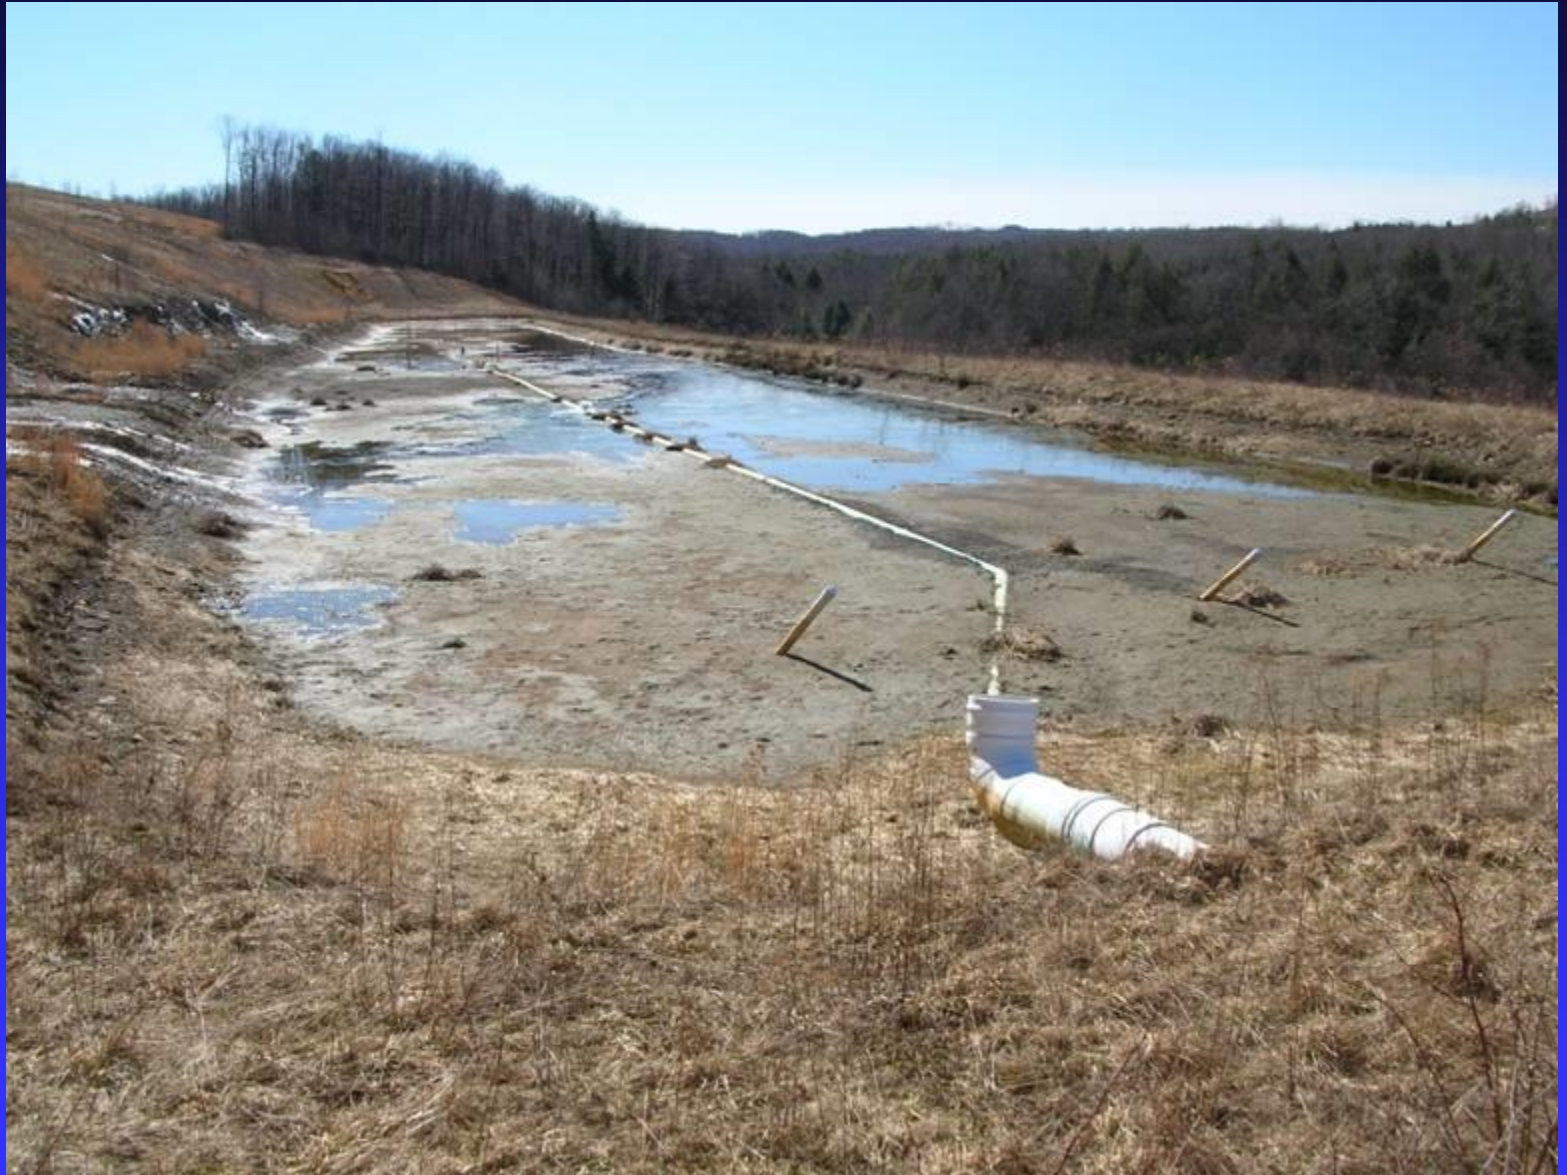
- Full flow from the Collection Basin is directed to the treatment system
- Water level in SAP #1 is very low; exposing much of the compost layer to the atmosphere

**FLOW DISTRIBUTION PIPE IN SAP #1;  
COMPOST LAYER EXPOSED TO THE ATMOSPHERE**

- Fluff the compost layer of SAP #1 and SAP #2 and replace compost in any areas as needed
- Using the survey results, adjust the stop log elevations in the flow control boxes on the Collection Basin to prevent overloading the treatment system beyond the designed flow rate of 350 GPM – emergency spillway should be three inches (3”) above the primary discharge

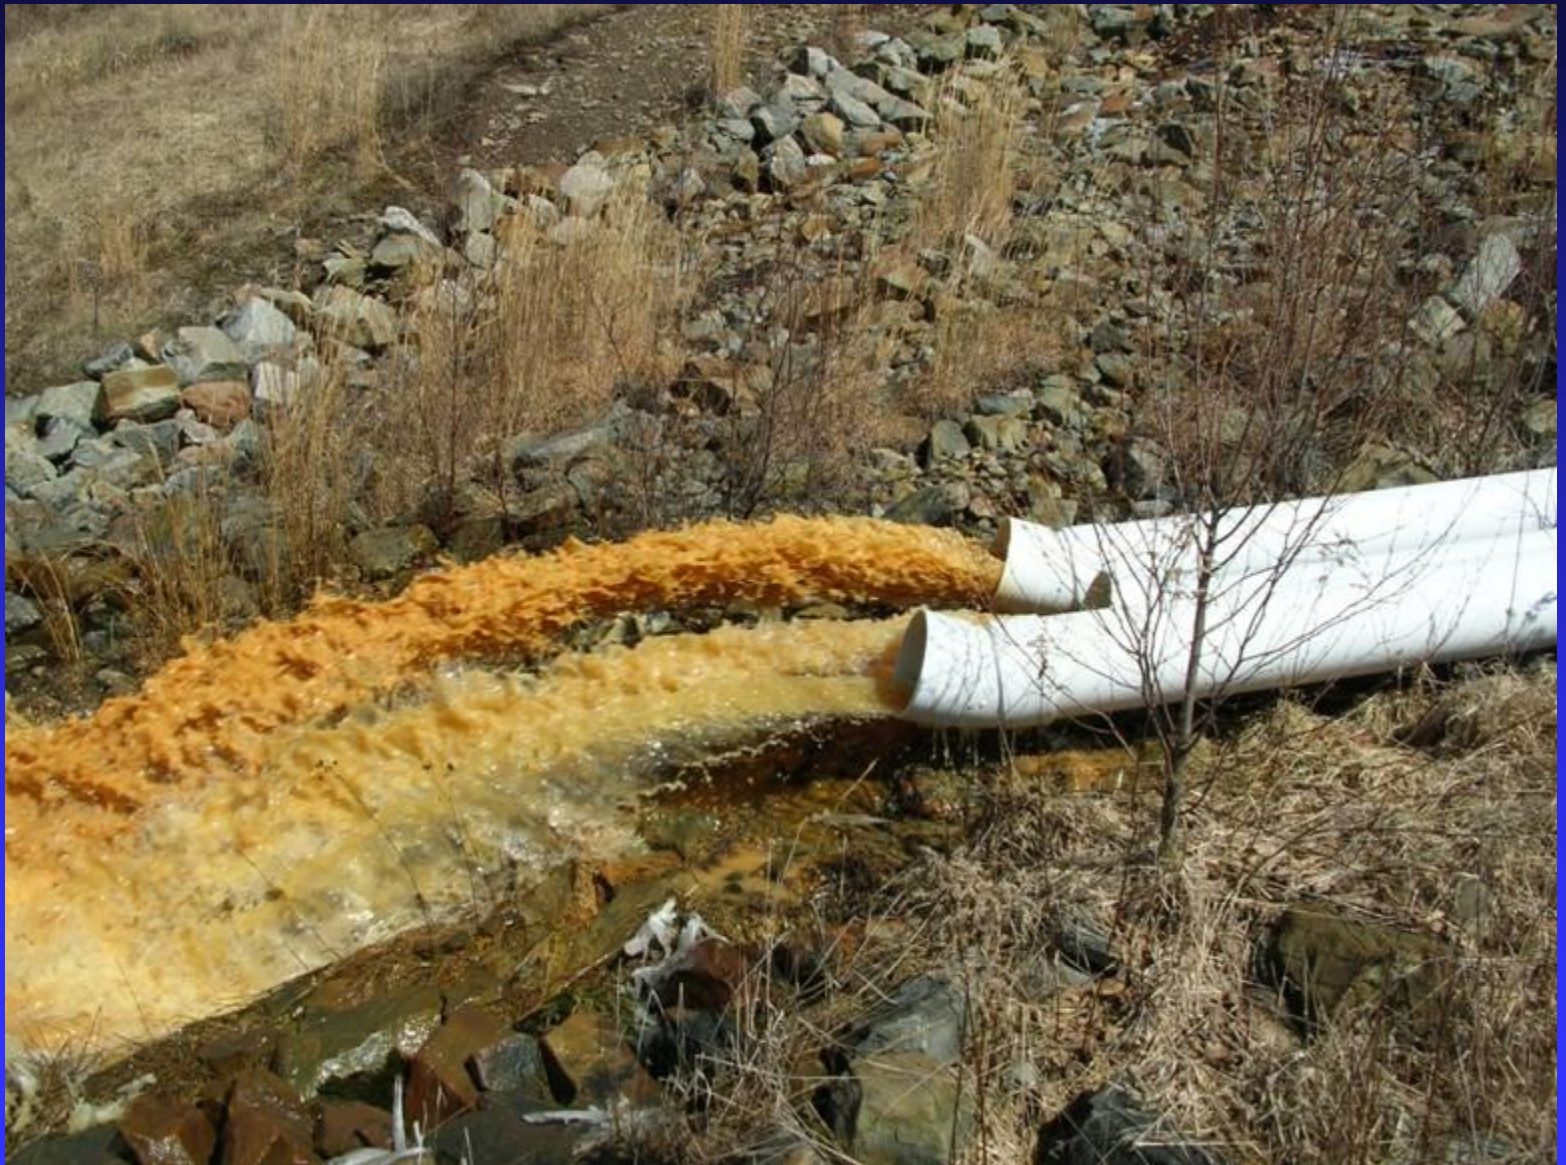
- Flushing discharge rate on flush pipe #3 appears slower than #1 and #2
- Flushing discharge rate on flush pipe #4 and # 5 appears fine; but broken cleanout on back end of SAP #2 allows short circuiting

## DISCHARGE FROM FLUSH PIPE #3 APPEARS SLOWER

- Divert the system inflow to the emergency spillway of Pond #1 and treat the discharge with caustic soda or soda ash briquettes
- Dewater the SAPS and power clean all of the flush pipes

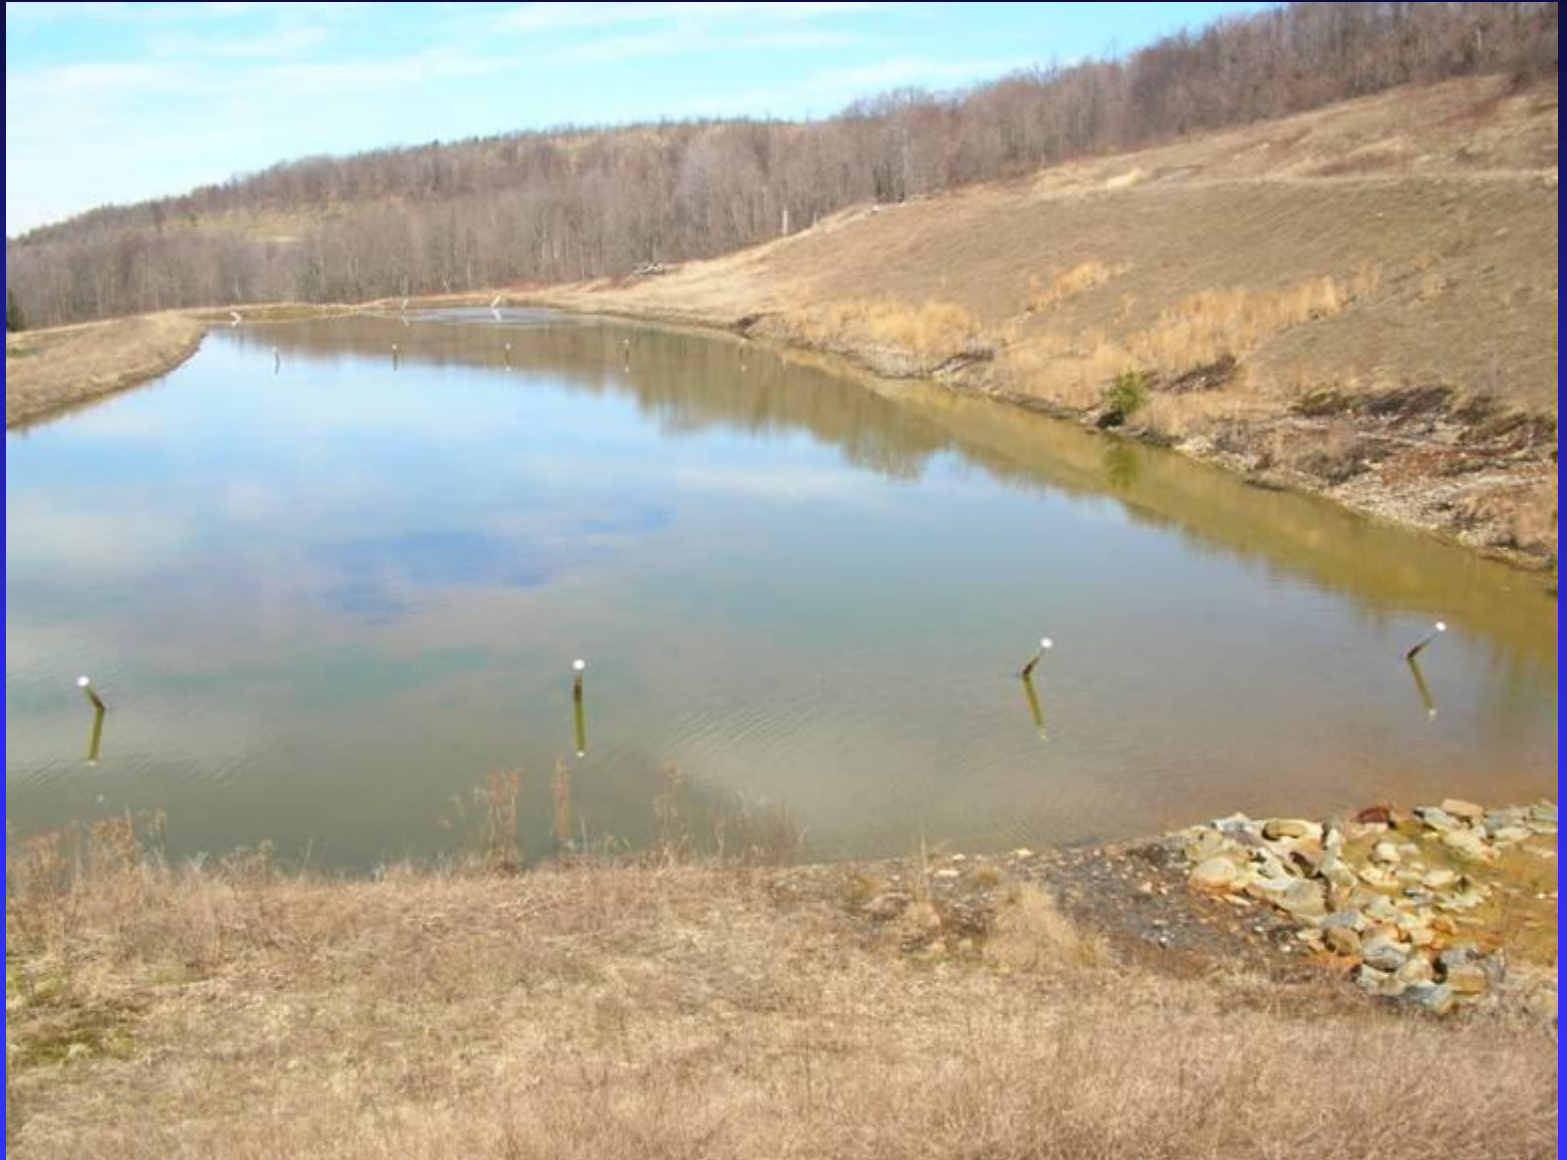
- Access ramp to level control structure on Pond #3 is under water
- Cleanout pipes are located in the ponds instead of along the sides

## CLEANOUT PIPES IN MIDDLE OF SAP #2

- Power clean all of the other SAPS pipes via the exposed cleanouts
- Cut off all cleanouts just below the compost layer and install adapters and reinstall the existing screw caps – fix broken cleanout at back of SAP #2

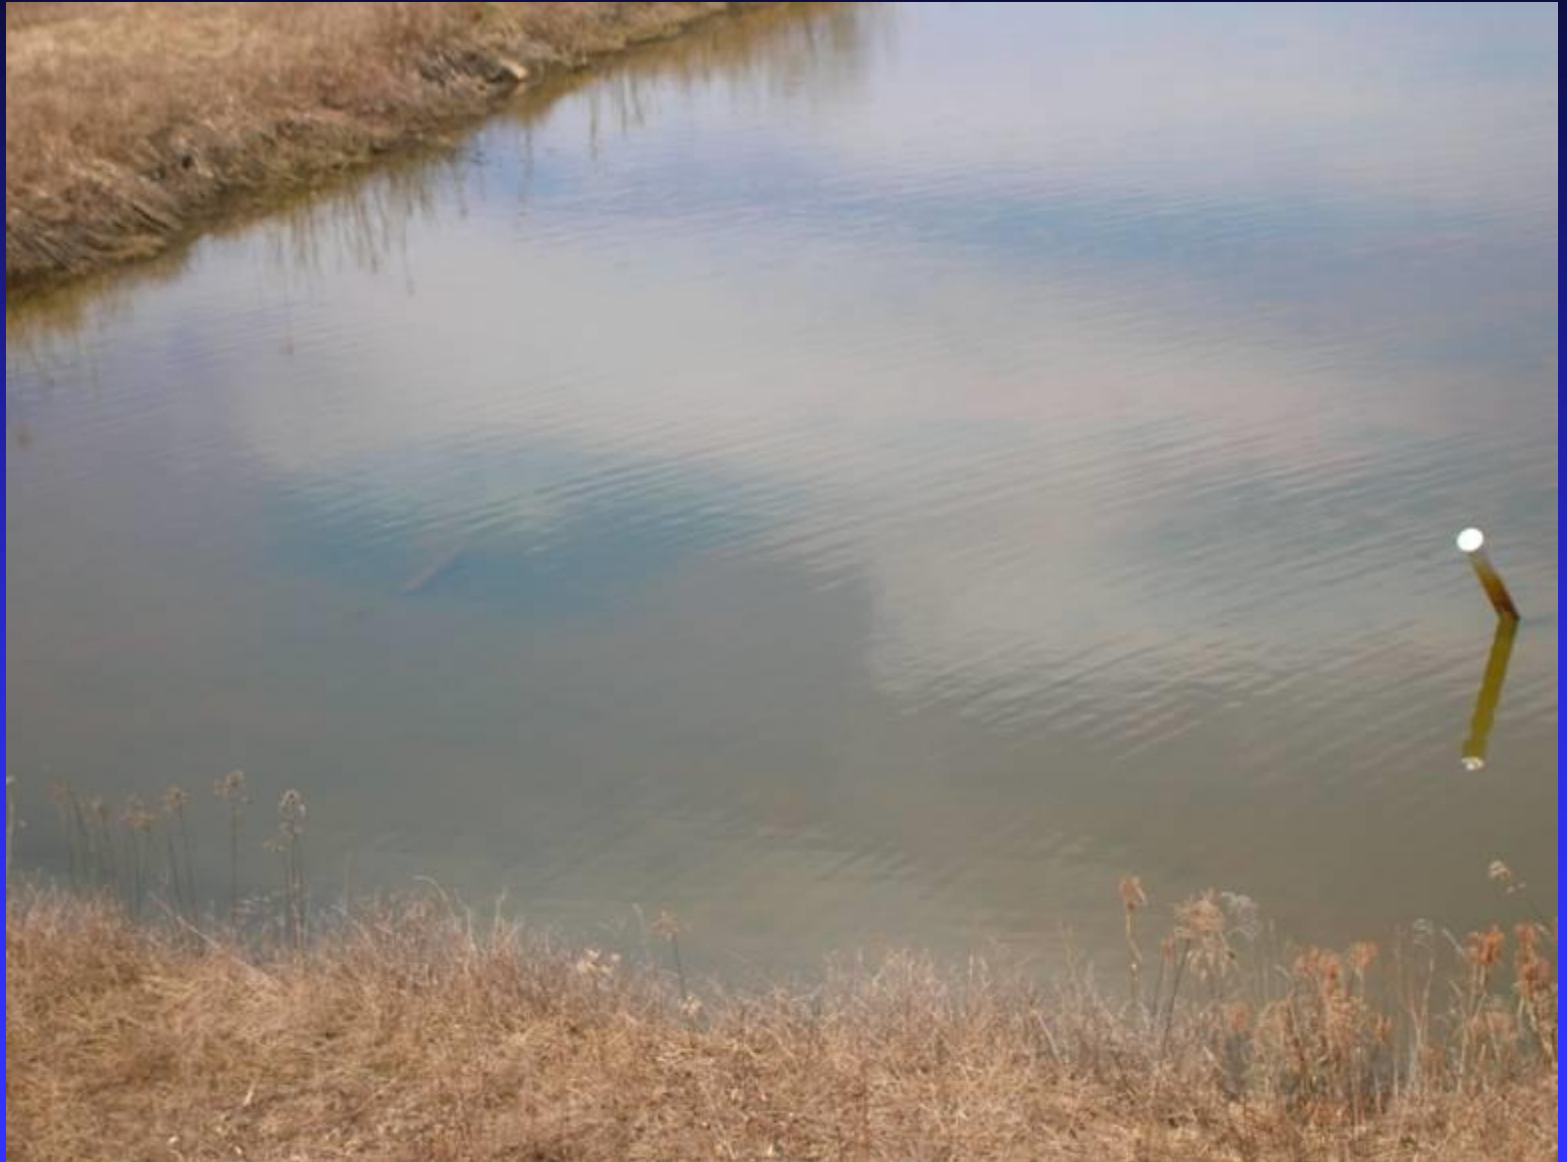
- Broken cleanout on back end of SAP #2 allows short circuiting
- Dewatering valve on Pond #3 not functioning; thereby decreasing settling time for suspended solids in the flush water

**BROKEN CLEANOUT AT BACK END OF SAP #2  
LYING ON THE BOTTOM OF THE SAP**

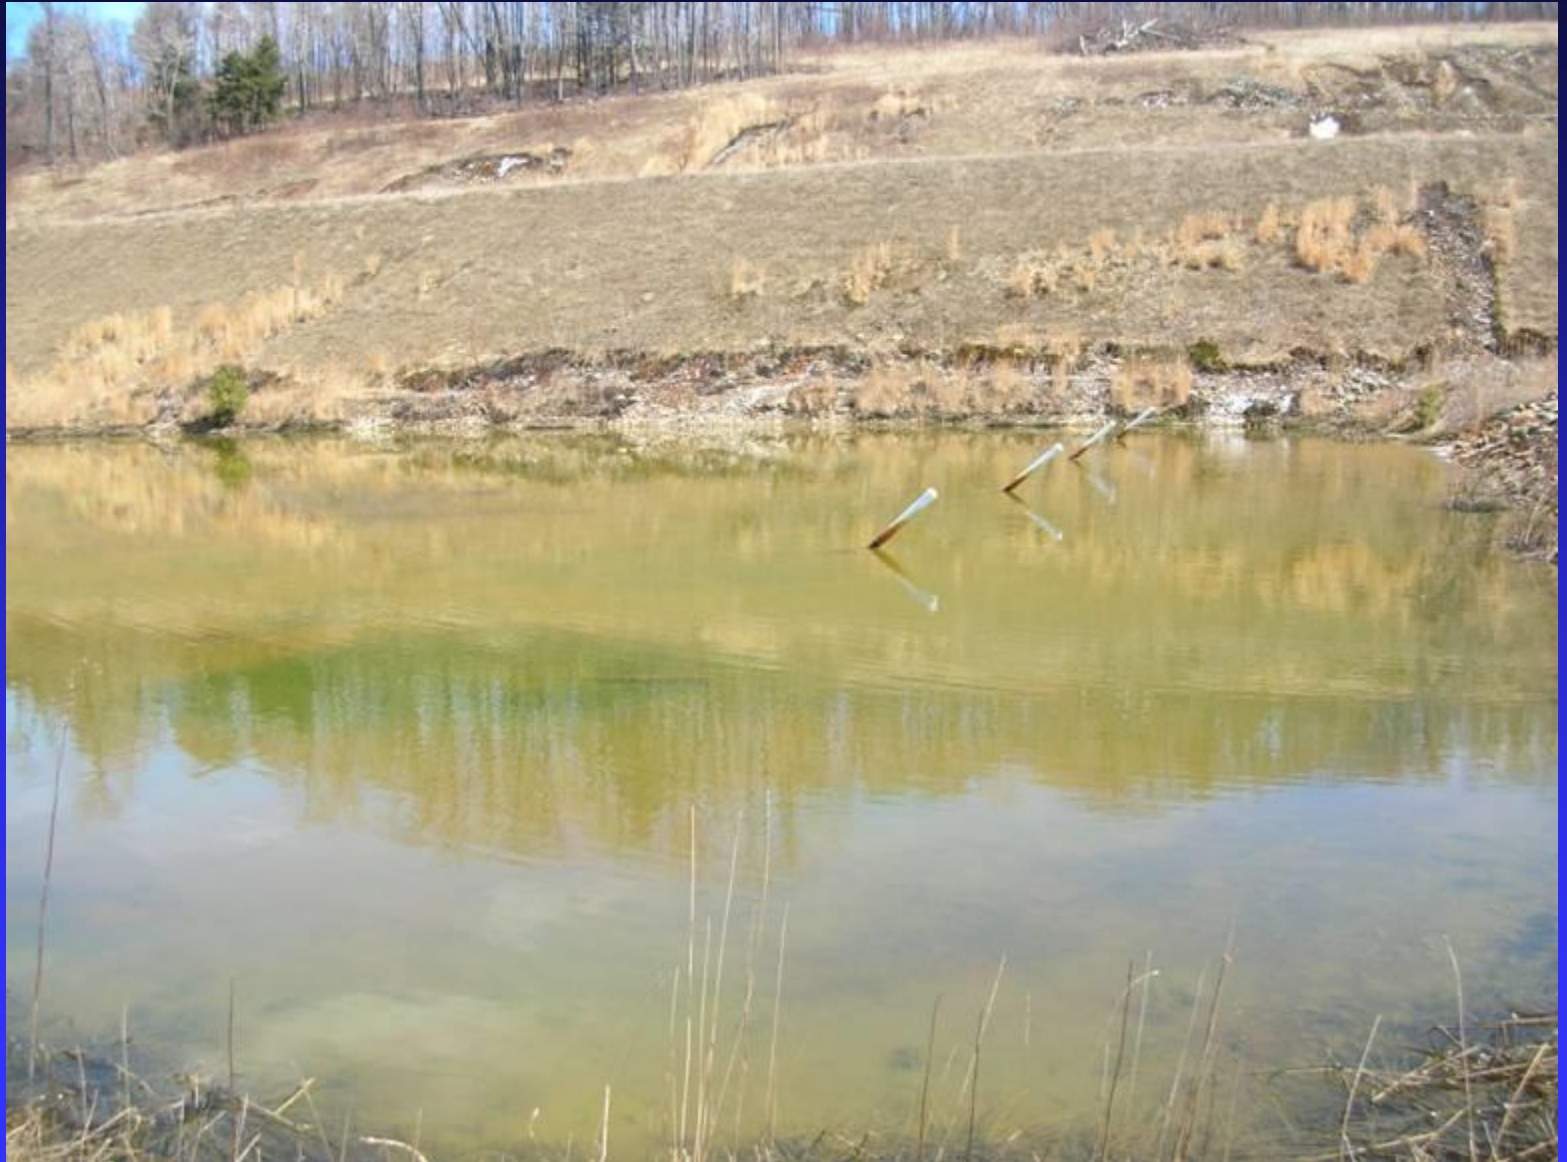
- Possible AMD flow paths on surface of SAP #1 causing short circuiting
- Seep through lower embankment of SAP #1
- Apparent preferential flow paths through compost layer over top of perforated piping system particularly at cleanout locations

**SEEP ON EMBANKMENT OF SAP #1;  
BROKEN CLEANOUT IN FOREGROUND**

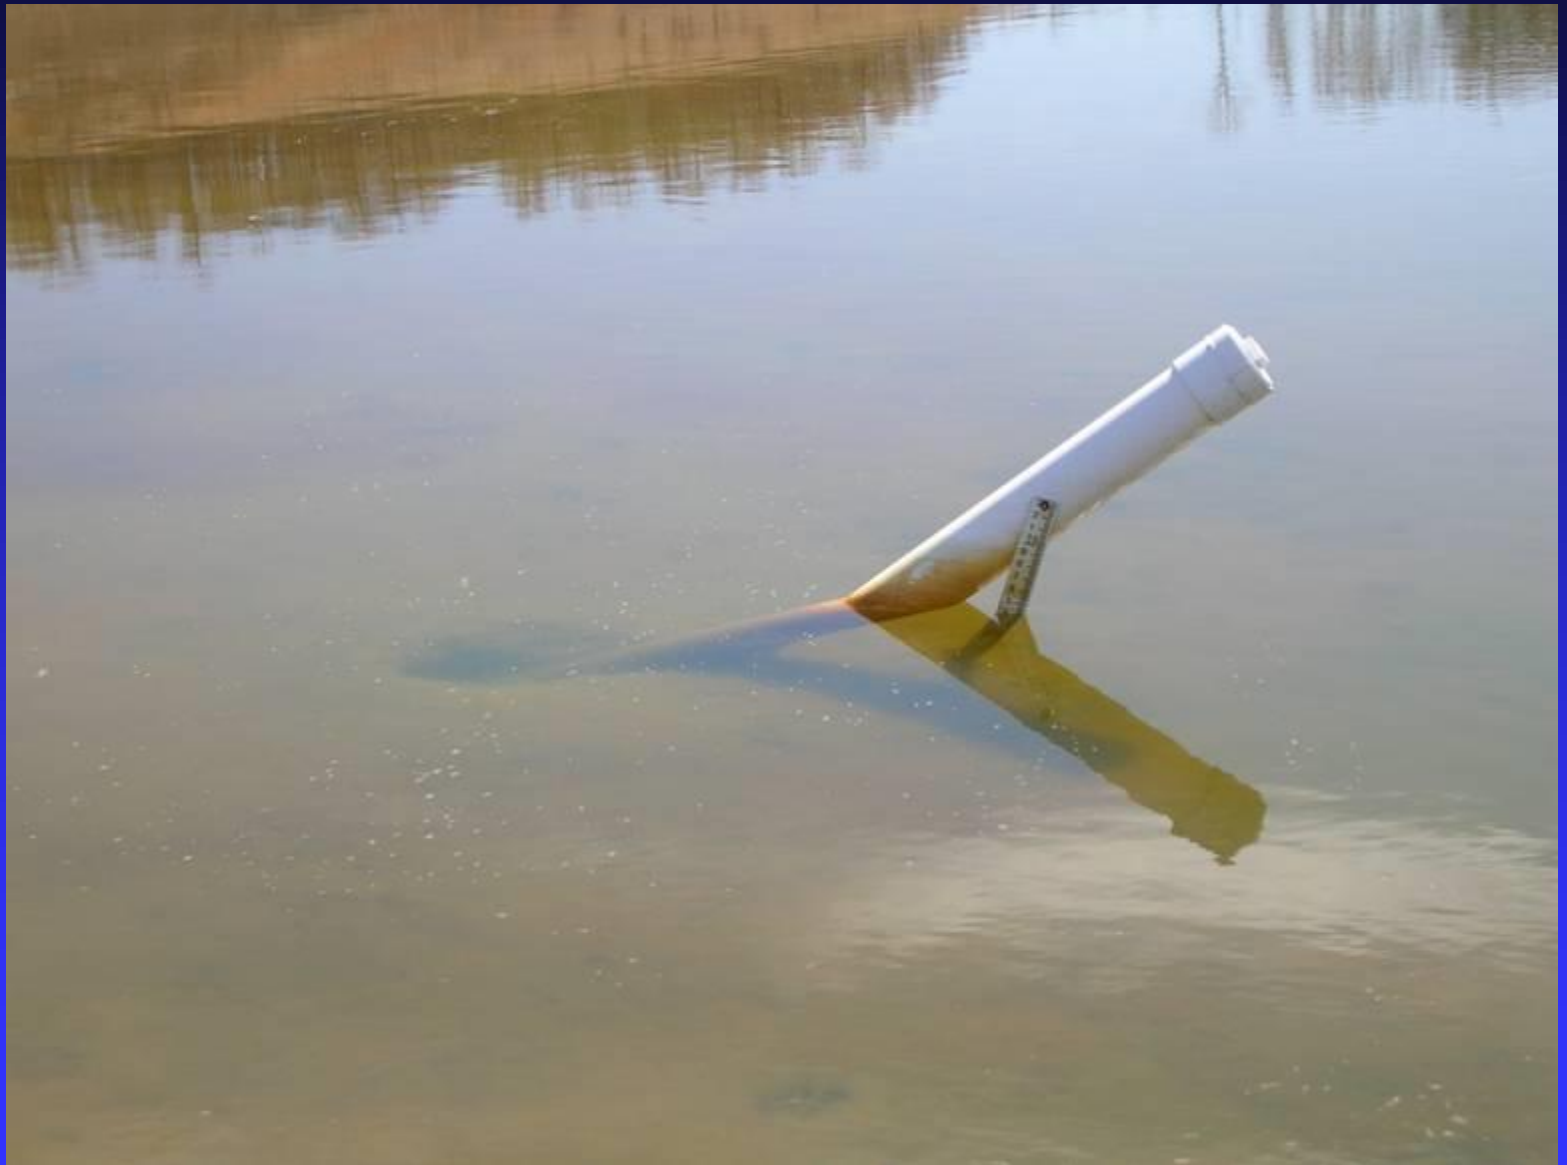
# WATER PREFERENTIAL FLOW PATH THROUGH COMPOST LAYER AT CLEANOUT

- Separate the SAP discharge header pipes from the perforated flushing pipes (by cutting and capping all of the 6” perforated pipes) to conform with current design practices for SAP systems to reduce preferential flow paths
