Maiden Mine Passive Treatment System SRI O&M TAG Project #41 Request #1 OSM PTS ID: PA-279

<u>Requesting Organization:</u> Stream Restoration Inc. <u>Municipality/County:</u> Dunkard Township, Greene County <u>Dates of O&M Work Performed:</u> 8/23/16 – 10/27/16 and 9/5/17 -9/8/17 <u>BioMost O&M Construction Personnel:</u> Tim Danehy, Dan Guy, Julie Labar, Ryan Mahony, and Cal Spigler

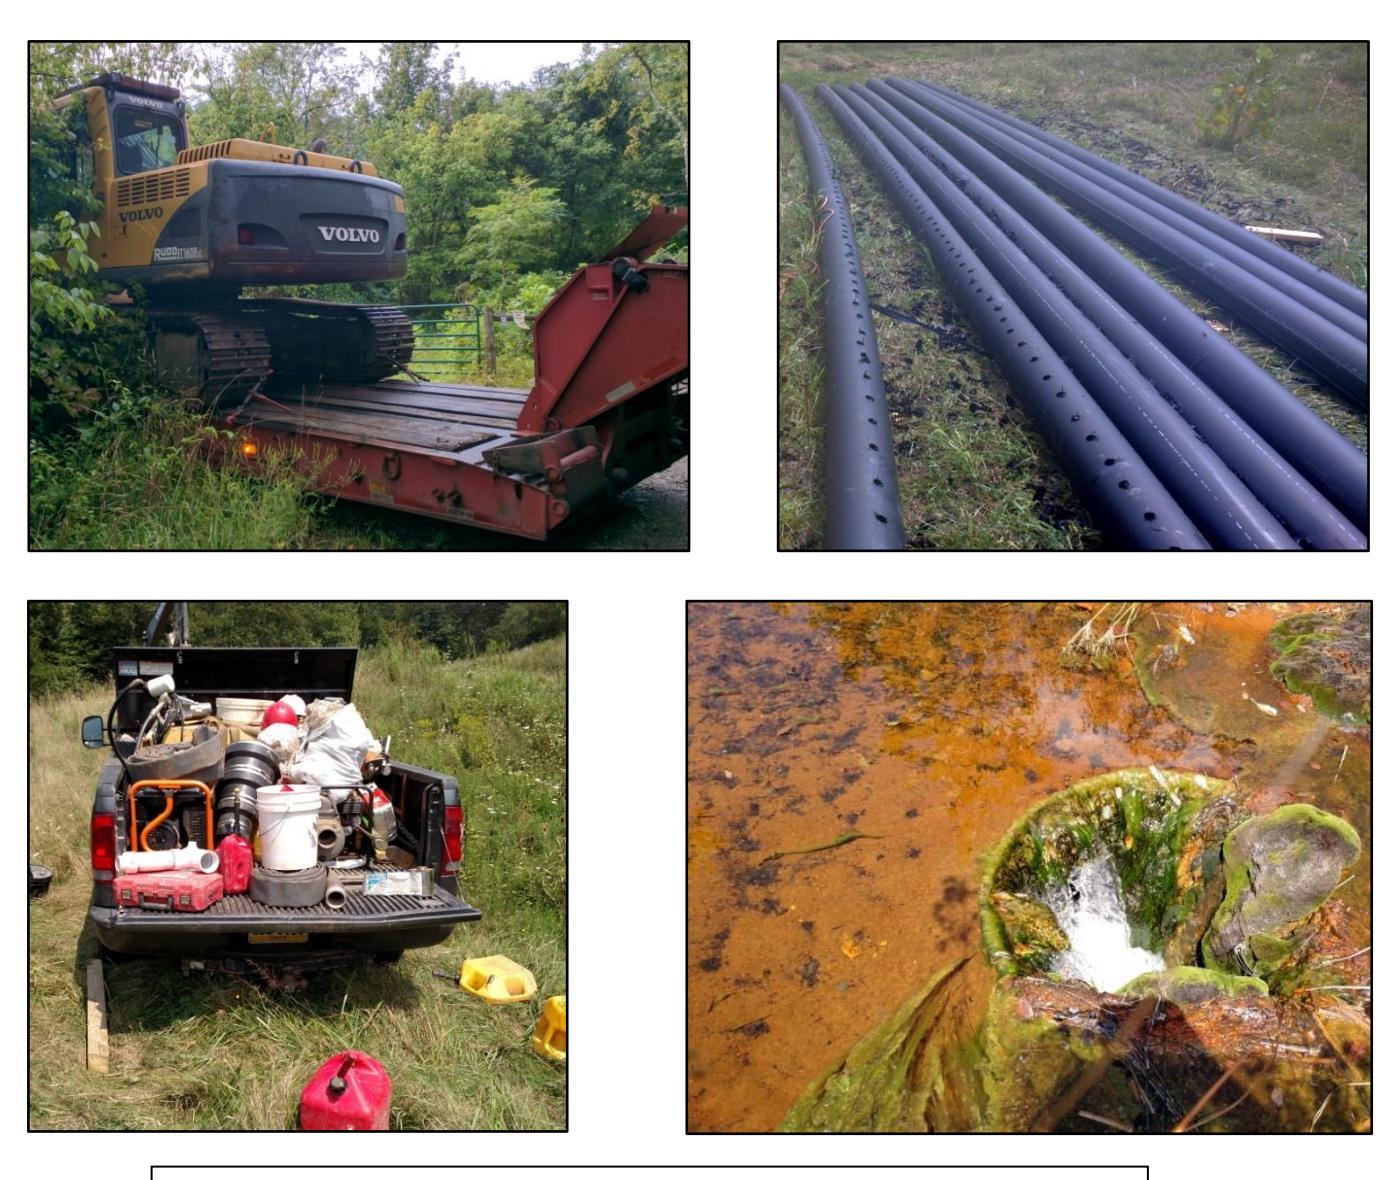
Top Left: Excavator delivered to the site.
Top Right: 600' of 8" Perforated DR-17 HDPE replacement underdrain pipes.
Bottom Left: Construction equipment and supplies.
Bottom Right: VFP1 limestone plugged and overflowing into siphon vault.

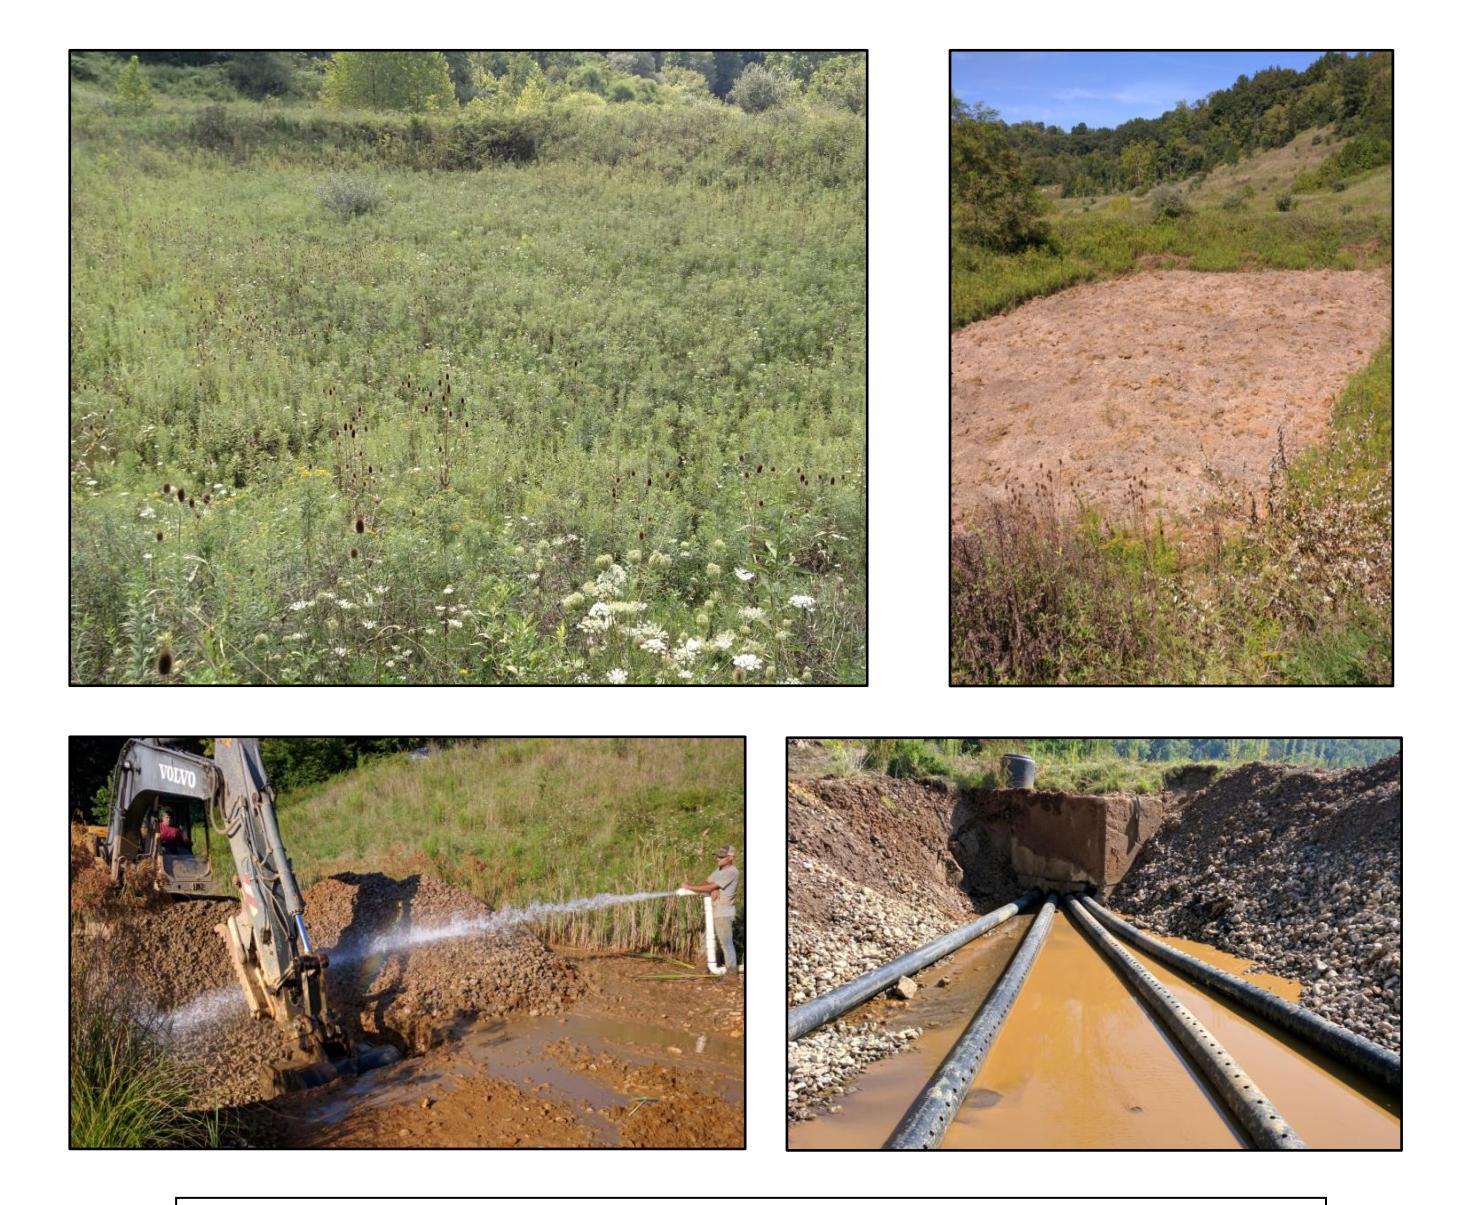
Top Left: VFP2B was being by-passed due to compacted media, overgrown with vegetation.
Top Right: VFP2B after media stirring (~1,150T limestone + ~630CY organic material) to increase permeability and facilitate flow through the treatment media.
Bottom Left: VFP1 during limestone (2,000T) washing and stirring.
Bottom Right: New VFP1 underdrain perforated HDPE pipes.

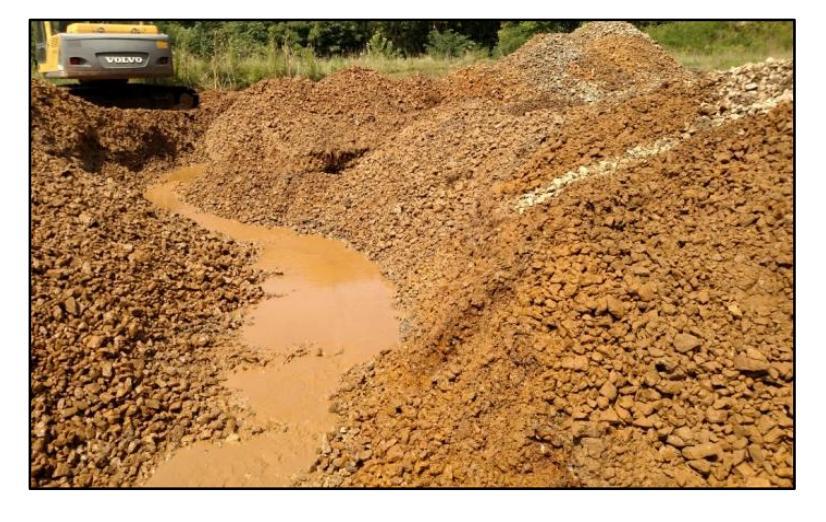
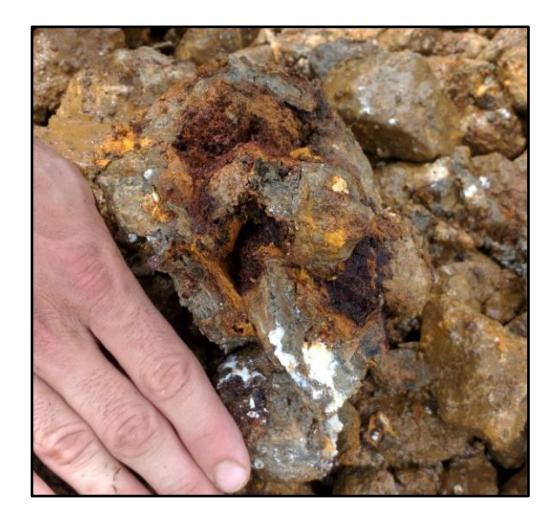
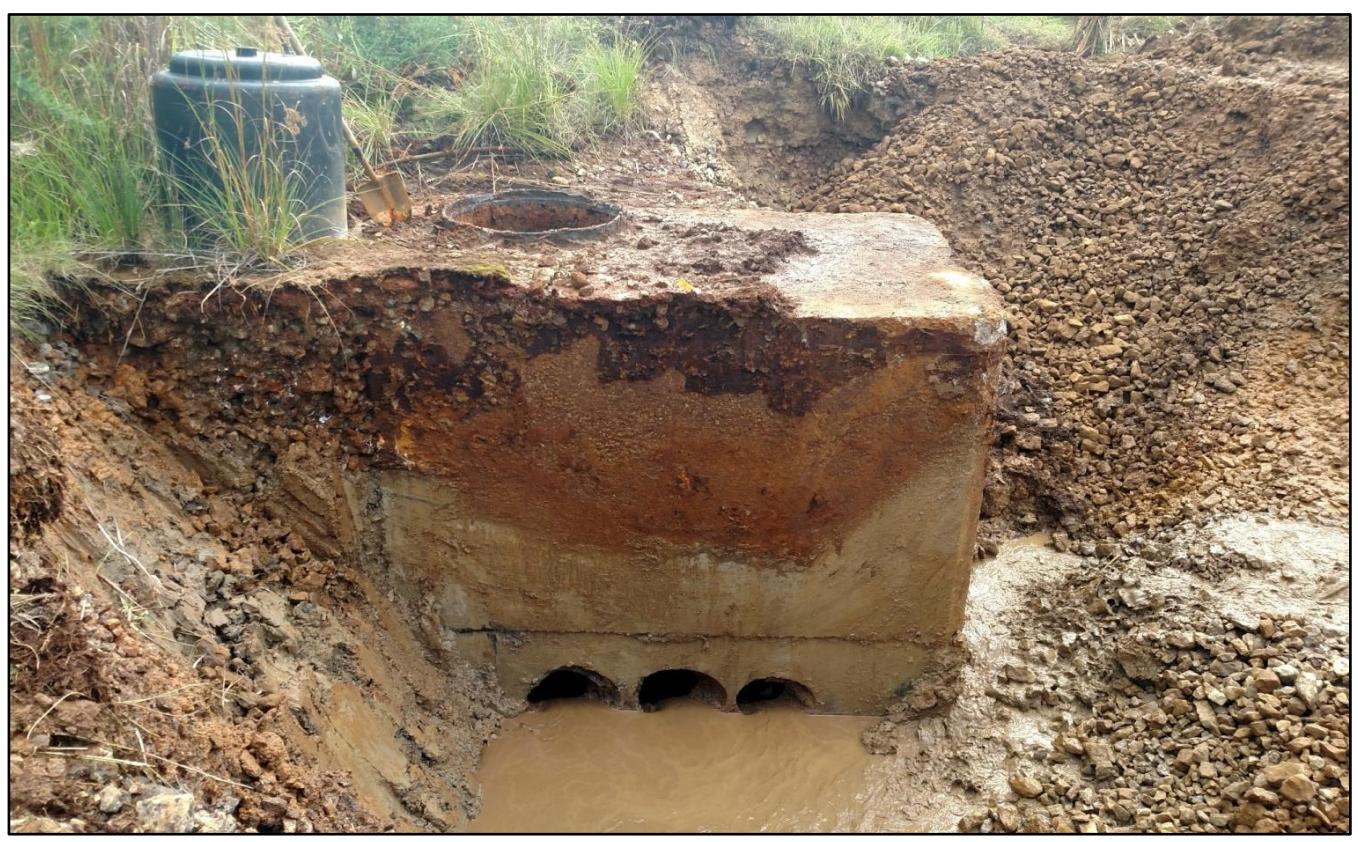
Top Left: Excavator stirring VFP1 limestone (2,000T).Top Right: Close-up of VFP1 limestone coated and plugged with metals.Bottom: Excavation of VFP1 siphon vault with old underdrain pipes removed.

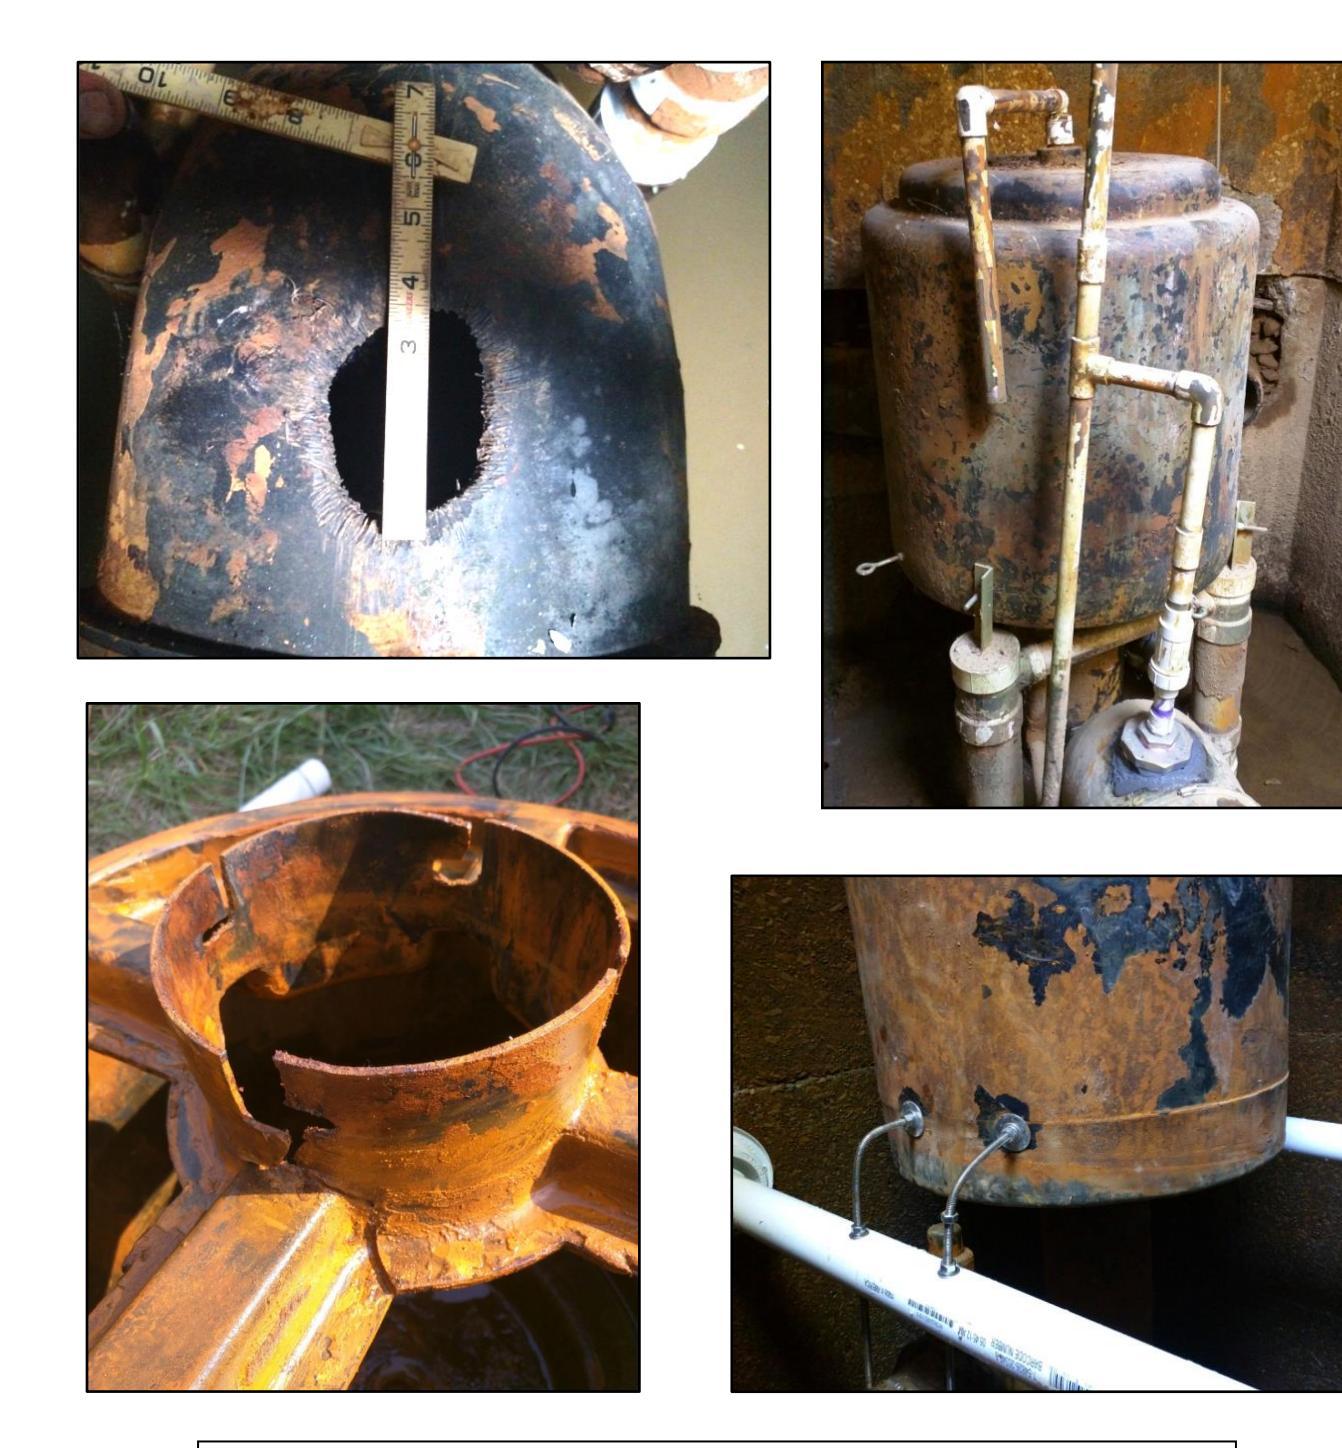
Top Left: VFP2B siphon trigger damaged by wildlife.
Top Right: Repaired VFP2B siphon trigger mechanism.
Bottom Left: VFP3 siphon bell after years of service with factory-provided support.
Bottom Right: VFP3 siphon retrofitted with secondary supports.

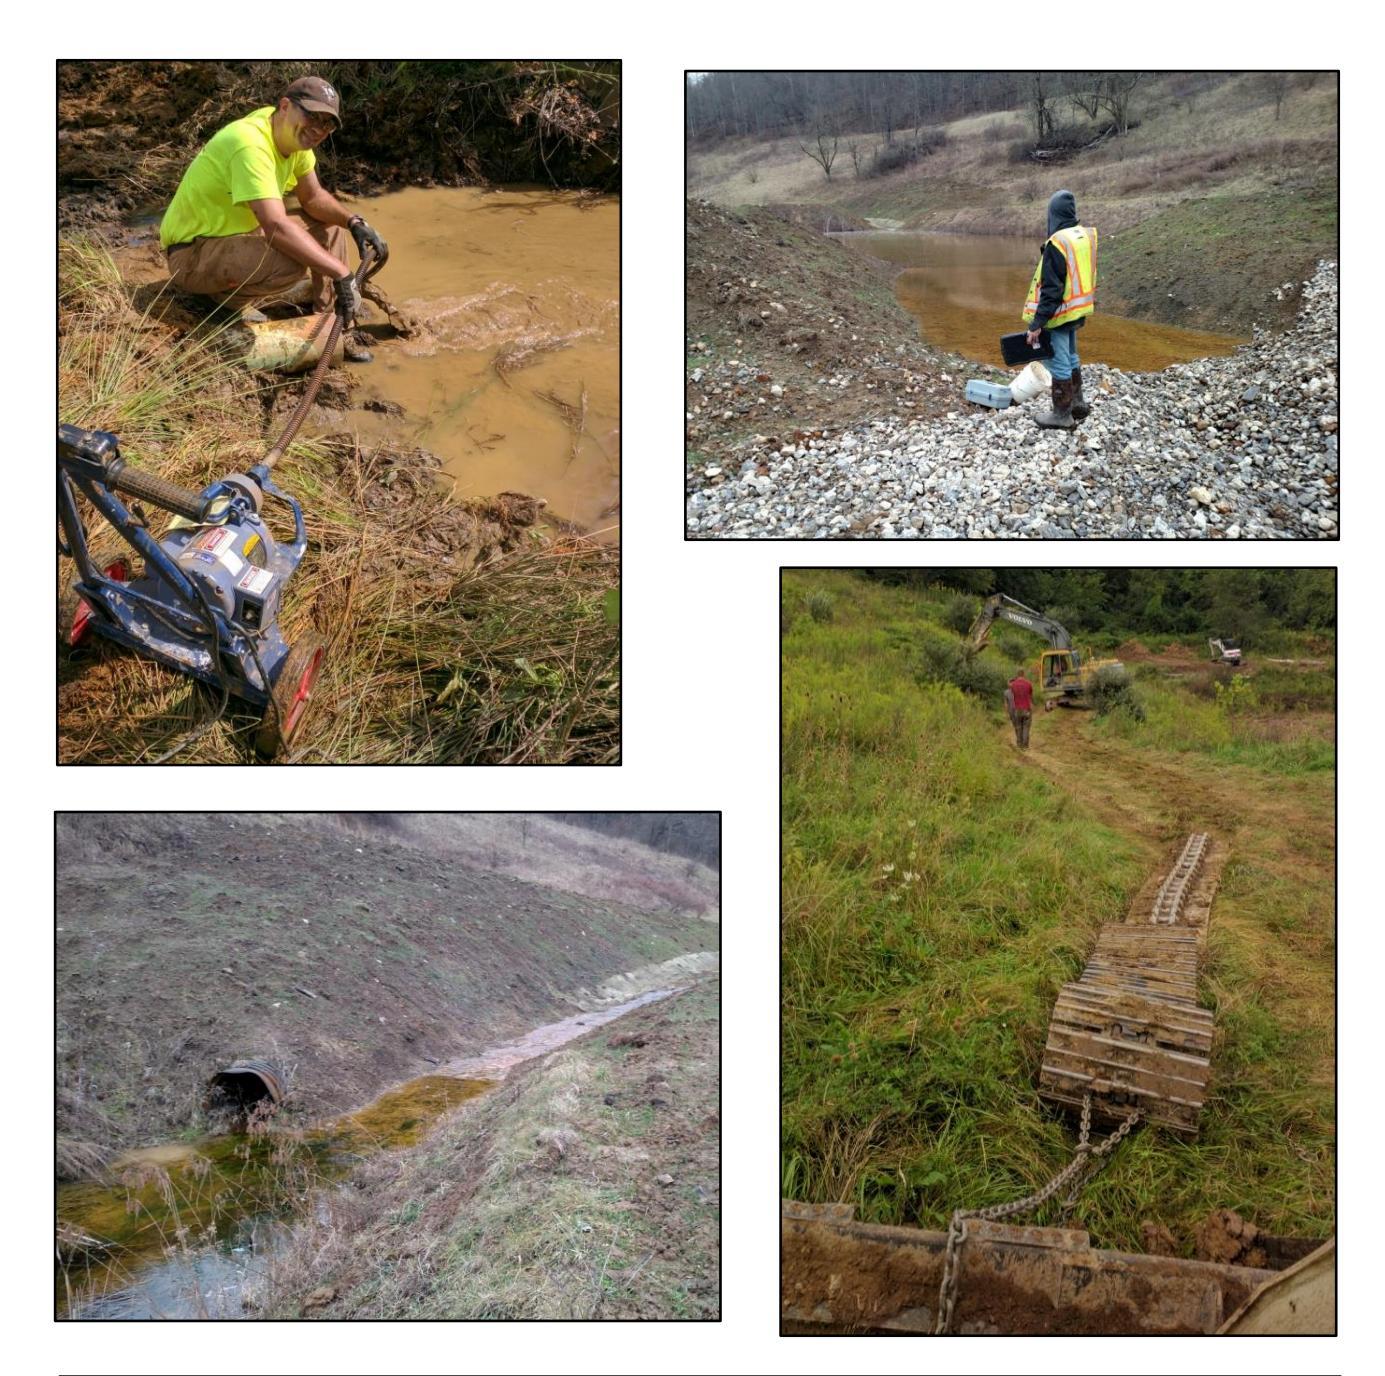
Top Left: VFP3 flush pipe mechanically cleaned to remove blockage.

Top Right: Channel excavated between VFP2A and VFP2B to use VFP2A as a conveyance to VFP2B and allow flow control through both VFPs.

Bottom Left: Looking from OPC toward VFP2A, a channel was excavated to VFP2A to bypass a clogged culvert (left) that previously conveyed water to VFP2A and VFP2B.

Bottom Right: Mechanical difficulties while stirring VFP2B limestone.

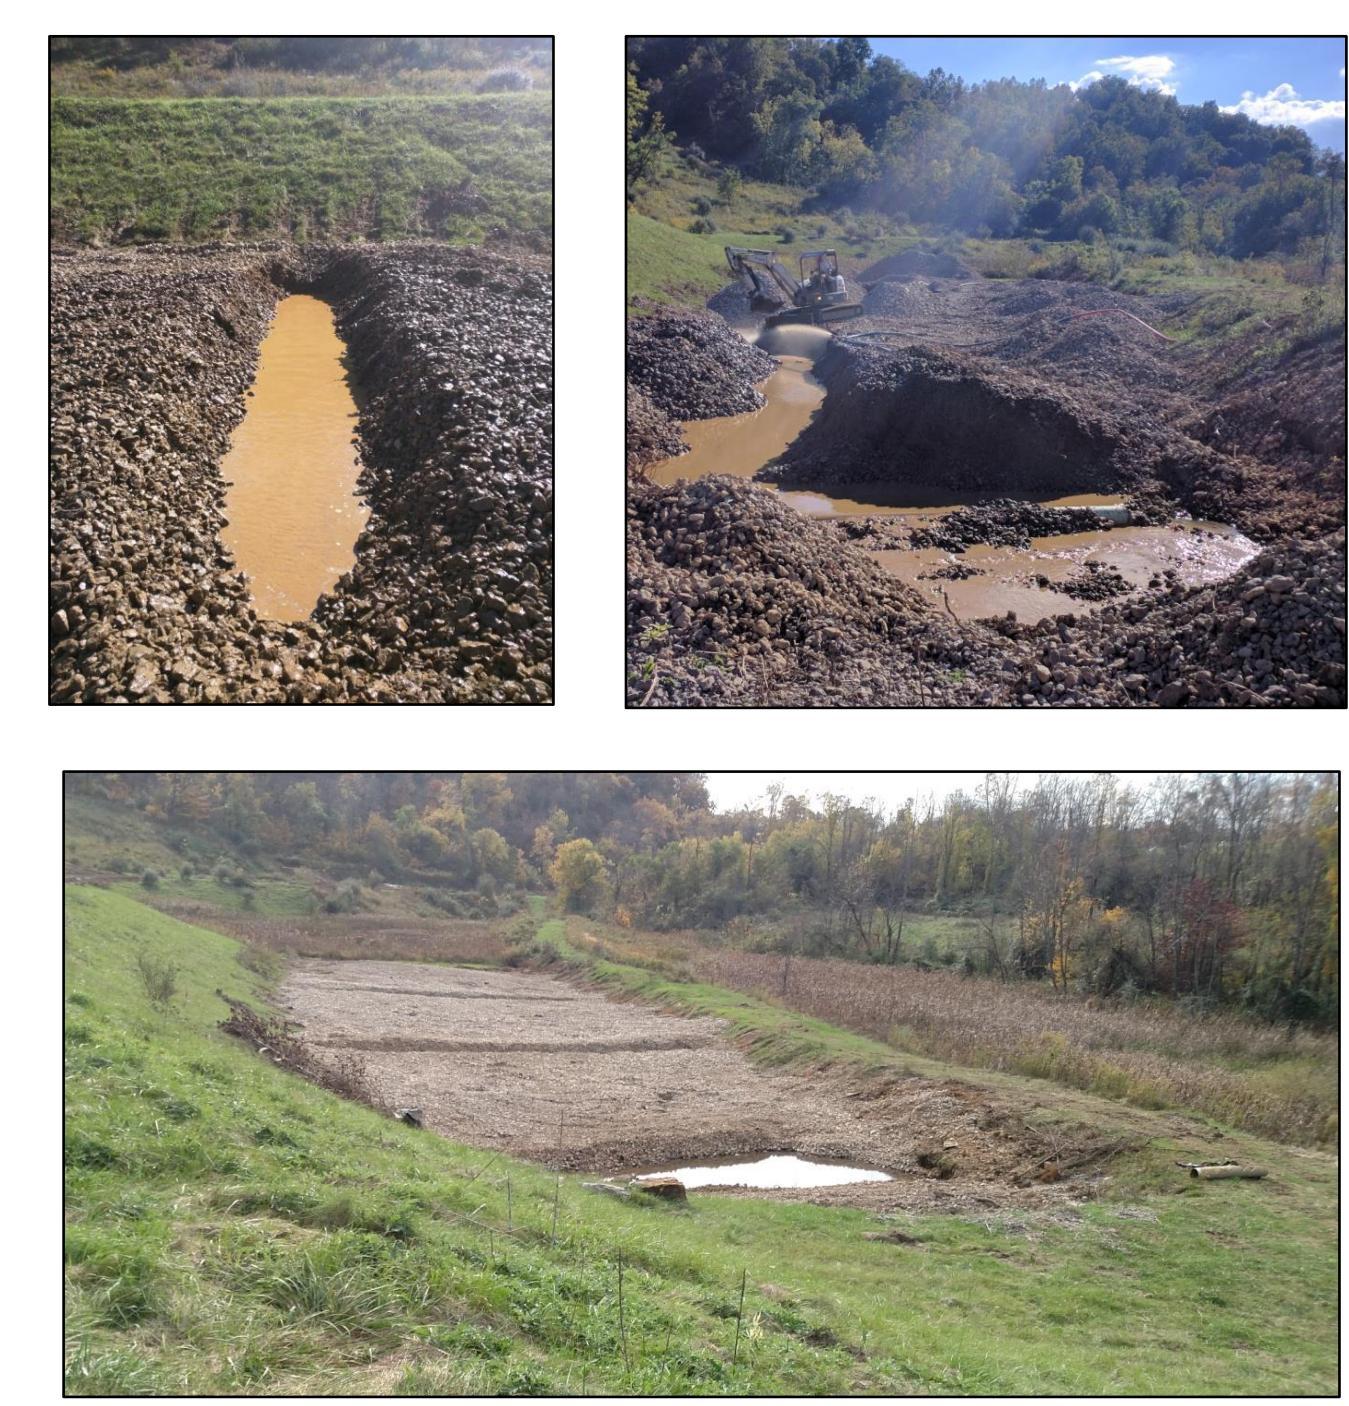
Top Left: Infiltration trenches were installed within the HFLB.Top Right: HFLB during limestone (4,000T) washing.Bottom: HFLB final grading with infiltration trenches and inlet/outlet pools installed.

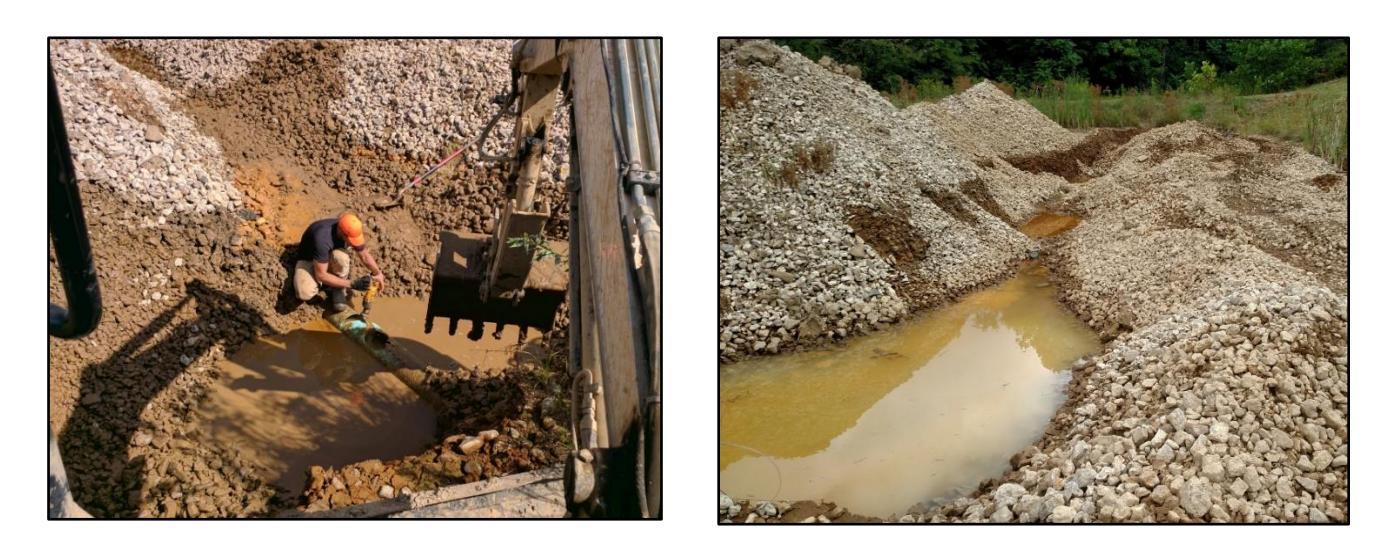
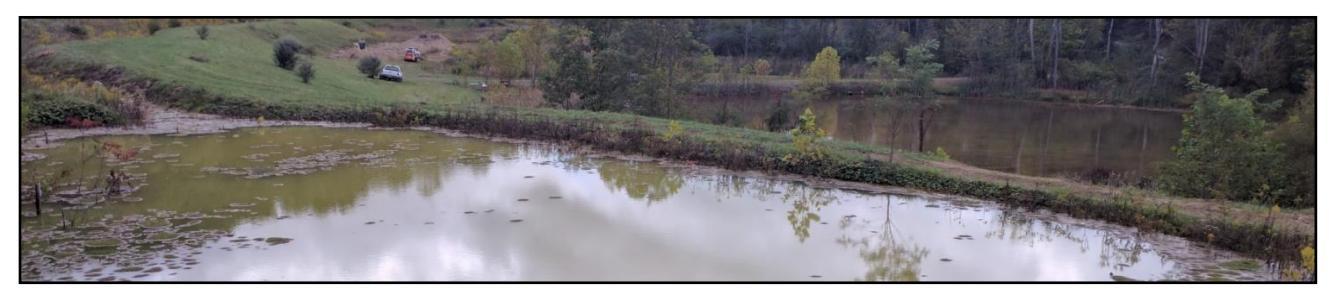
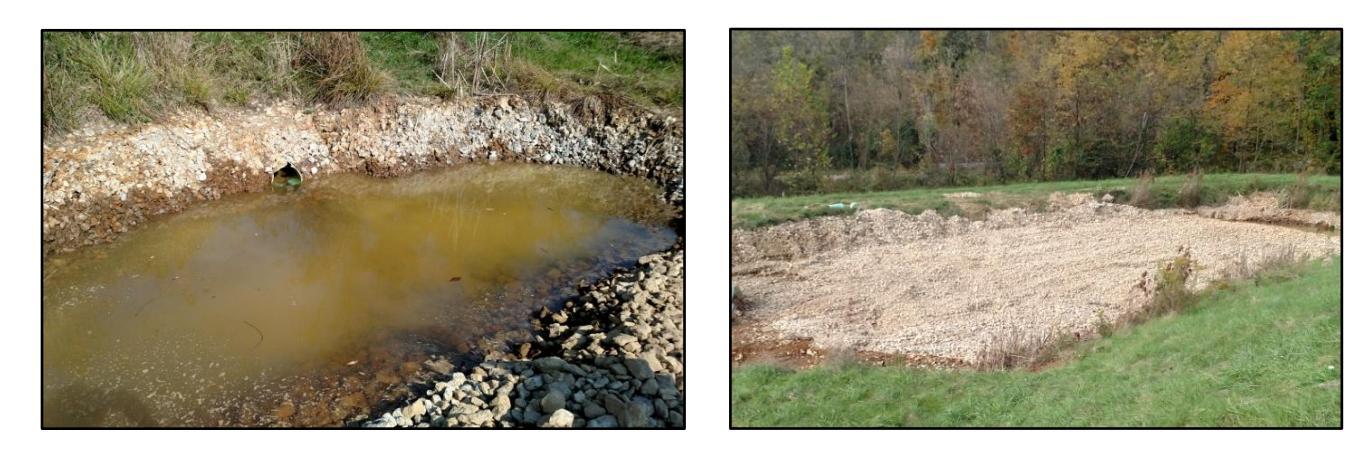
Top Left: Repair of VFP3 underdrain pipe.
Top Right: Washing limestone (1,000T) in VFP3.
Middle: Settling Pond 1 berm repaired and outlet channel cleaned to lower water elevation in settling pond.
Bottom Left: VFP3 inlet pool constructed after limestone washing.
Bottom Right: Clean limestone in VFP 3 before final grading.

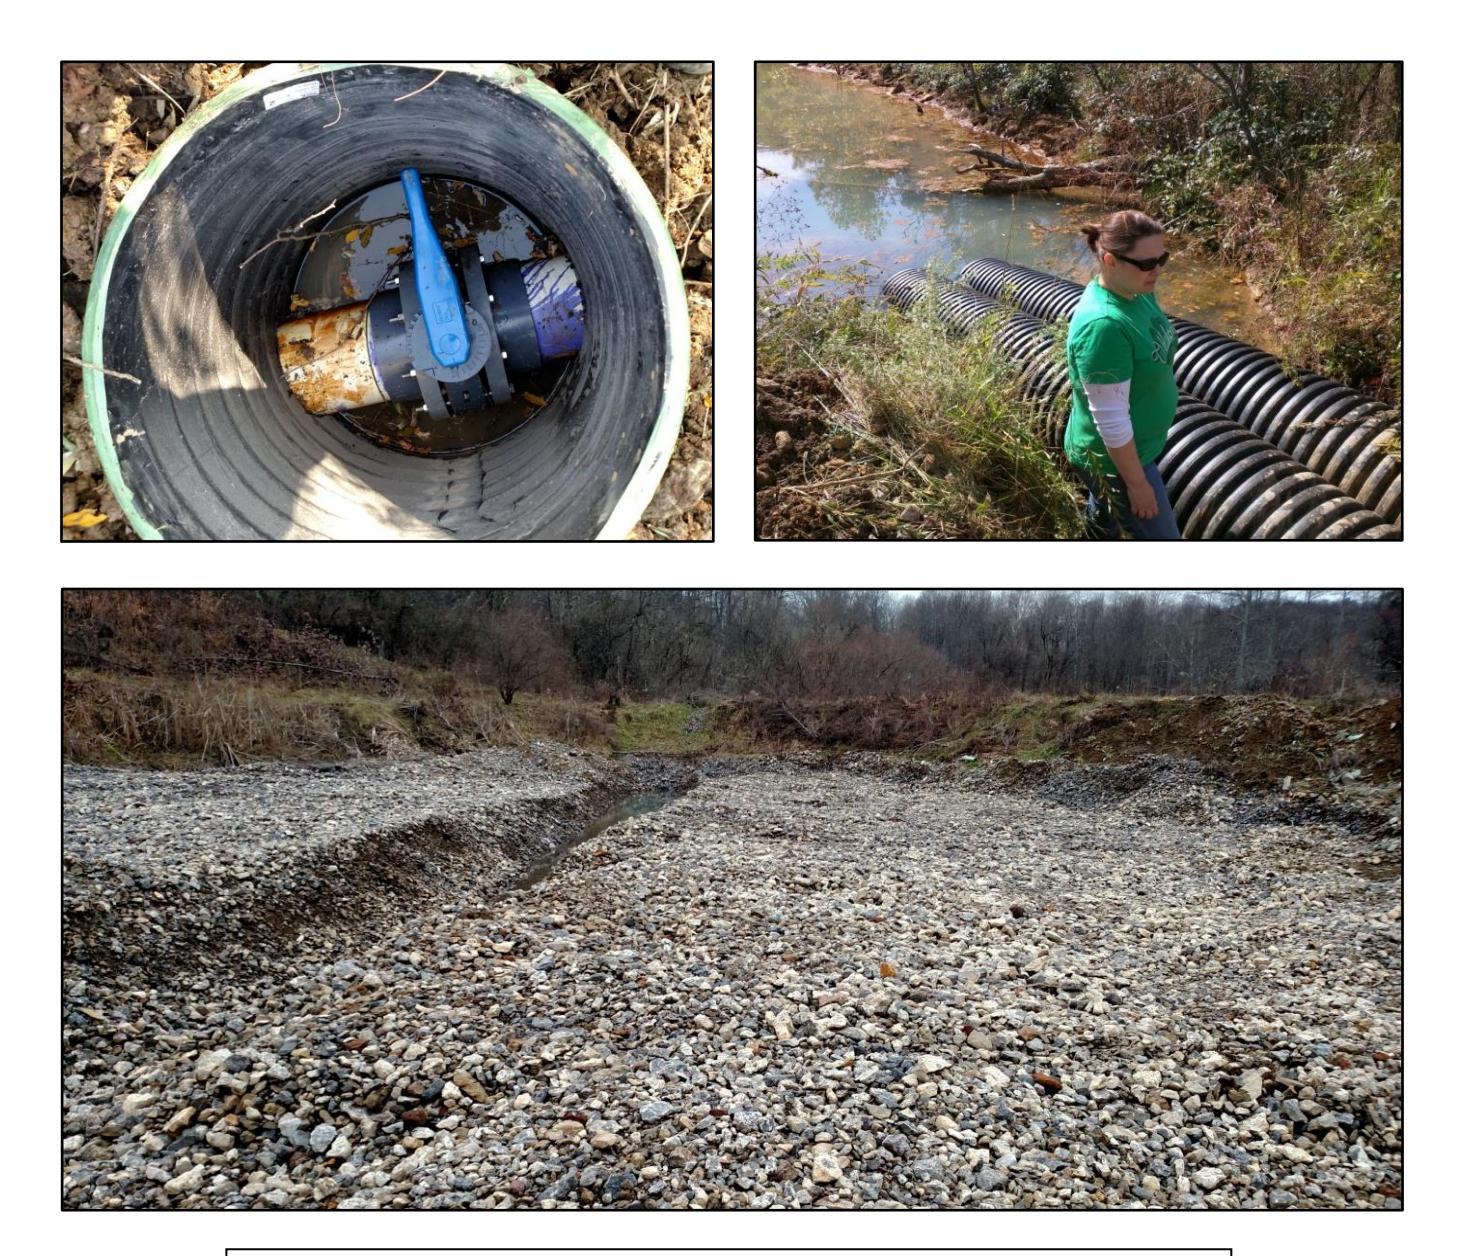
Top Left: New valve installed for Settling Pond 1 drain pipe.
Top Right: Culvert pipes installed with both ends underwater to deter beaver activity at system outlet near Taylortown Road.
Bottom: Limestone (3,500T) was stirred and an infiltration trench was installed to maintain permeability along with a new underdrain system in VFP2B.

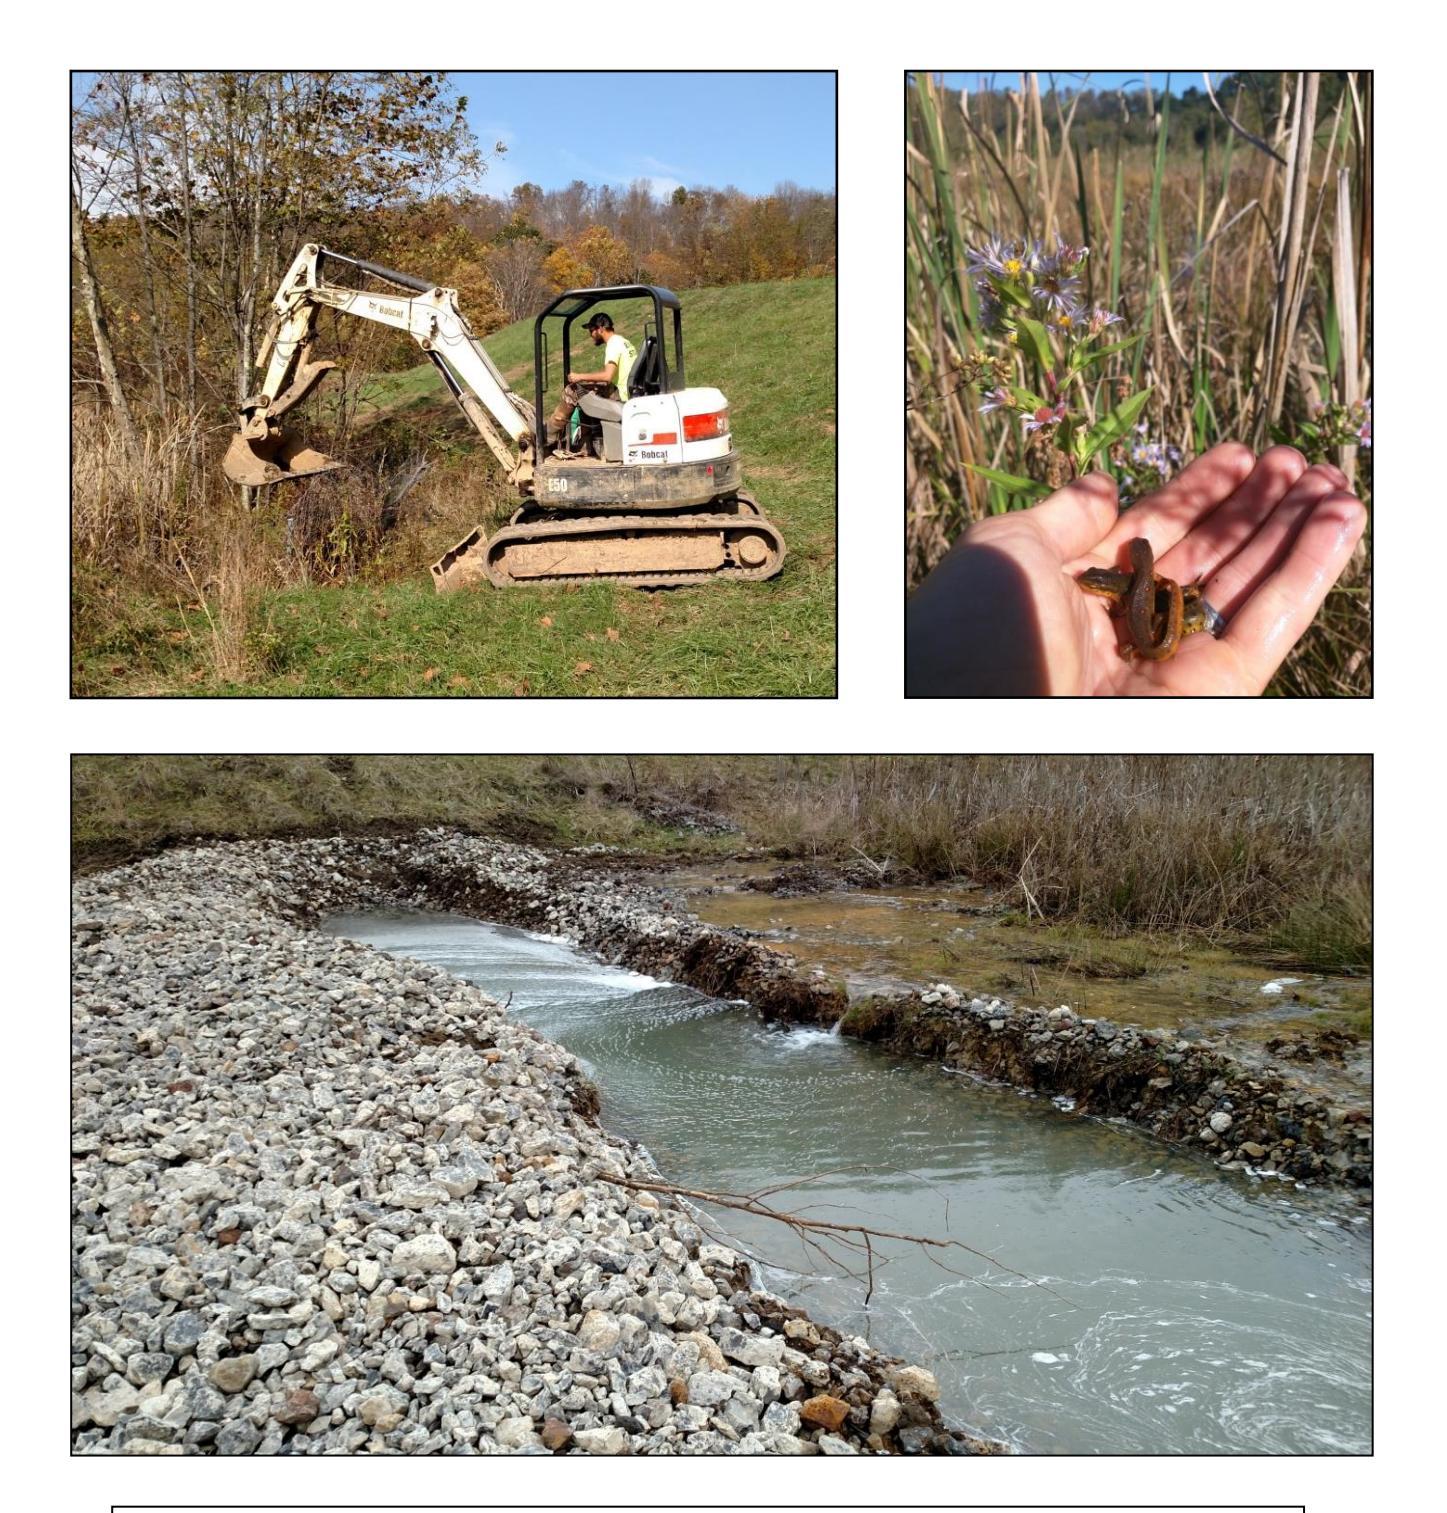
Top Left: Removal of E&S control measures no longer needed from original system construction. **Top Right:** Wildlife found on site (Red Spotted Newts, Notophthalmus v. viridescens). **Bottom:** HFLB inlet pool with flow distributed across wetland outlet.
