LOWER LOYALHANNA CREEK WATERSHED

Section 3 – Lower Loyalhanna Creek Watershed

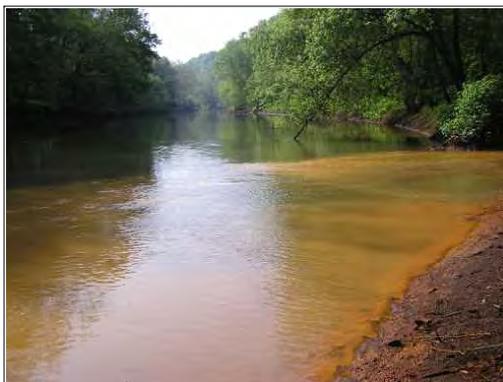
Where Crabtree Creek joins the Loyalhanna Creek, the substrate of the stream is no longer visible. Various tests showed that thick layers of sediment and iron oxide covered gravel and cobble. The streambanks are covered by mud and dirt. Streamside vegetation is primarily sycamore, silver maple, and shrubs. The water emits the odor of rotten eggs.

The confluence of Crabtree Creek and the Loyalhanna Creek main stem

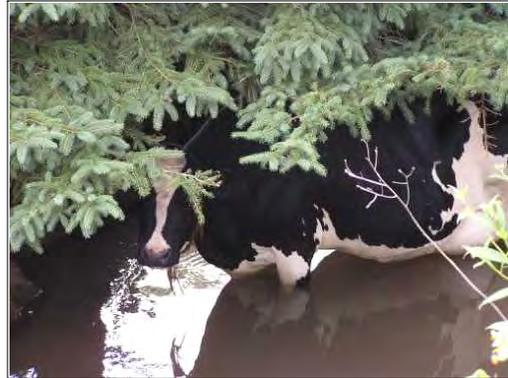
Holstein cow lounging in Union Run near Panizzi Road

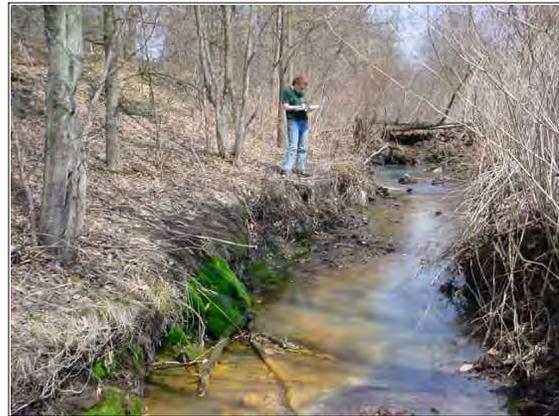
Assessment volunteer taking notes at the seeping bank on the Superior Branch of Union Run

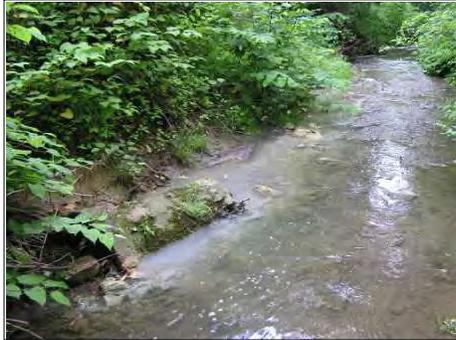
Aluminum seep entering Crabtree Creek from the Forbes Road coal refuse pile

from the coal refuse pile seeps into the stream in multiple areas through the section. One major seep enters the stream from the middle of the pile. That seep had a field pH of 2.9 and, upon meeting the stream, turns white with aluminum precipitate. Aluminum staining is visible downstream of the seep and the coal refuse pile for approximately 1,000 feet. Downstream of the coal refuse pile and the seep, the field pH of Crabtree Creek was 6.9.

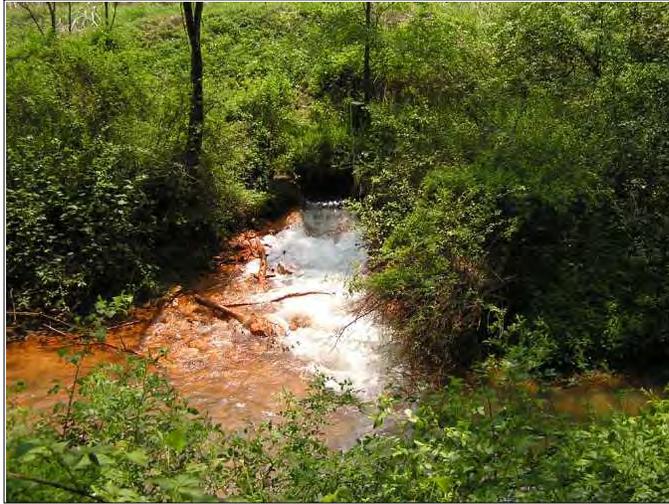
The Crabtree Creek Discharge, located behind the Crabtree Fire Hall

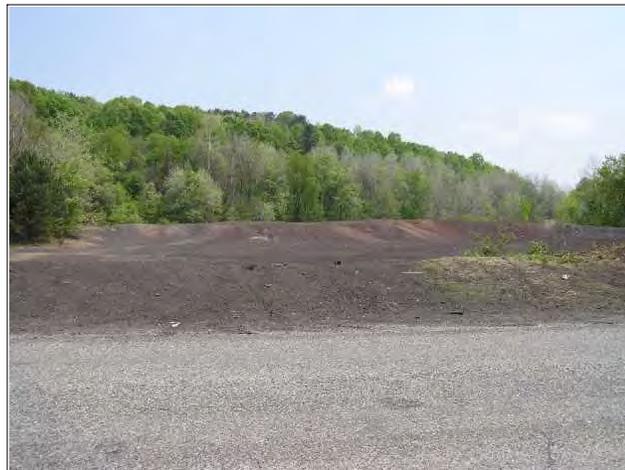
Small coal waste pile located in Greenwald at the intersection of Kiley Road and Latrobe-Crabtree Road

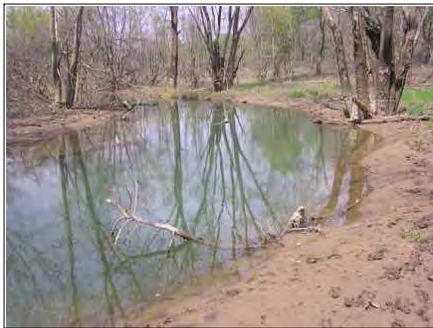
Looking upstream at a green-tinted Whitethorn Creek, close to the Salem Drive Bridge
