Oven Run F Passive Treatment System
SRI O&M TAG Project # 12 Request #1
OSM PTS ID: PA-78

Requesting Organization: Somerset County Conservation District (in-kind partner)
Receiving Stream: Oven Run (Oven Run Watershed)
Hydrologic Order: Oven Run→Stonycreek River→Conemaugh River→
Kiskiminetas River→Allegheny River→Ohio River
Municipality/County: Shade Township, Somerset County
Latitude/ Longitude: 40°08'03.9984"N / 78°55'30.0000" W
Construction Year: 2000

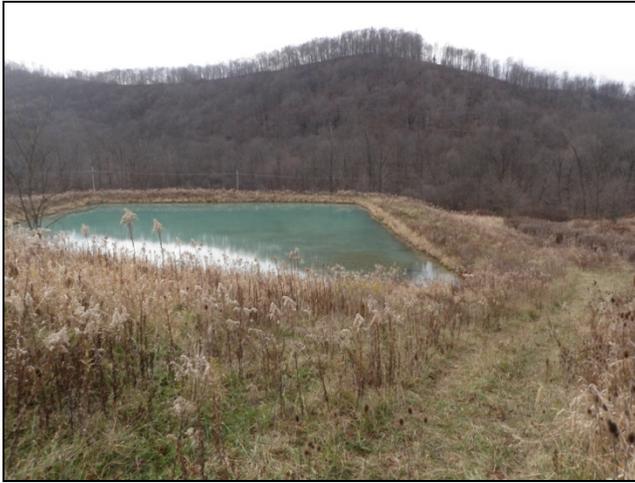
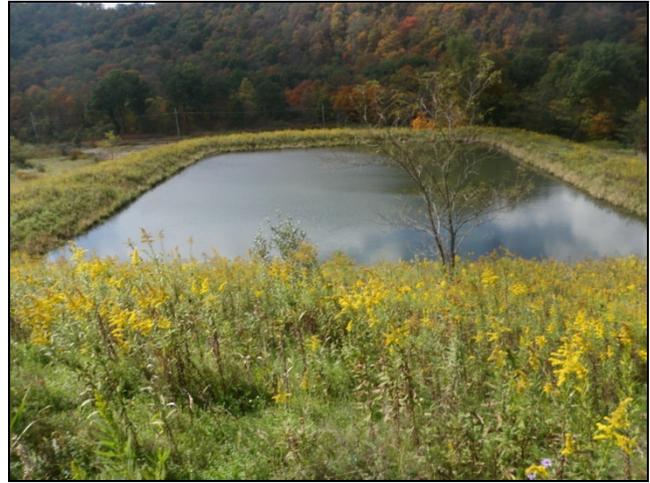
During the initial site visit on 11/20/12, the Oven Run F Passive Treatment System (*top left and right*) appeared to be functioning well. Greg Shustrick expressed concerns about the media becoming plugged; however, there were no obvious signs of decreased water treatment or water overtopping the berms. After reviewing available water quality data, BMI revisited the site to further investigate the apparent reduction in effluent flow rates. During the site visit, mine water was found to be flowing in a channel between SAPS2 and Settling Pond 2 (*bottom left*). The water was traced (*bottom right*) to the source, which was a pipe located near the influent pipe. This was believed to be an overflow or by-pass pipe. The Somerset County Conservation District was contacted and they have since acquired funding to complete repair work.

- Continue to completely flush the system on a quarterly basis,
- Continue monitoring the system, and
- If treatment begins to decline or permeability decreases within the system, first try to back-flush or stir the treatment media before replacing the media.
