De Sale Phase 1 Passive Treatment System
SRI O&M TAG Project # 21 Request #1
OSM PTS ID: PA-113

Requesting Organization: Slippery Rock Watershed Coalition (in-kind partner)
Receiving Stream: Unnamed Tributary (Slippery Rock Creek Watershed)
Hydrologic Order: Unnamed Tributary→Seaton Creek→Slippery Rock Creek→
Beaver River→Ohio River
Municipality/County: Venango Township, Butler County
Latitude/ Longitude: 41°08'33"N / 79°49'48"W
Construction Year: 2000

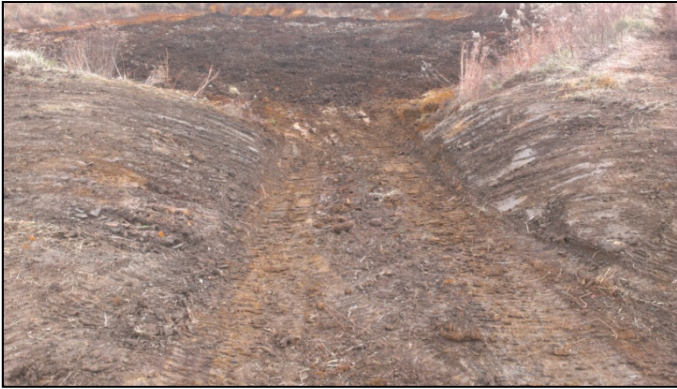
A permanent access ramp (*top left*) into VFPP was installed prior to stirring (*top right*) the treatment media to increase permeability and reduce short-circuiting. Overflowing of VFPP (*middle left*) along with clogging of the outlet pipes and overgrowth of vegetation and debris in the spillway (*middle right*), led to VFPP being stirred, to the replacement of the outlet pipes with adjustable peri-pipes (*bottom left*), and to clearing of the spillways. Plugging of the forebay outlet pipes (*bottom right*) has been an ongoing problem.
