**Wingfield Pines Passive Treatment System**  
**SRI O&M TAG Project #24 Request #1**  
**OSM PTS ID: PA-276**

Requesting Organization: Allegheny Land Trust (in-kind partner)  
Receiving Stream: Chartiers Creek (Chartiers Creek Watershed)  
Hydrologic Order: Chartiers Creek→Ohio River  
Municipality/County: Upper St. Clair Township, Allegheny County  
Latitude/Longitude: 40°20'26.9988"N / 80°06'34.9992"W  
Construction Year: 2009

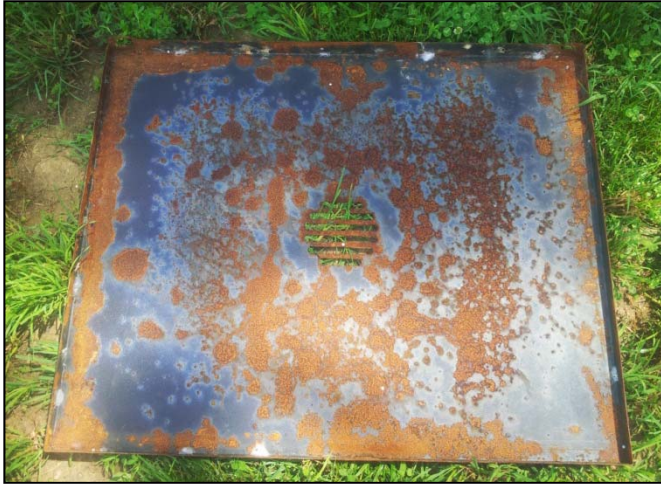
At the Wingfield Pines site, the lid and locks on the In-line Flow Control structure had become badly rusted (*top left*). A new lid and locking mechanism was constructed and installed (*bottom right*). High water levels within the wetland were eroding around the final outlet weir structure (*top right*). A portion of the embankments were dug by hand (*middle left*) and forms built in order to create a cement barrier (*middle right*) which was keyed into the ground to stop erosion. After installation a board was placed on top of the structure to allow volunteers to cross from one side to the other (*bottom left*).

On 5/21/13, Bryan Page of BioMost, Inc. met with ALT volunteers to perform maintenance on the Wingfield Pines Passive Treatment system. As this is a highly-visited site, regular maintenance includes keeping the treatment components aesthetically-pleasing. Shortly after system installation, the cover for the in-line water level control structure box began to rust due to

exposure to mine water, hydrogen sulfide gas, and the elements. The locking mechanism on the water level control box became severely rusted, providing a possible opportunity for vandalism, which was a significant concern as the box controls the mine pool elevation. The rusting lid was replaced with a new, custom-made, plastic box lid with new locking mechanism.
