Laurel Run #1 Passive Treatment System
SRI O&M TAG Project # 29 Request #1
OSM PTS ID: PA-191

Requesting Organization: Blacklick Creek Watershed Association (in-kind partner)
Receiving Stream: Laurel Run (Blacklick Creek Watershed)
Watershed: Laurel Run→Blacklick Creek→Conemaugh River→
Kiskiminetas River→Allegheny River→Ohio River
Municipality/County: Center Township, Indiana County
Latitude/Longitude: 40°30'29.6496"N / 79°06'46.4112"W
Construction Year: 2001

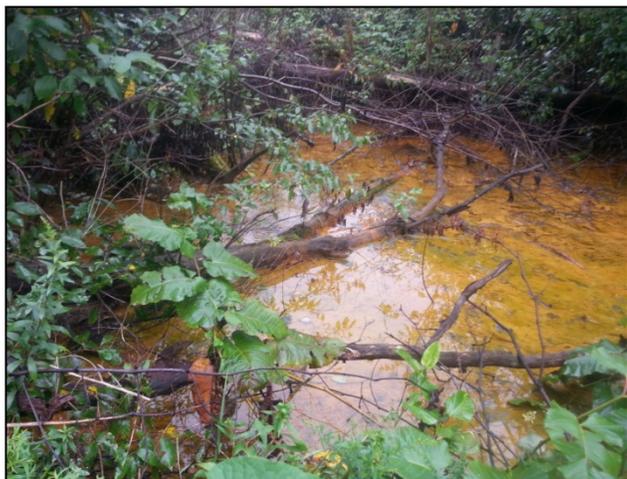
The existing underground collection system had become plugged; therefore, at times, a large portion of the abandoned mine drainage was upwelling to the surface and bypassing the Laurel Run #1 Passive Treatment System (*top left*). Drain valves were opened with difficulty to flush the system (*right*). The corroded valves were later replaced (*bottom left*).

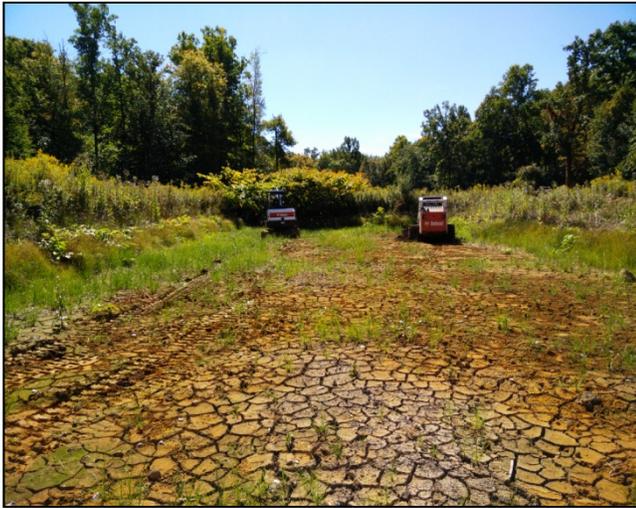
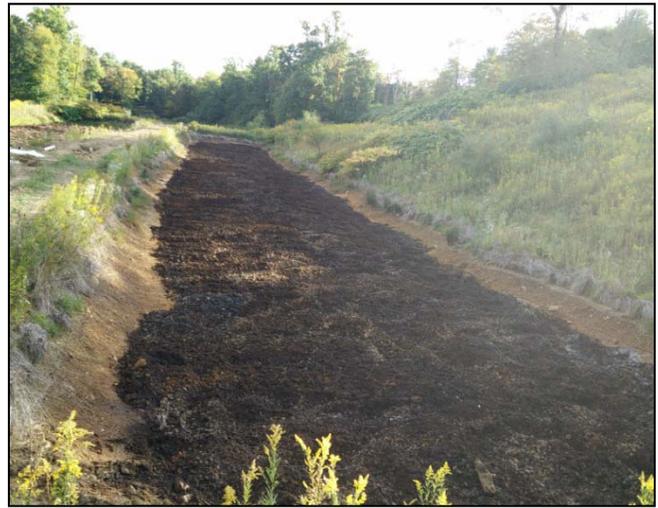
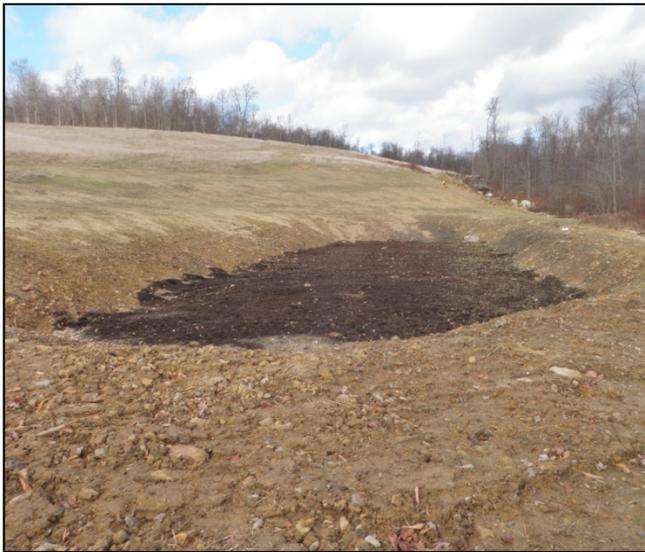
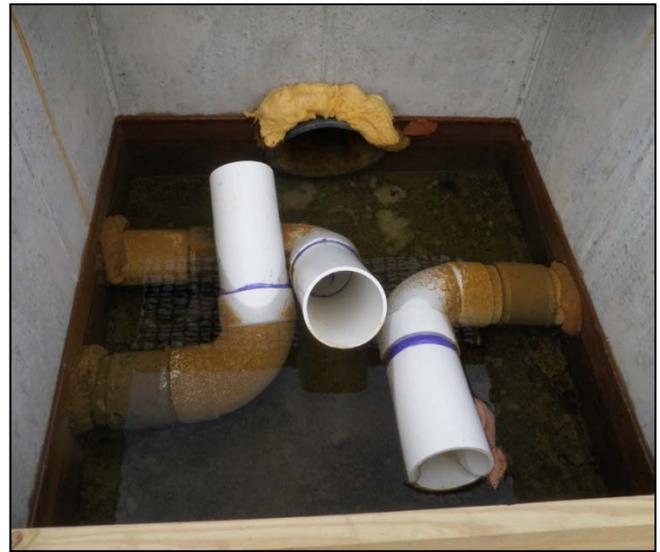
After replacing the valves, a skid-loader and small excavator were used to stir the upper 2 to 3 feet of the treatment media of the existing Vertical Flow Ponds to increase permeability and promote better utilization of the treatment media. Compare the photo prior to stirring the media (*top left*) with the photo taken after the stirring operation (*top right*). As part of the surface mine permit conditions, Amerikohl converted a settling basin to a third Vertical Flow Pond (*bottom left*) to provide greater treatment capacity especially during high flow periods. Amerikohl also installed a new collection and distribution system that included a concrete flow splitter box (*bottom right*) in which flow can be controlled to the three VFPs by simply lowering or raising the pipes via a Fernco and elbow.

Once the valves were replaced, the VFP media was stirred to maintain uniform flow and increase permeability. A small excavator and skid-loader were used to stir the media. Both machines started at one end of the VFP and worked toward the other end in order to prevent compaction of the freshly stirred media. The media was stirred to a depth of approximately 2 to 3 ft. Where "short circuiting" was observed with water flowing directly into the limestone aggregate layer, the piping was found to be 1 to 2 feet below the surface of the media. Precautions were made to not damage the piping in this area; however, some sections of the pipe were possibly compromised. If poor water quality is observed from a specific upper tier outlet pipe, SRI recommends increasing the elevation of that particular peri-pipe to increase residence time within the VFP. Capping of those pipes may also be an option.
