# BOGGS ROAD MINE DRAINAGE

# REMEDIATION SYSTEM

## FINAL REPORT 2005

## MONTOUR RUN WATERSHED ASSOCIATION

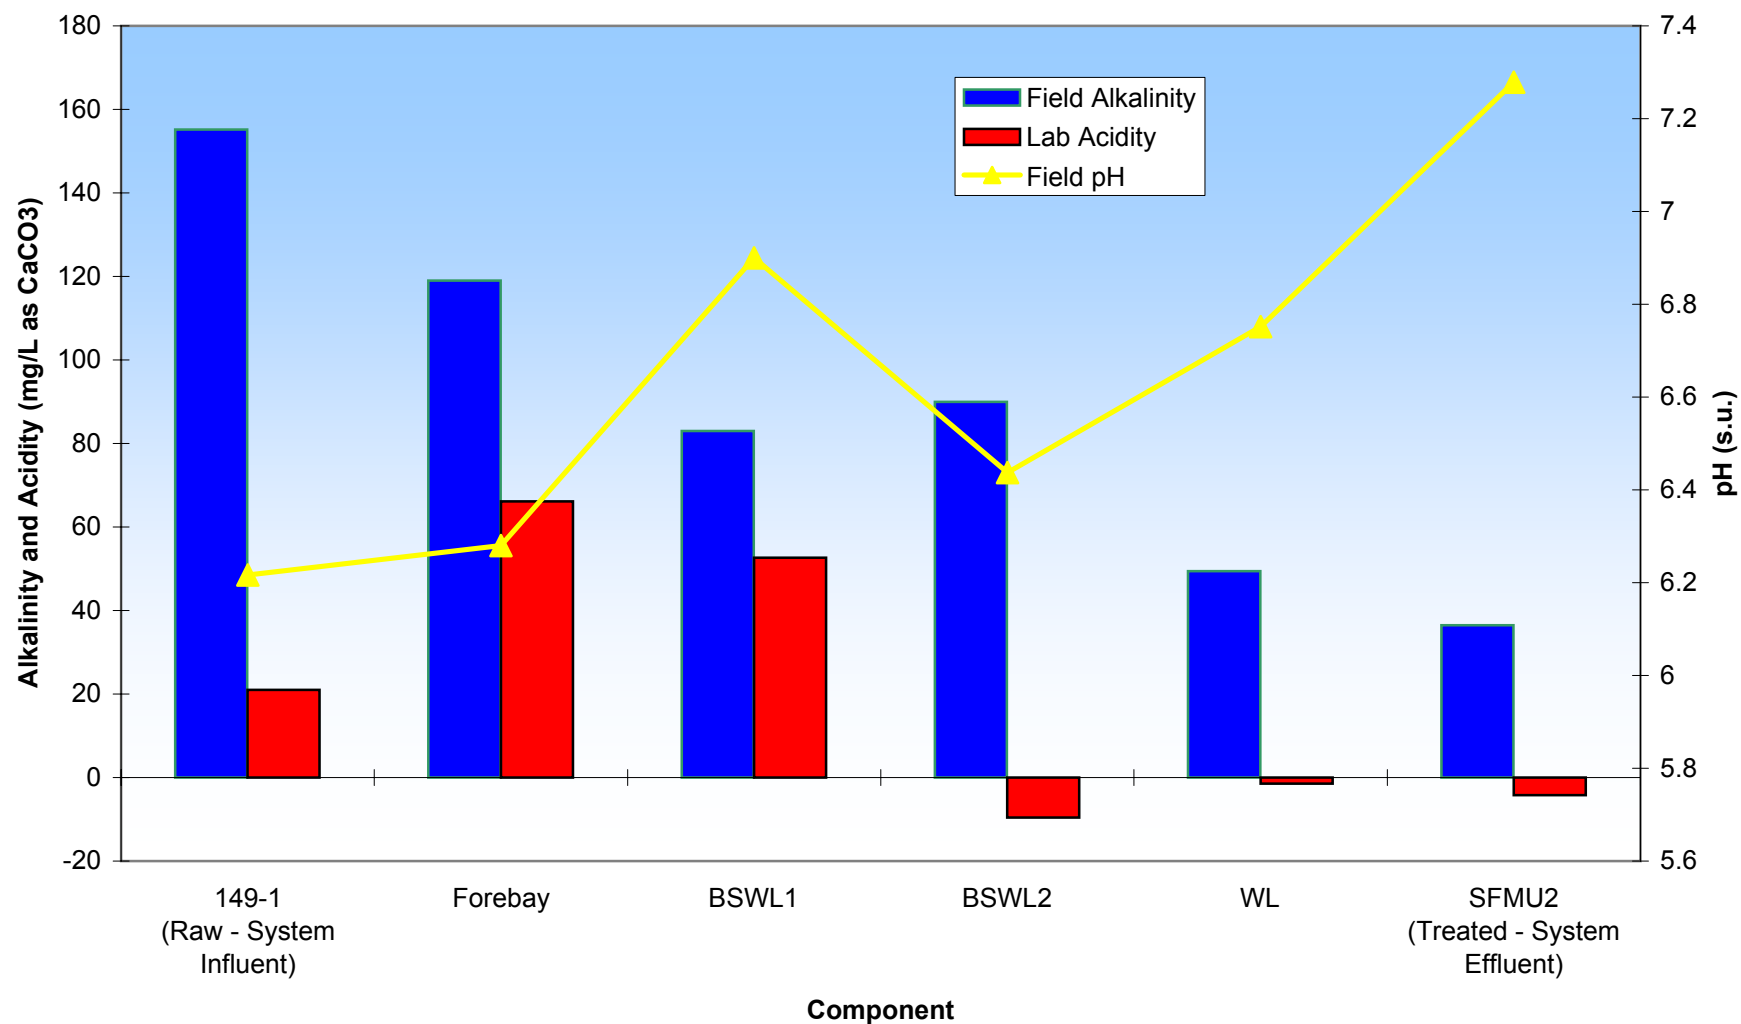
Figure 2

**Comparison of Field Alkalinity, Laboratory Acidity, and Field pH Through  
The Boggs Road Passive Treatment System (Average Values)**

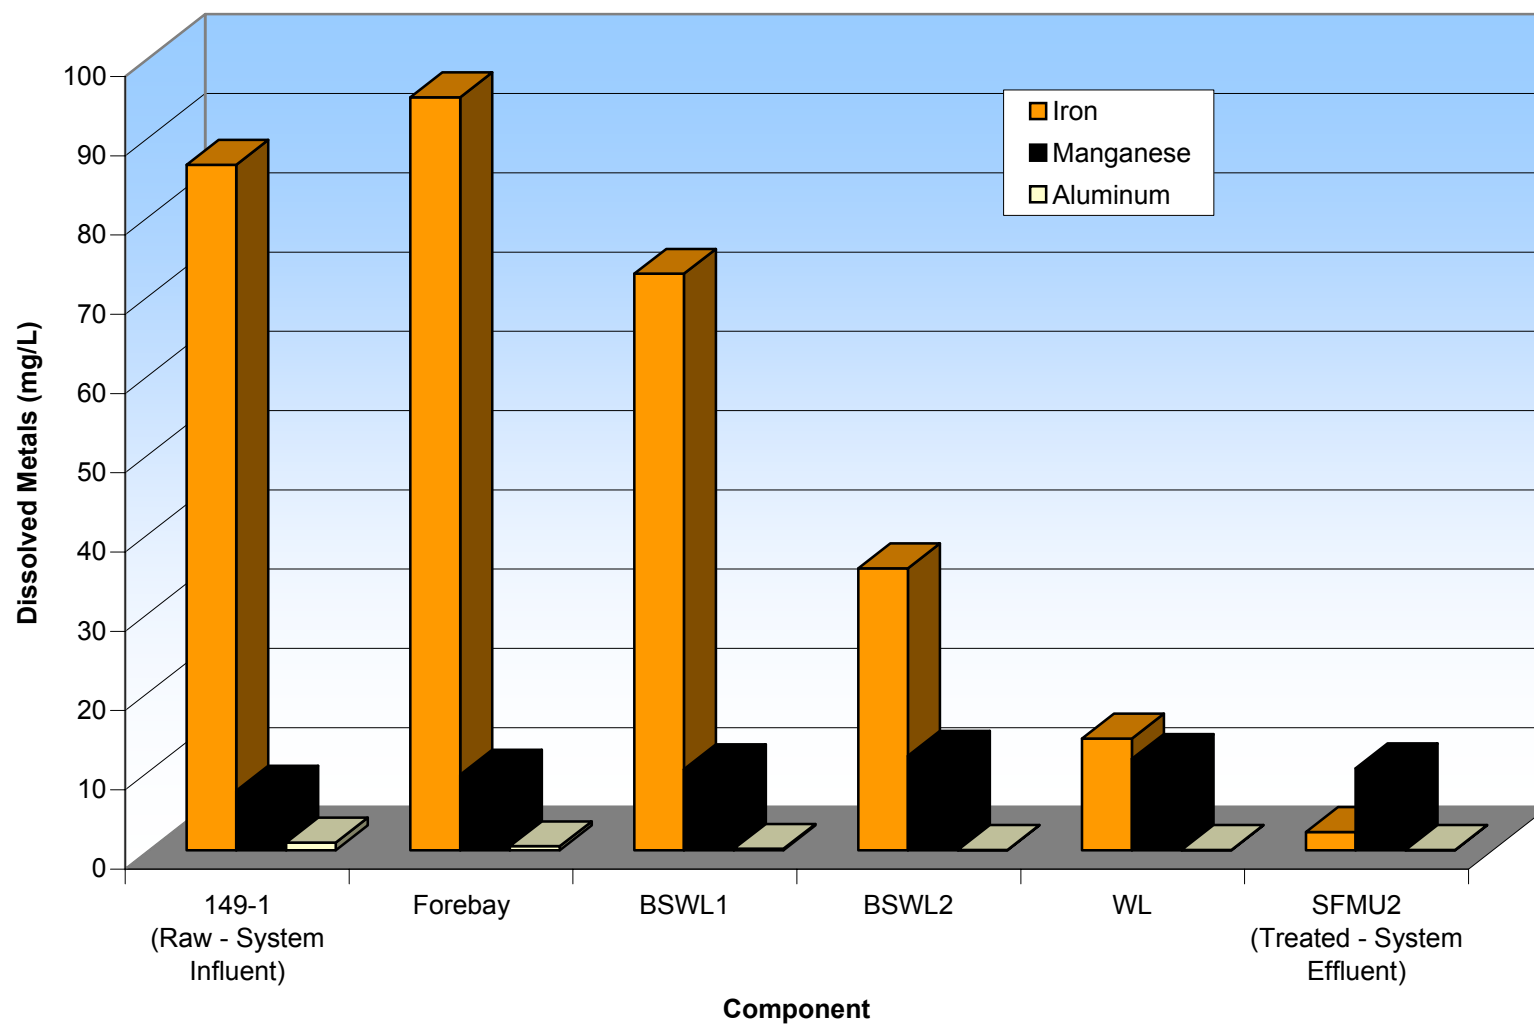
Figure 3

**Comparison of Dissolved Metal Concentrations Through  
The Boggs Road Passive Treatment System (Average Values)**

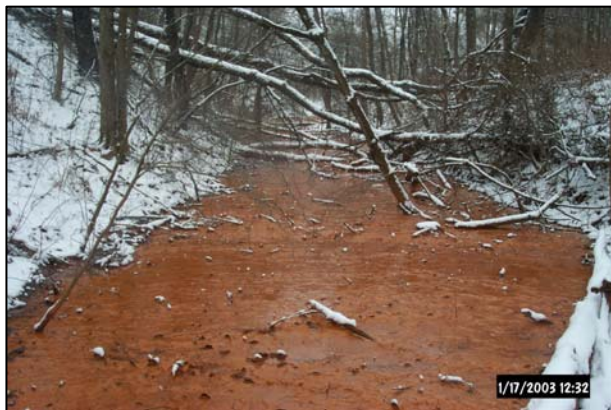
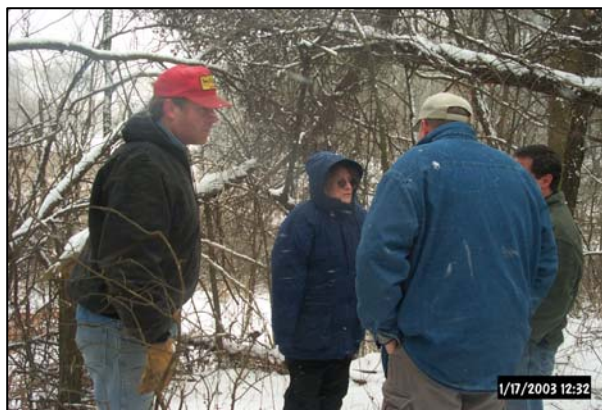
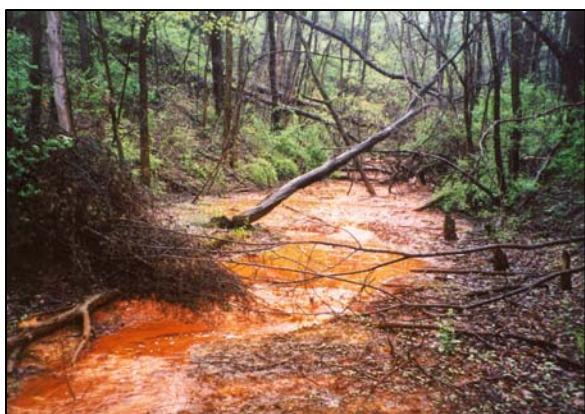
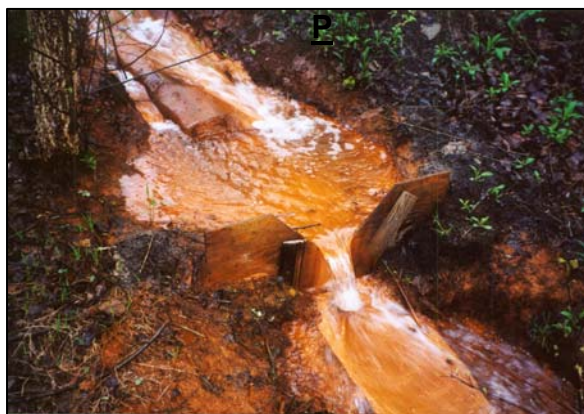
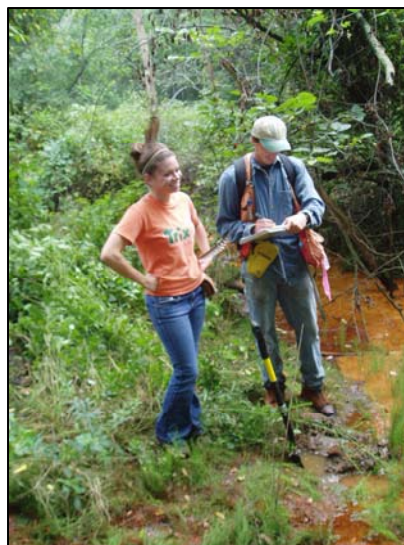
**Above:** Views of the SFMU2 abandoned mine discharge prior to construction of the passive treatment system. Seen also are personal from BioMost, Inc., Quality Aggregates Inc., and Aquascape Wetland & Environmental Services during site investigations and Environmental Assessment.

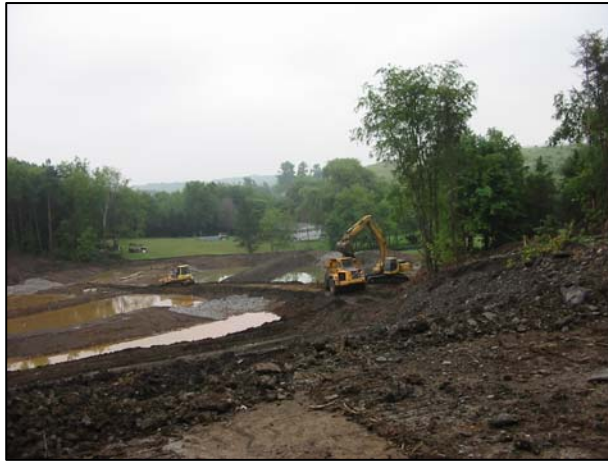
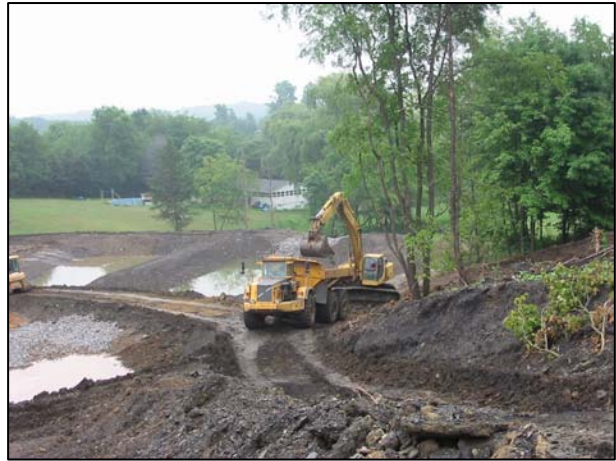
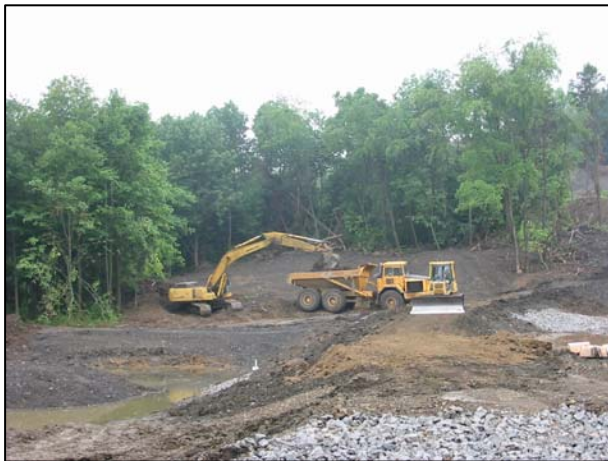
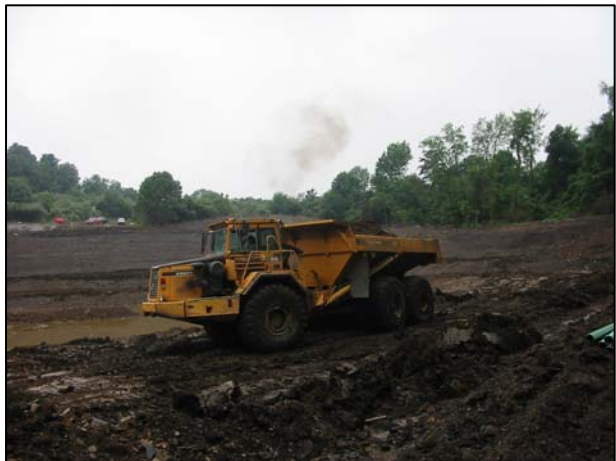
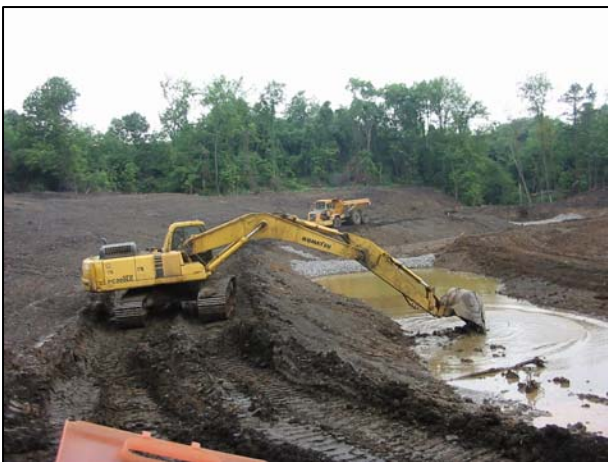
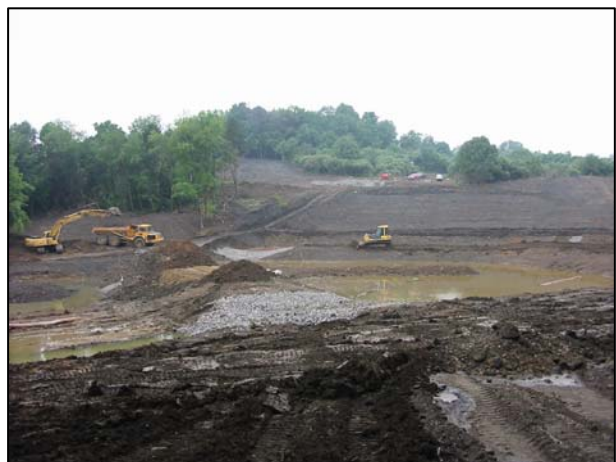
### Excavation & Construction of System

Photographs of Quality Aggregates Inc. constructing the passive treatment system. The excavator and rock truck are removing excess fill while the bulldozer builds and compacts the berms.

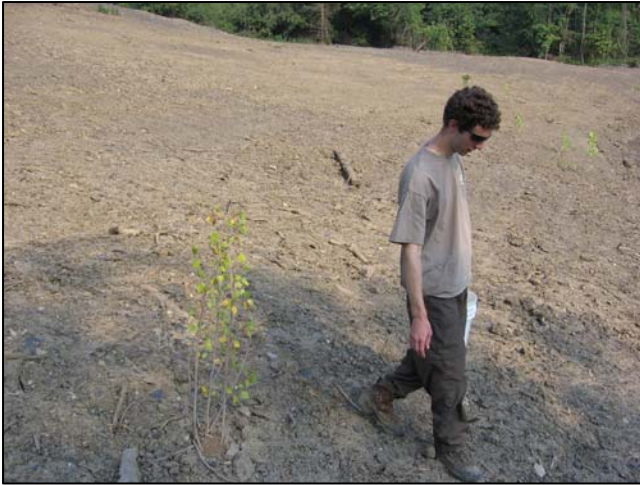
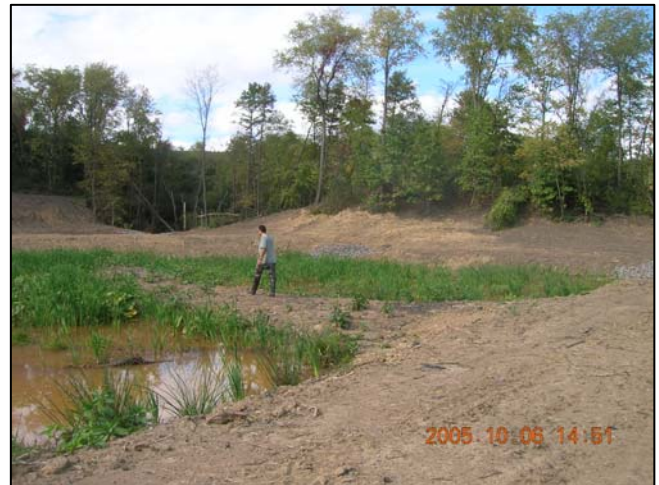
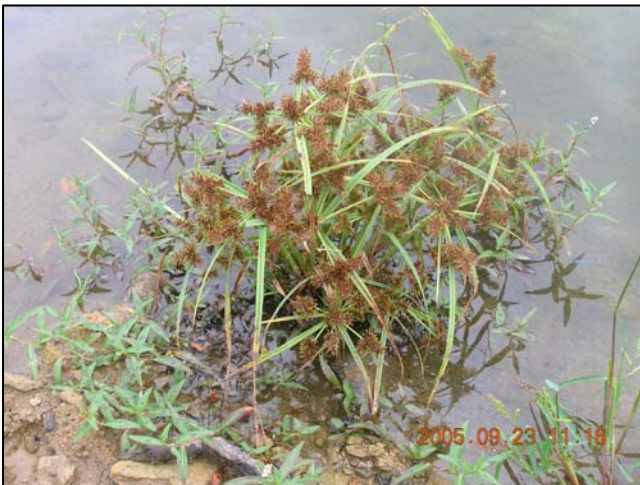
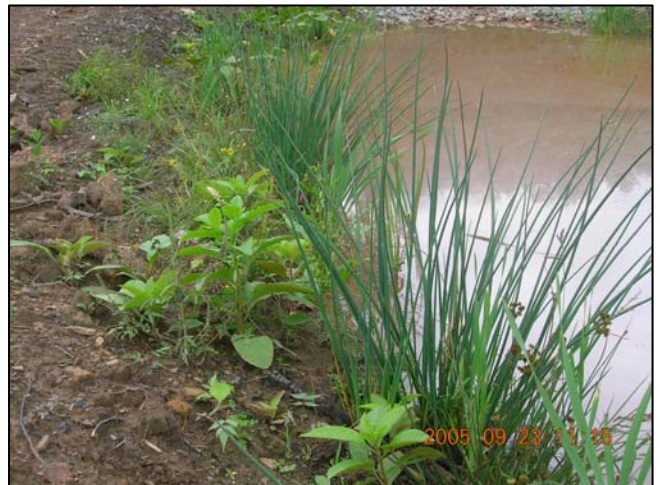
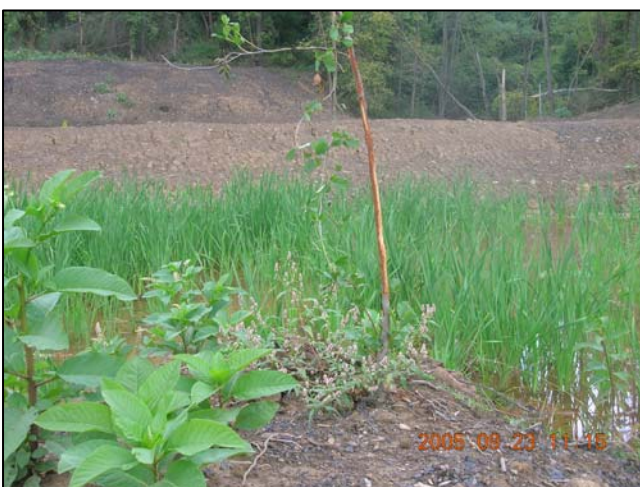
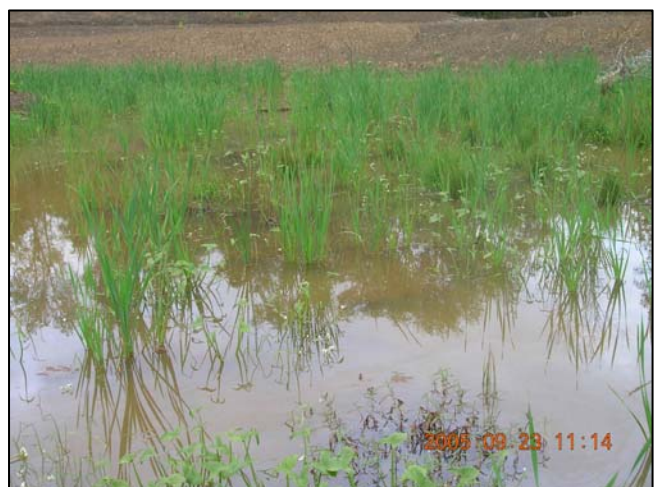
Views of the passive treatment system vegetation during post-construction site inspections conducted by BioMost, Inc. personnel Shaun Busler (**Top left**) and Tim Danehy (**Top right**).

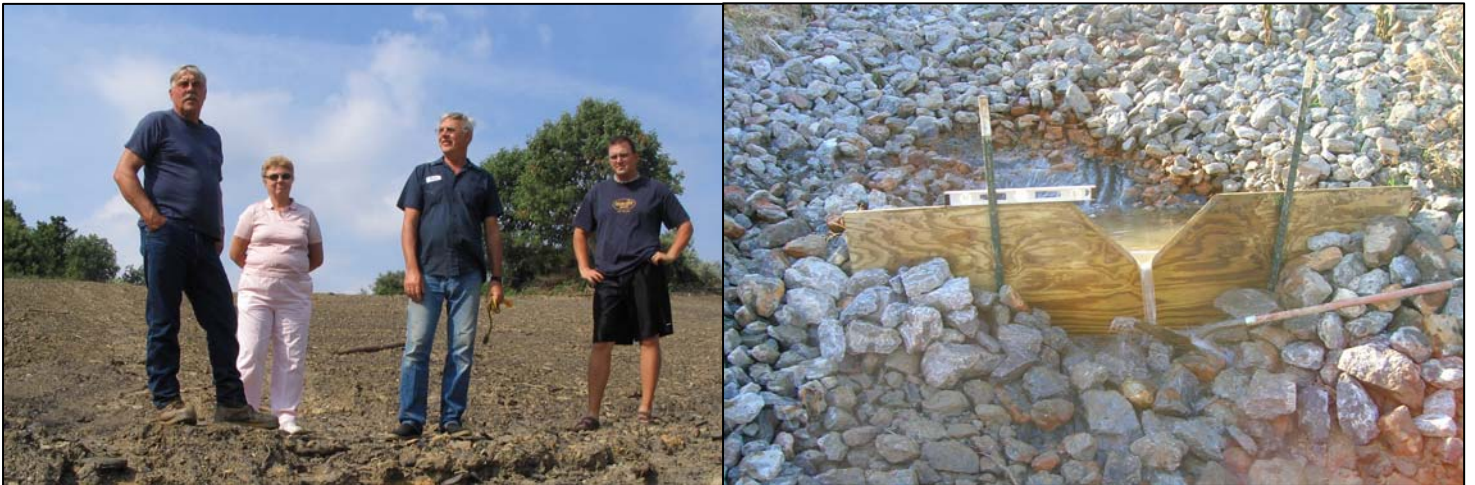
**Top right:** Weir installed in the final spillway below the final pond (current SFMU2 monitoring point).

In order to continue measuring flows accurately, the weir must be maintained. The weir must be kept as level as possible, both horizontally and vertically, to ensure accuracy of flow measurements. Leaking around or under the weir will also result in inaccurate flow measurements. Metal precipitates, sediment, leaves, and other debris should be removed from the V-notch prior to measurement. The area behind the weir should also be cleaned if the pool becomes filled with sediment and debris. When removing debris or sediment from the pool or weir, sufficient time should be allowed for the water level to equilibrate before taking a flow measurement.

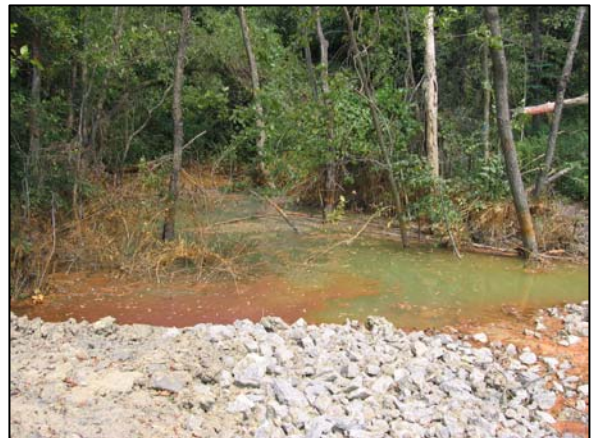
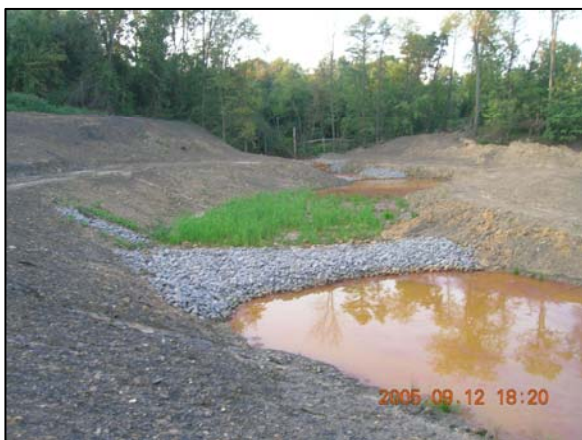
**Forebays:** (right) can serve multiple purposes. They can be used to convey water, provide for settling of debris, and allow for oxidation, precipitation, and accumulation of metal solids. There is one Forebay at the Boggs Road Mine Drainage Remediation System. The Forebay captures the water from the pre-existing abandoned mine drainage seep zone. The Forebay outlet spillway to the first wetland (Bioswale 1) “agitates and aerates” the drainage to further encourage formation of metal solids.

**Wetlands:** (left) are typically used in passive treatment systems to allow for the oxidation, precipitation, filtering, and accumulation of metal solids that occur when alkaline drainage issues from a mine site or after acidic drainage has passed through an alkalinity-generating component. Although many treatment wetlands are angular-shaped shallow ponds with predominantly cattails, the wetlands at this site have been designed, built, and planted to look and function as natural wetlands with high species diversity to provide not only treatment but also wildlife habitat. One large diverse aerobic wetland complex was designed and

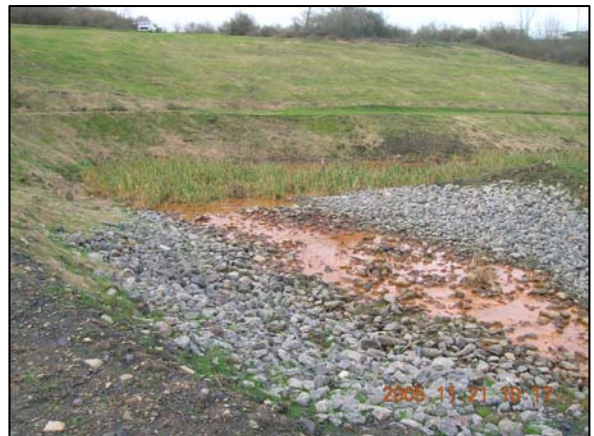
All diversion ditches, channels, and spillways should be inspected and maintained to minimize erosion and insure proper water handling. The channels should be kept free of obstructions that would restrict water flow. Any debris/obstructions should be removed. Vegetation should be removed from spillways if a "dam" is being created and causing the water level to be significantly raised in the component. The channels should also spread the flow to the maximum extent practical to help aerate the drainage, if concentrated channeling is developed, riprap should be rearranged to promote a broad flow path. If disturbed or eroded areas are present, then these areas should be stabilized as soon as possible with riprap or noninvasive plant species, as appropriate. Channels or ditches that carry mine drainage should be cleaned when accumulated material reduces the capacity by about one half.

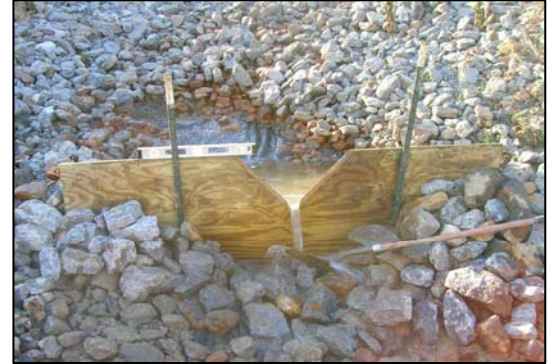
Flow rates can be measured at the SFMU2 weir using either an engineer's rule or a bucket and stopwatch method as the water flows over the weir.

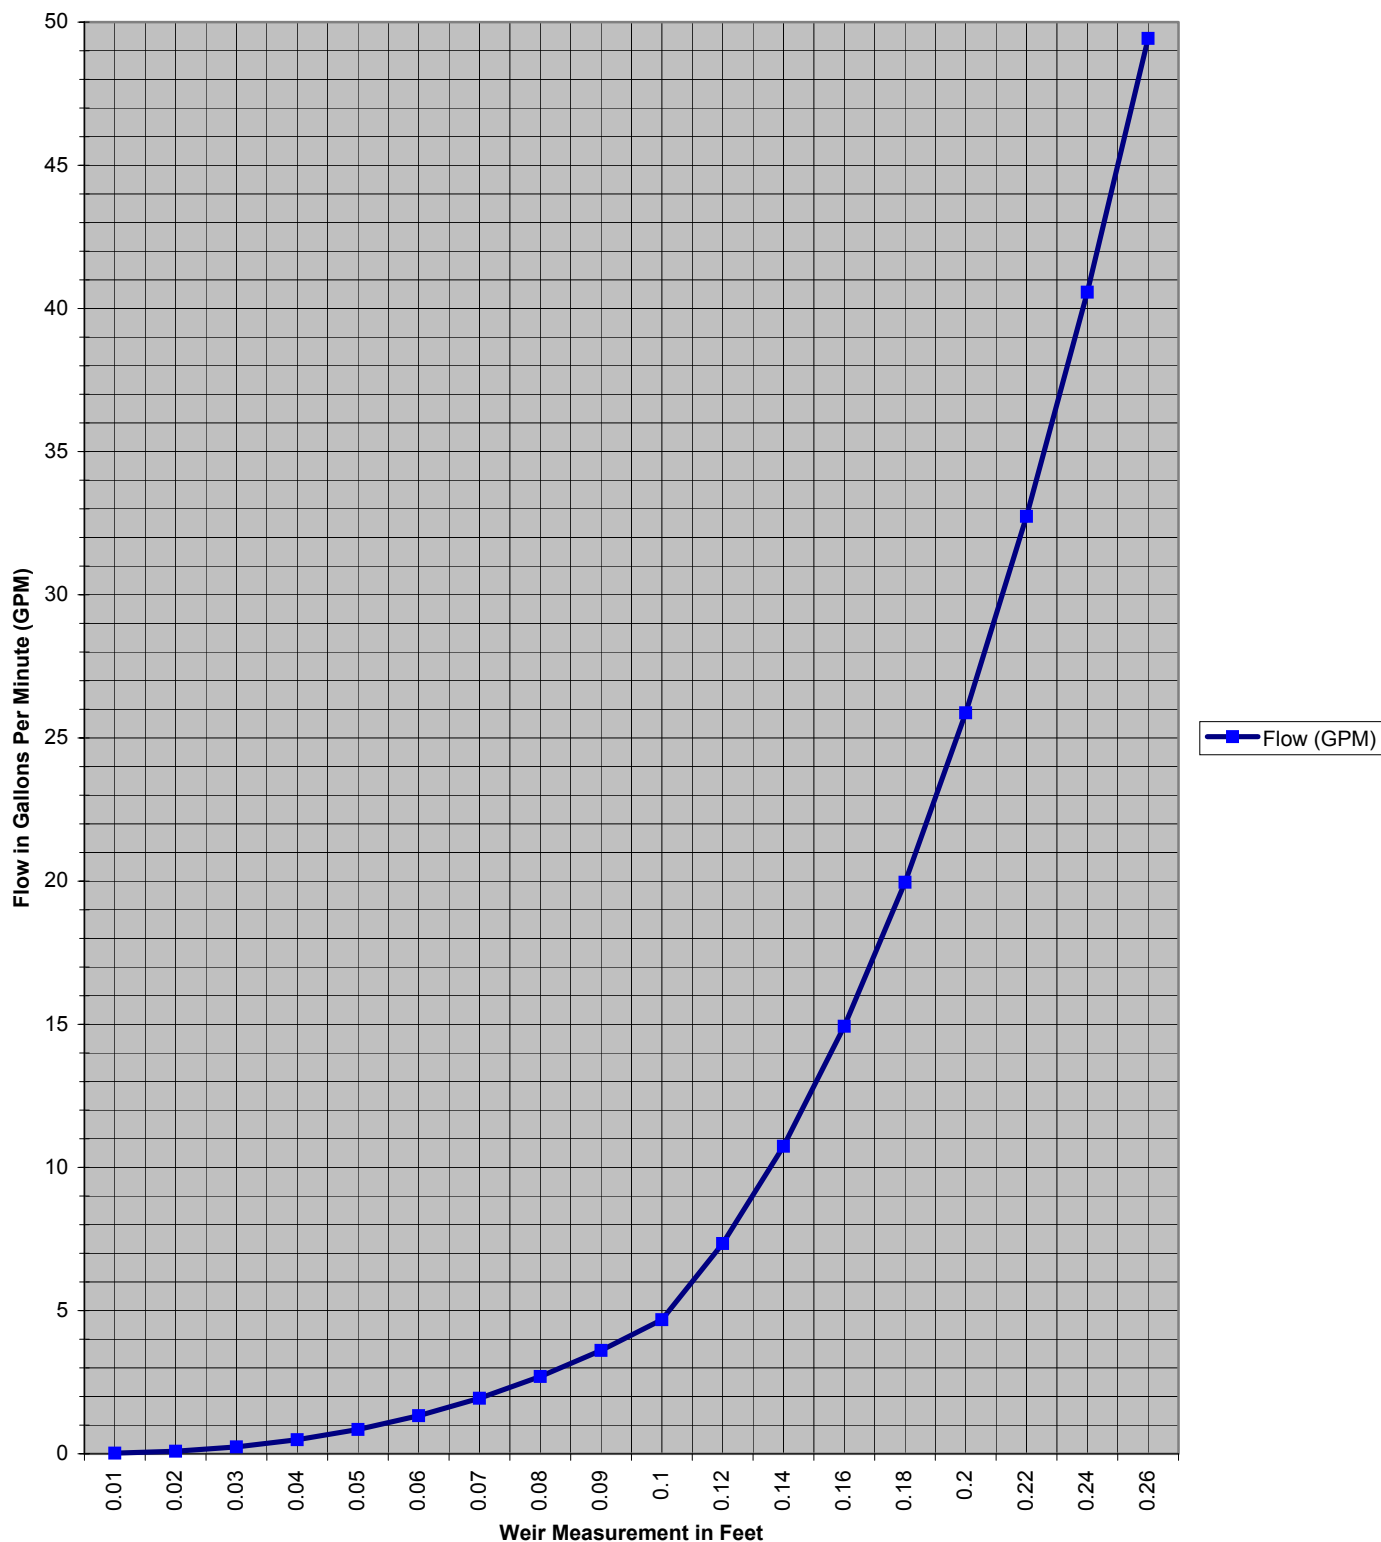
### 90-Degree V-Notch Weir Direct Read Flow Measurements For Low Flow (0-50 Gallons Per Minute) Conditions

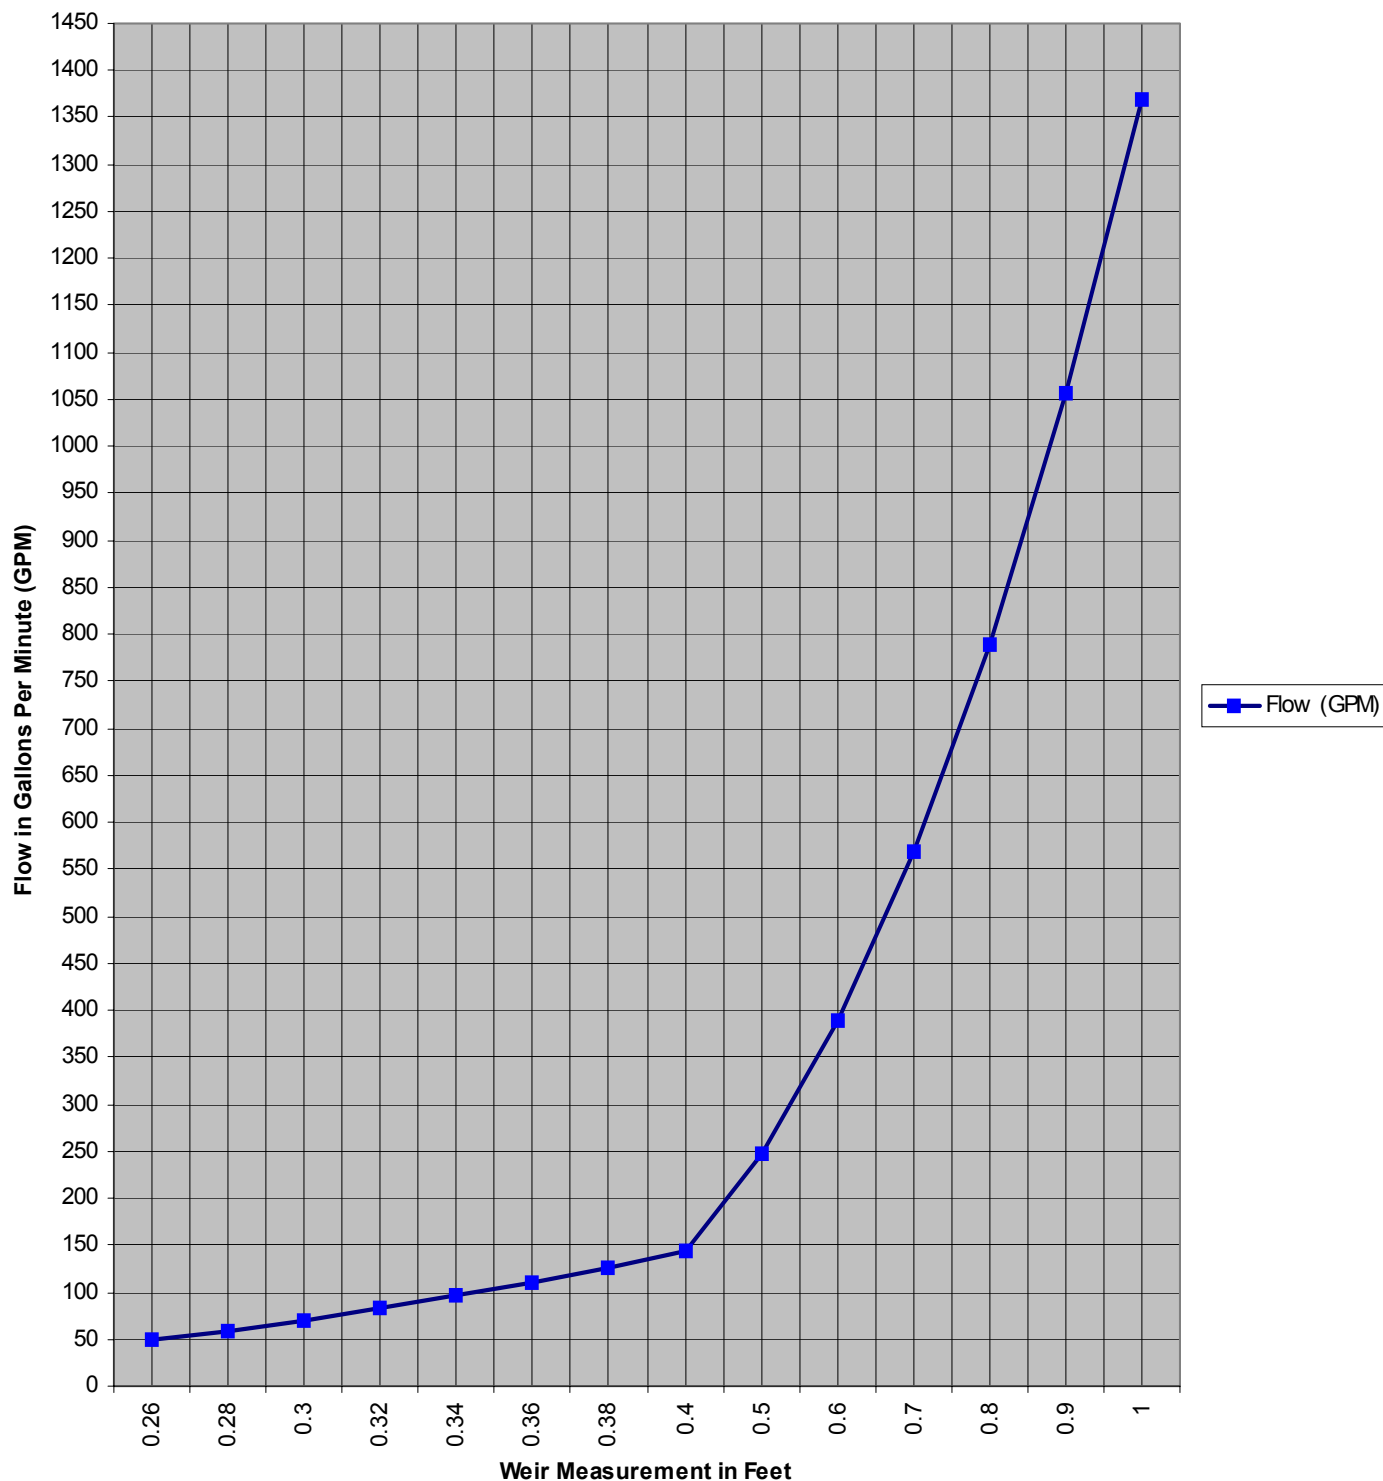
### 90-Degree V-Notch Weir Direct Read Flow Measurements For High Flow (50-1400 Gallons Per Minute) Conditions

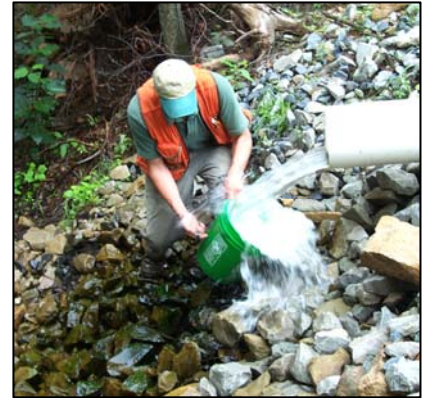
A bucket can be calibrated by using another container of known volume to add measured amounts of water to the bucket to be calibrated. Gradations (lines) can then be drawn with a permanent marker to connote the volume of water in gallons. For a 5-gallon bucket, gradations 1, 2, 3, 4, and 5 gallons should be used. For a larger bucket such as a 20-gallon bucket, gradations such as 5, 10, 15, 16, 18, and 20 or similar should be used.

Flow measurements at the weir and pipes can be made using a bucket and stopwatch. The bucket and stopwatch method consists of timing (in seconds) the filling of a bucket of known volume (preferably calibrated in gallons). The flow rate in gallons per minute can then be calculated utilizing the following formula:
