SR81 Passive Treatment System
SRI O&M TAG Project #46 Request #1
OSM PTS ID: PA-118

Requesting Organization: Pennsylvania Game Commission & SRWC
Receiving Stream: Slippery Rock Creek
Watershed: Slippery Rock Creek Watershed
Municipality/County: Washington Township, Butler County
Latitude/Longitude: 41°5'54"N / 79°51'34"W

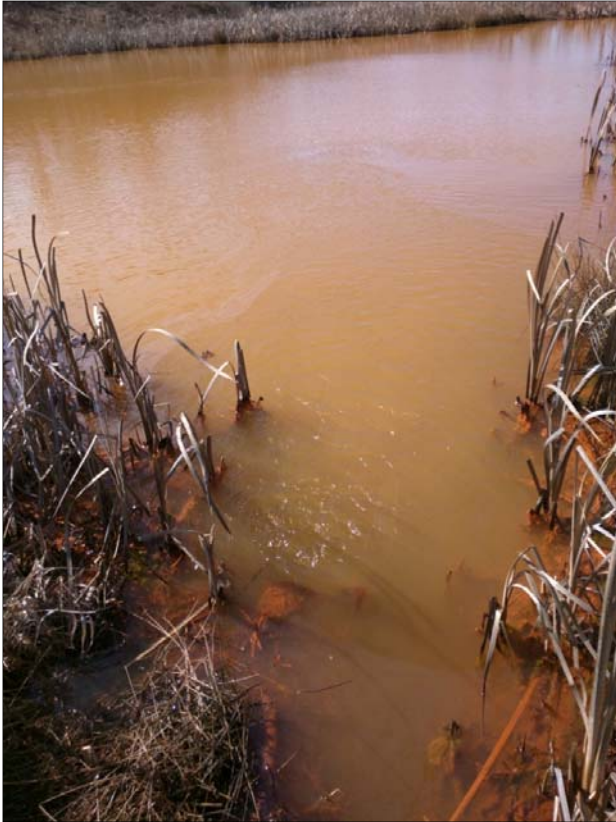
Top Left: A buildup of vegetation and sediment within the wetland was backing up water into the settling pond and overtopping the ALD effluent pipe.
Top Right: The wetland berm was built higher to temporarily prevent over-topping.
Bottom Right: Vegetation was removed from strategic locations in the wetland to encourage flow and lower the water elevation.
