Blacks Creek: BC16 Remediation Project

FINAL TECHNICAL REPORT

Blacks Creek Watershed, Slippery Rock Creek Headwaters
Marion Township, Butler County, PA

A US EPA & PA DEP 319 Project

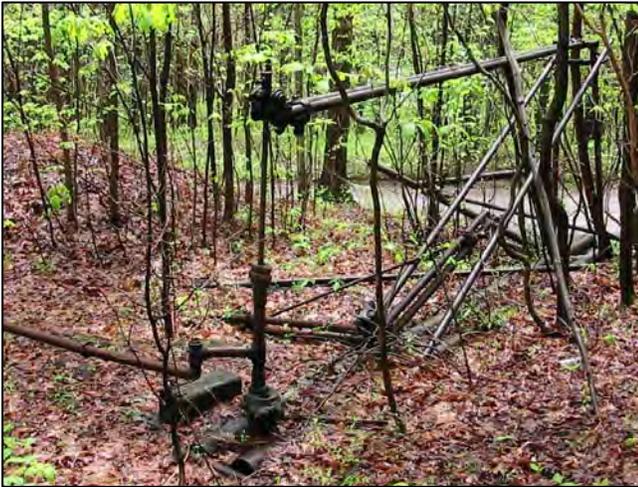
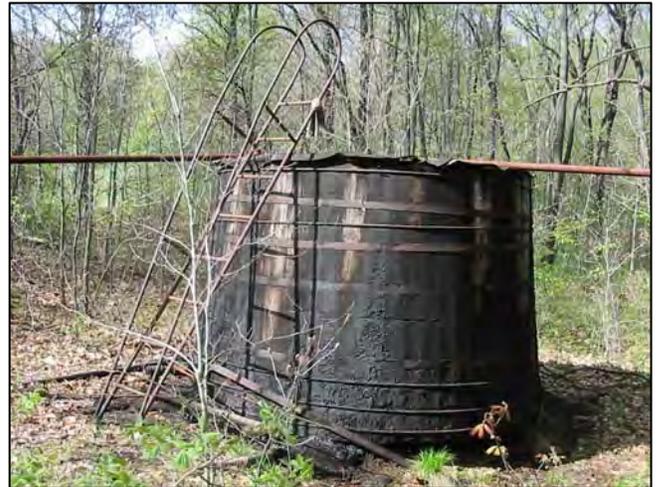
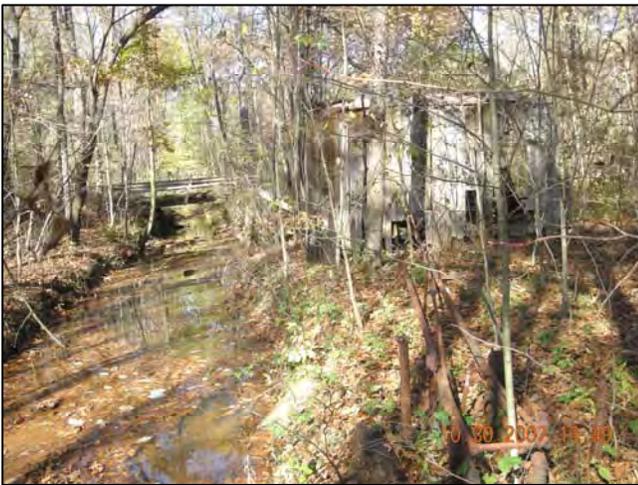
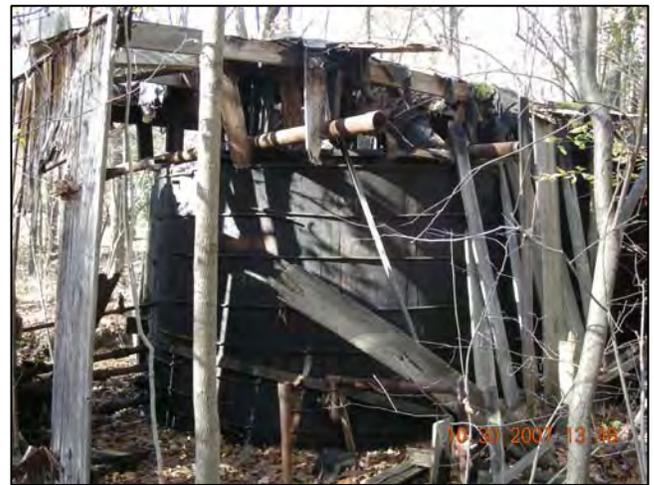
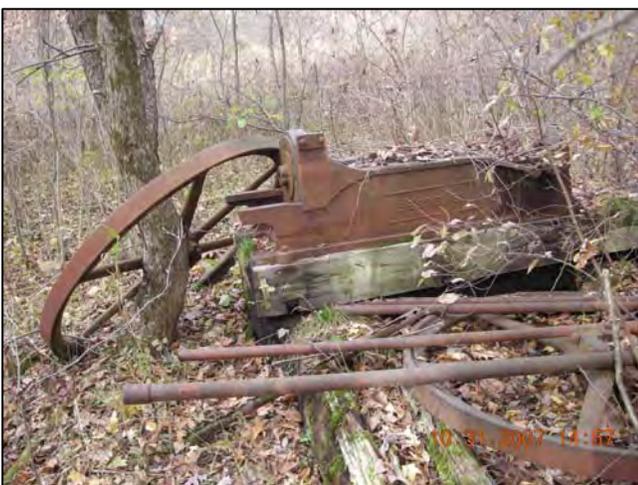
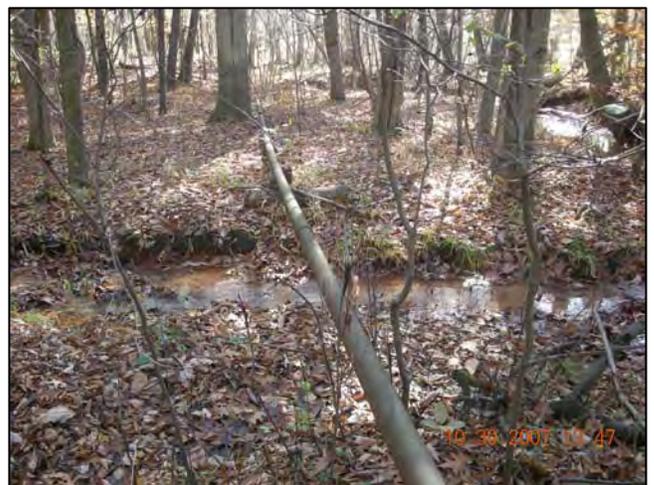
The northern portion of the 9-sq. mi. Blacks Creek watershed is part of the Bullion-Clintonville Oil Field with “pay zones” at a depth of ~1050 feet in the Venango Second and Third Sandstones. Petroleum exploration was reported to have begun around 1876. Numerous historic, as well as more recent, oil wells, pumping facilities, storage tanks, and piping systems are commonly observed. If casings are compromised, the old oil wells can provide a conduit for mine drainage to reach the surface.

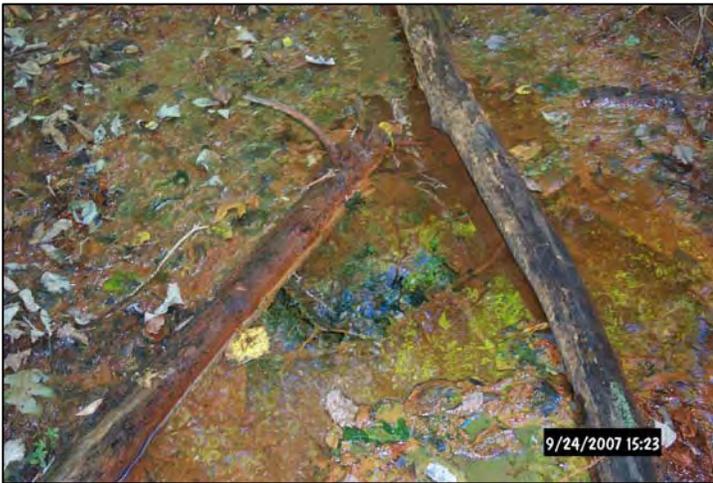
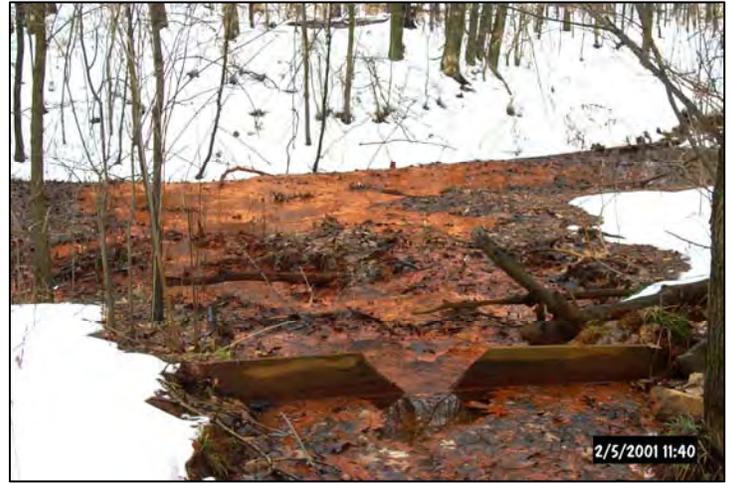
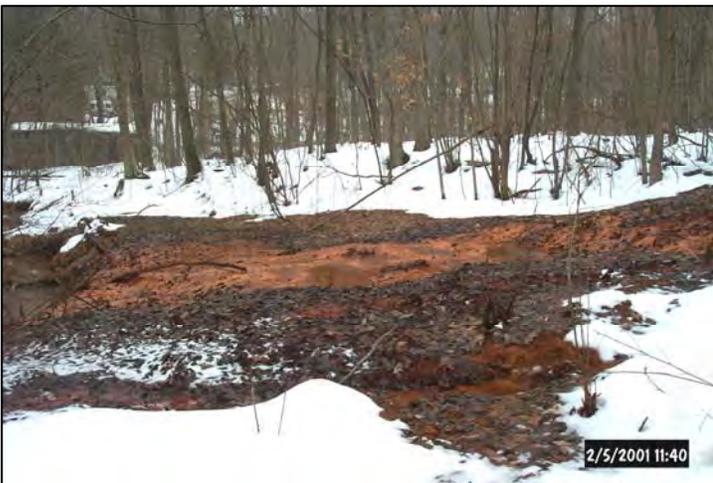
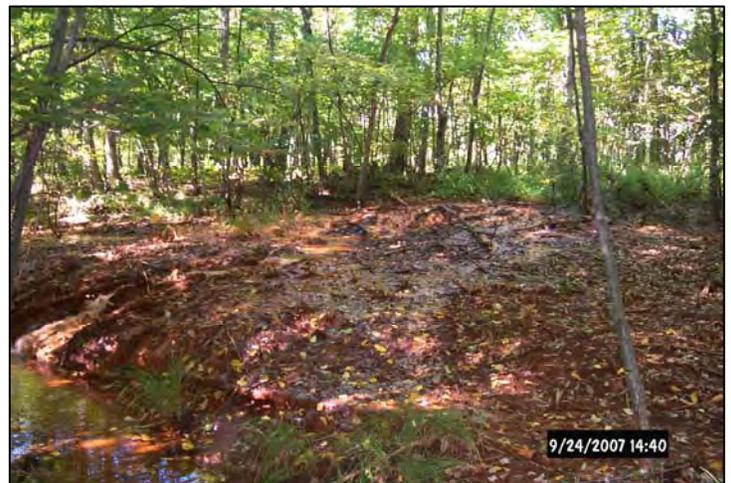
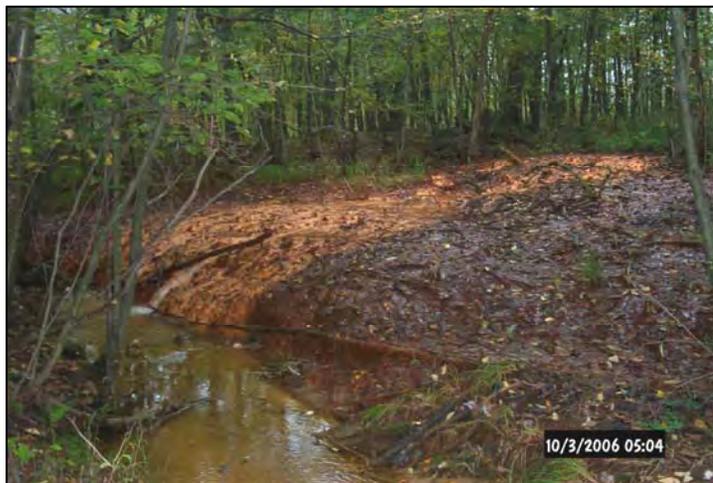
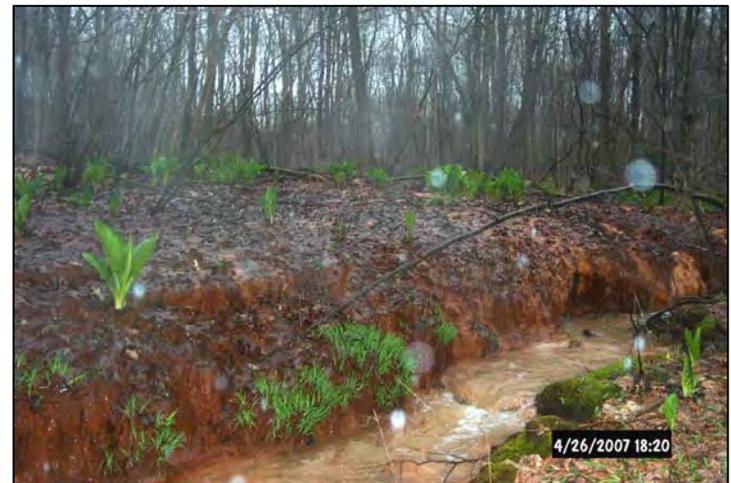
The BC16 abandoned mine discharge (Above) issues (Top Left) from what is believed to be an old oil well. BC16 is generally characterized as an alkaline, iron- and manganese-bearing, discharge. In the Blacks Creek Watershed Restoration Plan, the BC16 discharge was 2nd highest in terms of metal loadings and, therefore, identified as the #2 priority site for restoration. The BC16 discharge flows directly into tributary #15 (Bottom Left and Right) which was identified as the most polluted tributary within the watershed and representing nearly 50% of the pollutant loading to Blacks Creek.

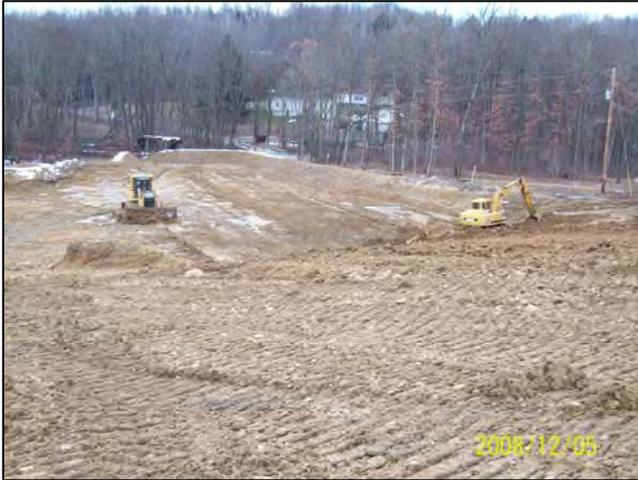
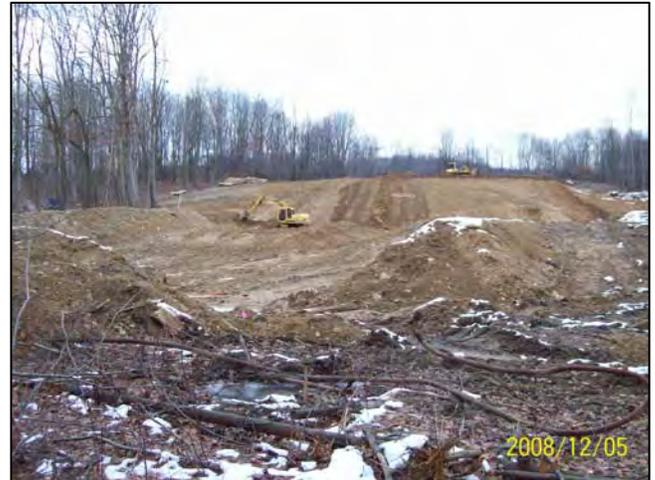
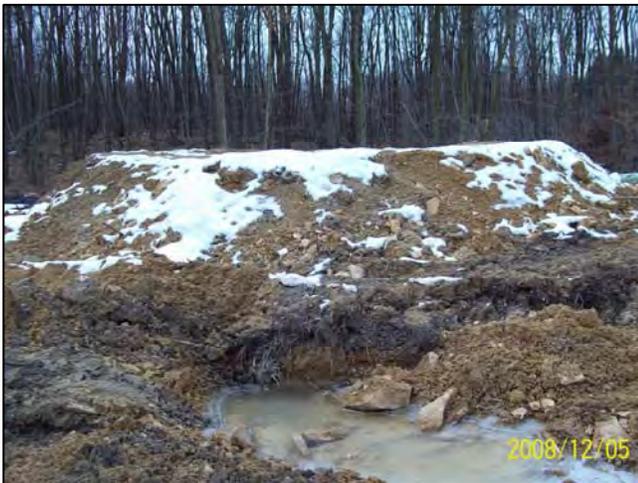
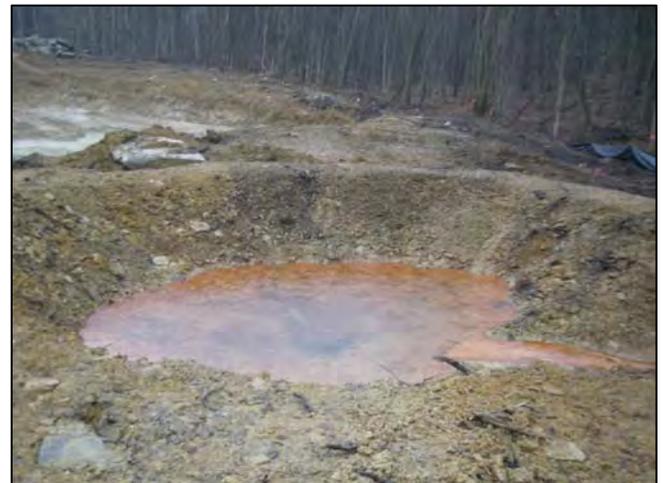
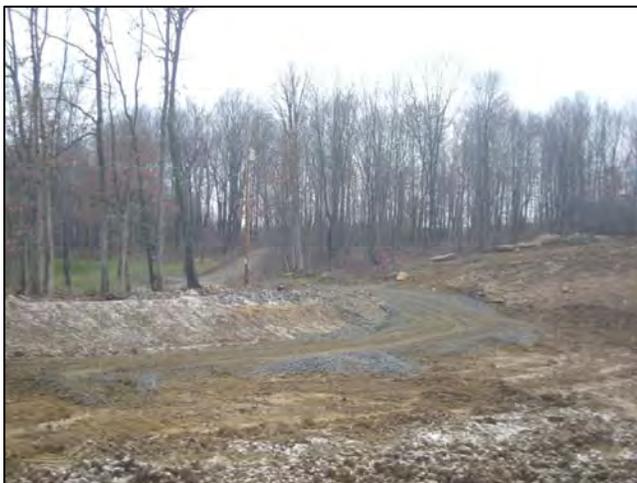
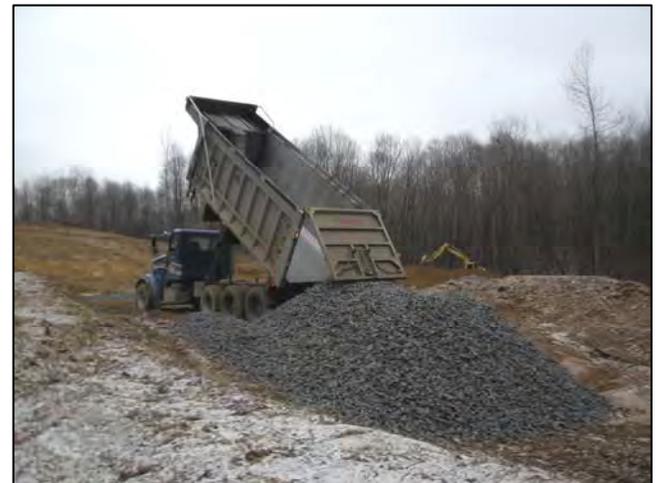
Once the passive system design and associated permitting were completed, the construction area was cleared and grubbed (Top Left and Right). Next, earth material was excavated using a dozer and excavator to the design elevation of the system. Suitable material from the excavation was used to construct the embankments for the passive system. Large boulders encountered during construction were placed to provide wildlife habitat (Bottom Right).

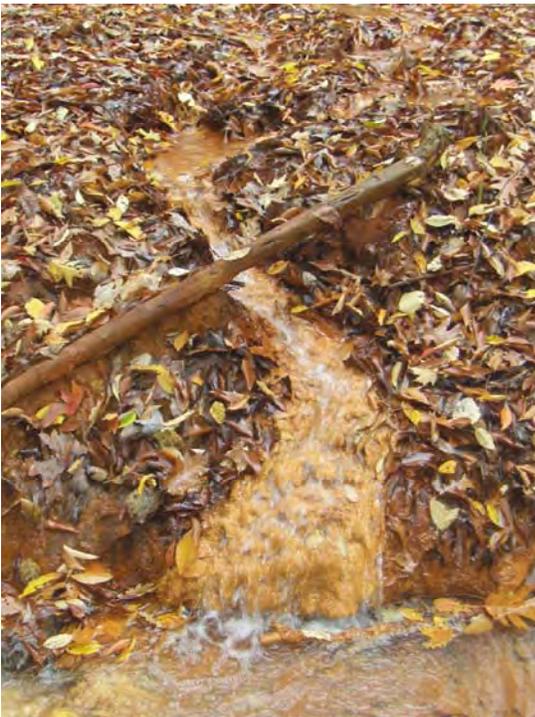
BC16 runoff into unnamed tributary

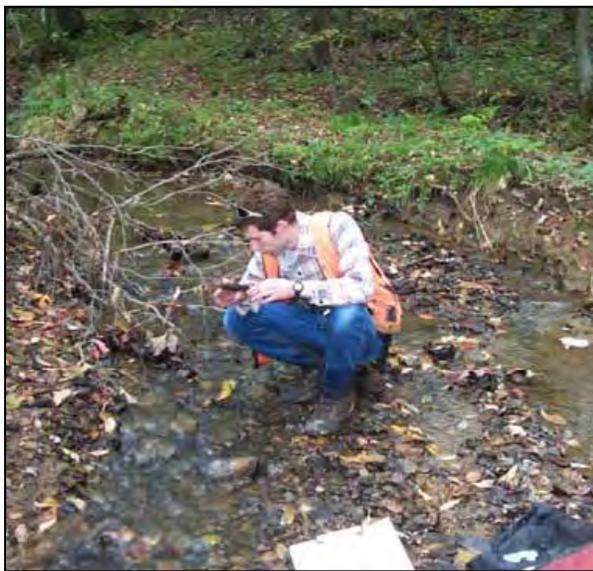
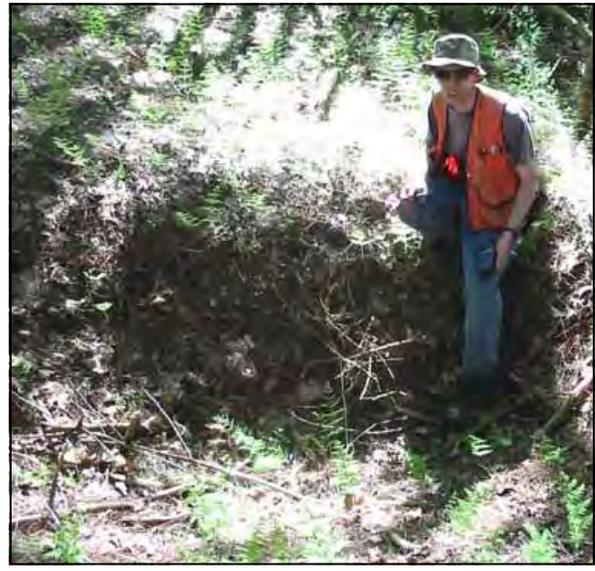
Shaun Busler, SRWC participant, is shown doing field work for the Blacks Creek assessment and implementation plan. Shaun checks rocks during a macroinvertebrate inventory (Left) and shows the location of an abandoned underground mine (Right), indicated by subsidence. See article on back page.

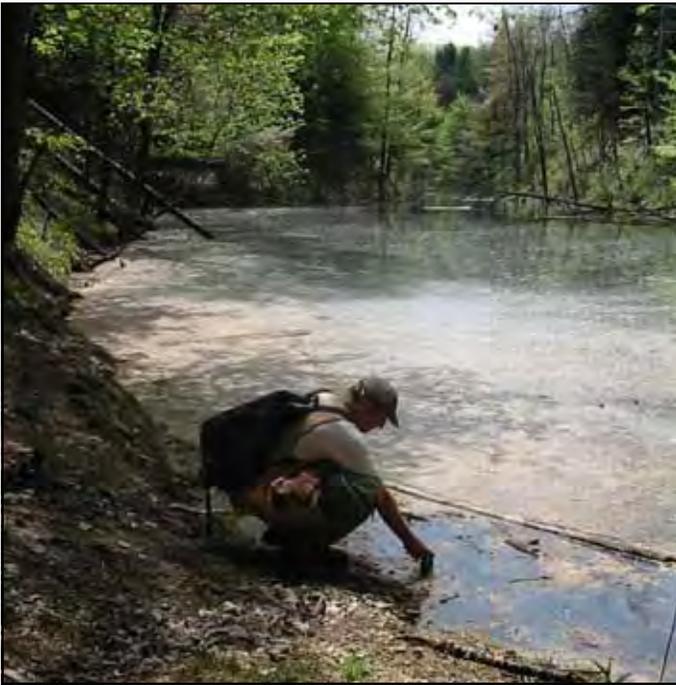
Cliff Denholm takes a water sample from one of many water-filled pits
