BF 389-101.1

AMD Passive Treatment System

Project #: BF 389-101.1 (Primacy Bond Forfeiture)

Project Name: Darmac Coal, Inc. (Darmac 14)

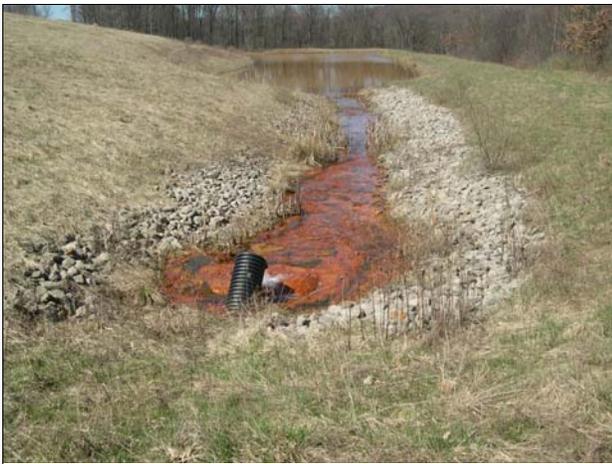
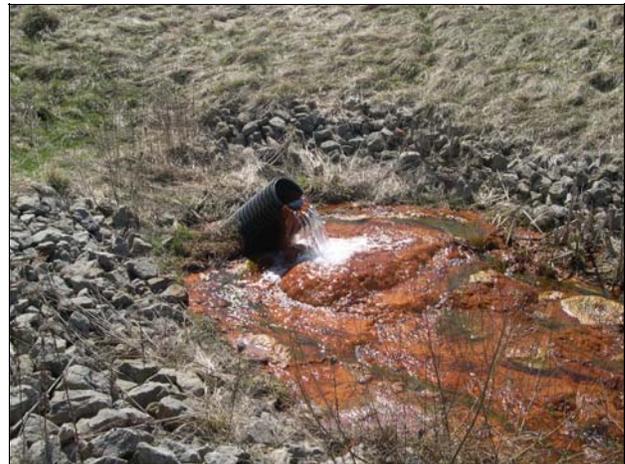
The evaluators were Dave Fromell, Steve Golembiewski, PJ Shah, and Mitch Smith. During the field review discussion Dave Fromell, Steve Golembiewski, PJ Shah, & Mitch Smith walked the site and inspected the system. Locations of all 9 sampling points were walked to show Mitch (who replaced Dale Eury) where to sample. Mitch's first round of sampling began the day of this inspection. Outflows were not bucket-tested due to flow volume (ALD outflow PC 11-6 est ~120 gpm) and lack of a bucket. The majority of wetland vegetation was dead, probably due to inundation when the outlet pipe was plugged for a long period of time until repairs could be made in 2005, however cattails were growing near the pond outlet. The R-5 rock baffle was not visible, which could mean that the water is still a bit too deep. The untreated discharge, PC 11-9, est ~60 gpm. The system is currently working well, and generally has been since it was constructed. Project goals to increase pH and Alkalinity, & decrease metals loading were met. Glade Run water quality has improved, however another (new) discharge (PC 11-9), which remains untreated, still exists at the site. It is the evaluator's understanding that the District Mining Office is investigating treatment options for this new discharge (PC 11-9).

No retrofit/repairs/modifications recommended at this time, as the system is still functioning as designed. However, future improvements, which could be undertaken by the BD Crew, include installing one weir, either at the outlet of the ALD, or the outlet of the Wetland, installing one or two "floating" baffles in the settling pond, & re-establishing wetland vegetation. These improvements could be undertaken when the pond needs cleaned.

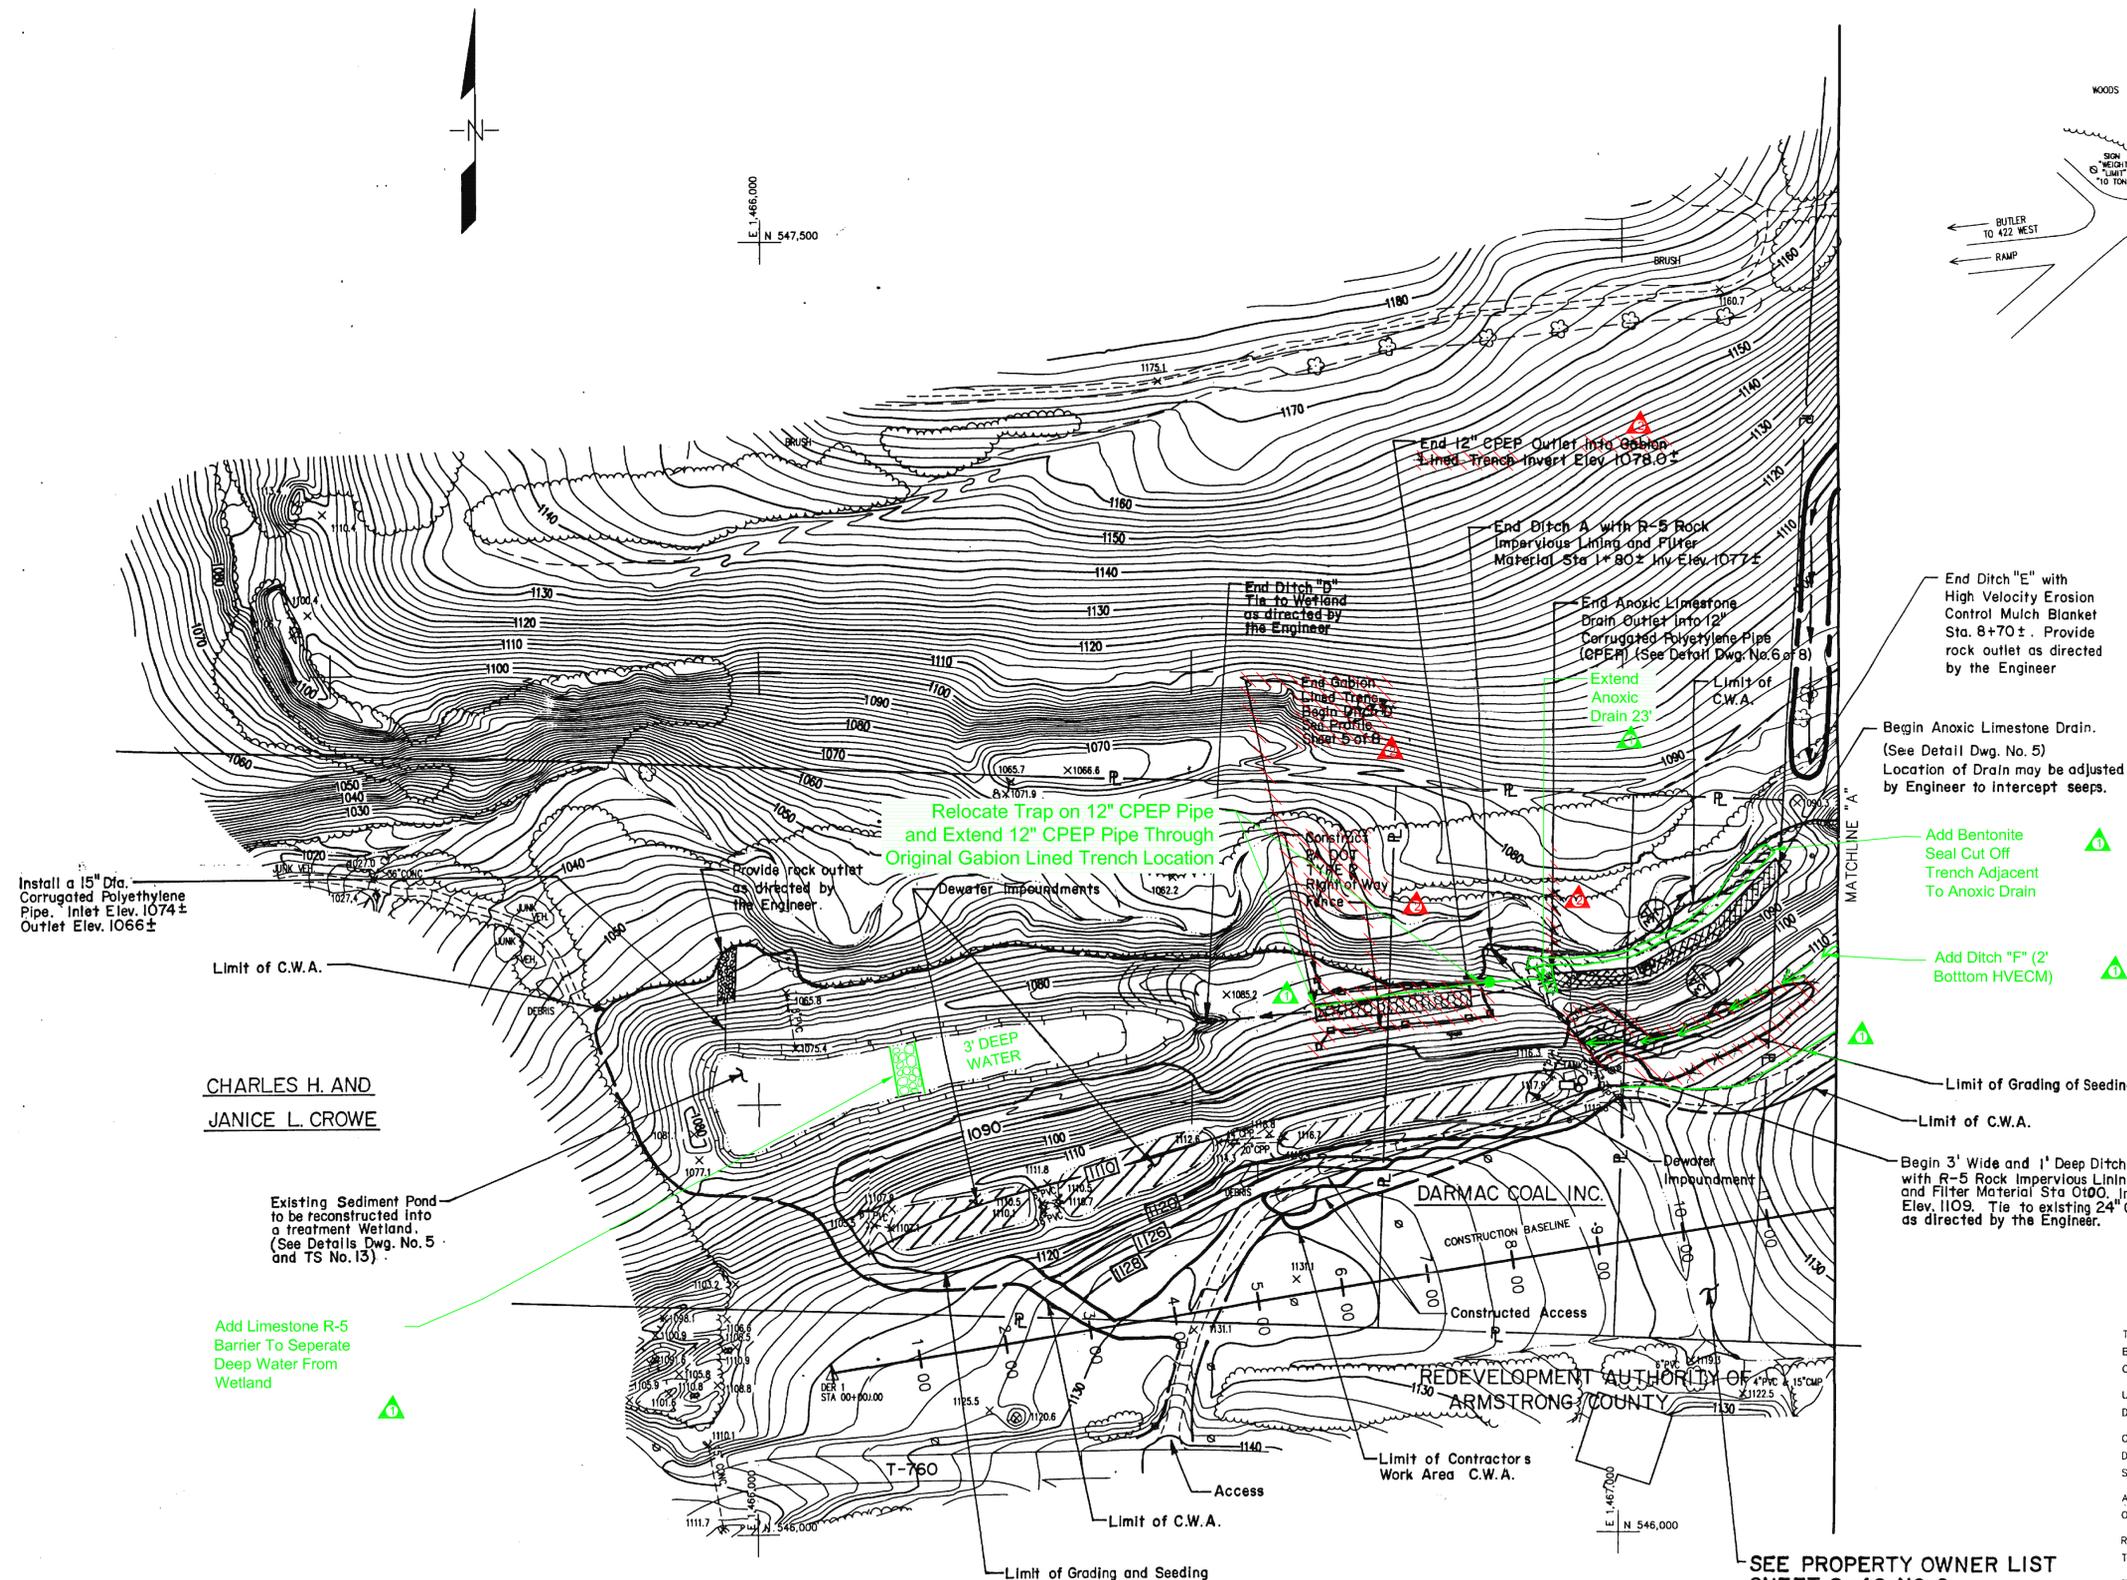
PLAN

- End Ditch "E" with High Velocity Erosion Control Mulch Blanket Sta. 8+70 ±. Provide rock outlet as directed by the Engineer
- Begin Anoxic Limestone Drain. (See Detail Dwg. No. 5) Location of Drain may be adjusted by Engineer to intercept seeps.
- Add Bentonite Seal Cut Off Trench Adjacent To Anoxic Drain
- Add Ditch "F" (2' Bottom HVECM)
- Limit of Grading of Seeding
- Limit of C.W.A.
- Begin 3' Wide and 1' Deep Ditch A with R-5 Rock Impervious Lining and Filter Material Sta 0+00, Invert Elev. 1109. Tie to existing 24" CMP as directed by the Engineer.

Existing Sediment Pond
to be reconstructed into
a treatment Wetland.
(See Details Dwg. No. 5
and TS No. 13)

Add Limestone R-5
Barrier To Separate
Deep Water From
Wetland

Install a 15" Dia.
Corrugated Polyethylene
Pipe. Inlet Elev. 1074 ±
Outlet Elev. 1066 ±

Relocate Trap on 12" CPEP Pipe
and Extend 12" CPEP Pipe Through
Original Gabion Lined Trench Location
