Cessna Run Abandoned Mine Drainage Treatment System Operations, Maintenance, and Replacement Plan

Thomas J. Clark, Susquehanna River Basin Alliance
Anne Daymut, Indiana County Conservation District

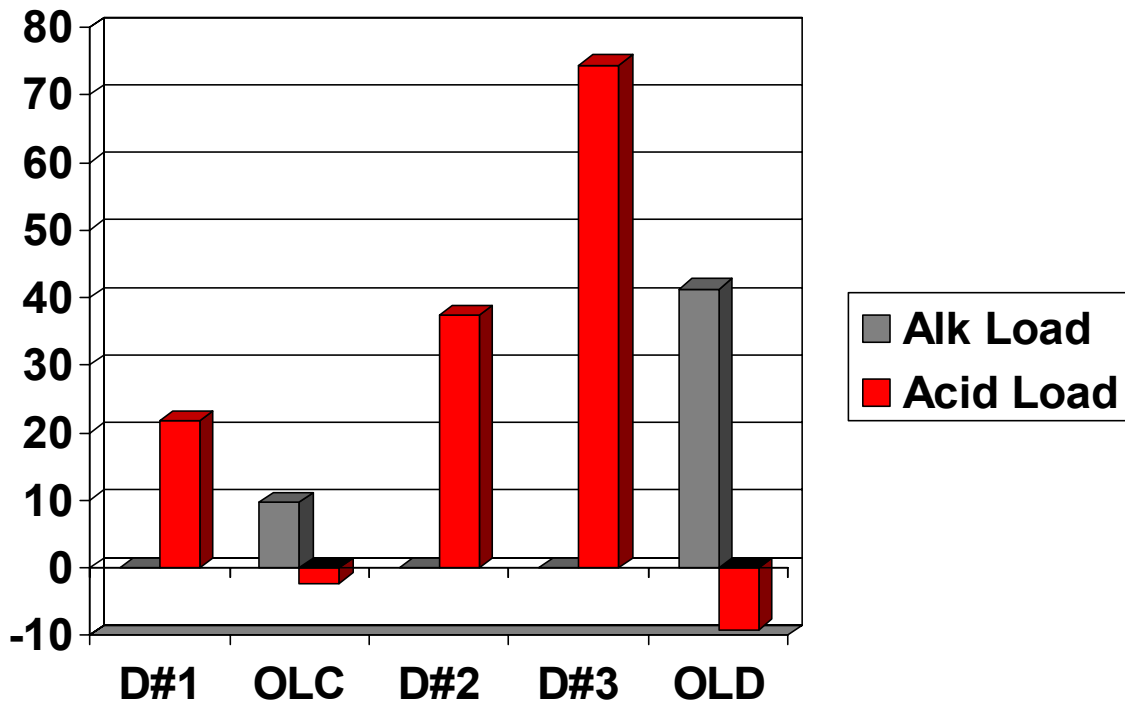
Figure 3. The influent and effluent alkalinity and acidity loadings of the two Phase I Cessna Run treatment systems.

50.98 lbs/day of alkalinity were added. In addition, aluminum and manganese loadings have been reduced 65% and 52% respectively (Table 3 and Figure 3, 4 and 5). Metal concentration reductions are great, but not ideal because of the amount of land available for sedimentation due to stream and wetland constraints.
